Pecos Manor HOA
Gilbert, AZ

Report #: 12434-0
Beginning: January 1, 2023
Expires: December 31, 2023

RESERVE STUDY
"Full"

December 15, 2022

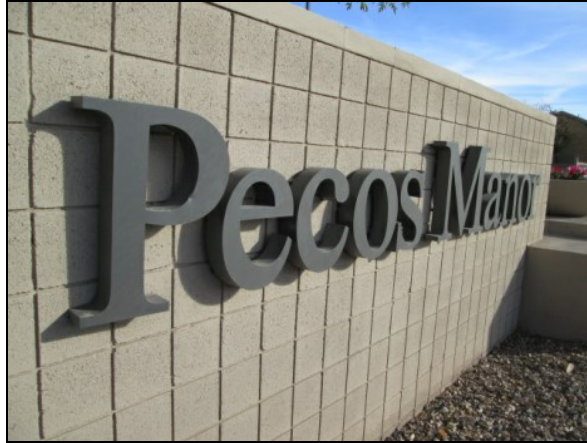
Comments: Monuments consist of reverse pan channel lettering mounted to walls. Letters read "Pecos Manor". Monuments are basic, intact and in fair condition. This component funds to update or modernize the monuments with new lettering plus repairs to the walls and landscape.

Useful Life:
20 years

Remaining Life:
6 years

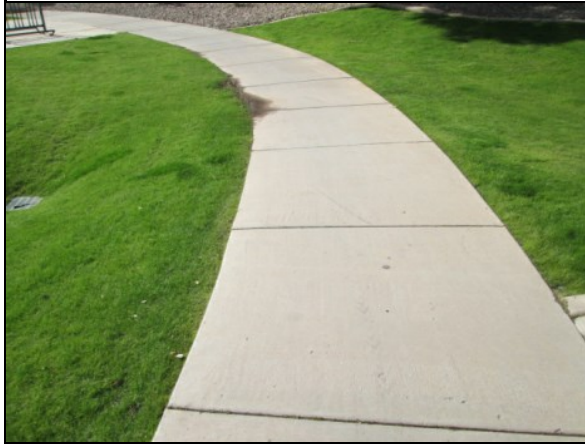
Comp #: 220 Concrete - Repair

Useful Life:
5 years

Remaining Life:
3 years
