Scottsdale Park Villas HOA
Scottsdale, AZ

Report #: 15925-0
Beginning: January 1, 2023
Expires: December 31, 2023

RESERVE STUDY
"Full"

October 12, 2022

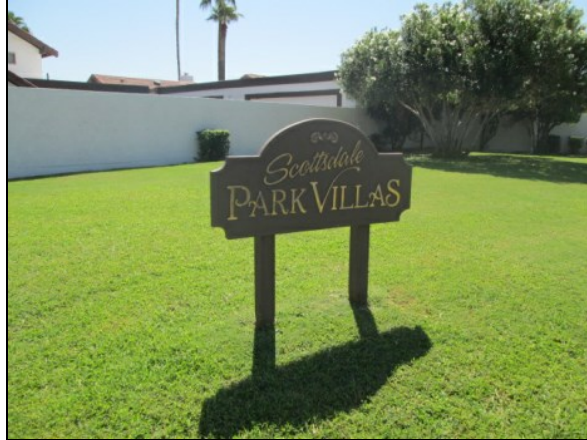
Comments: Monuments consist of lettering mounted to wood signs. Letters read "Scottsdale Park Villas". This component funds an allowance to update or modernize the monuments. Appear to be older, weathered and worn.

Useful Life:
20 yearsRemaining Life:
0 years

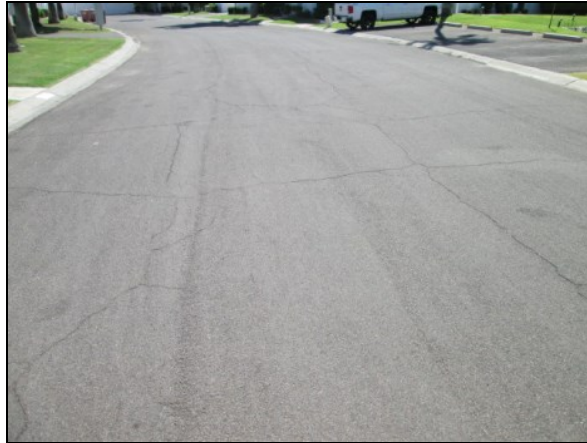
Comments: Appears to be older and worn with extensive cracking evident. Alligator cracking is forming throughout. This component funds to remove and repave the asphalt. Life span is based on periodically seal coating and maintaining the surface. Funding to overlay the concrete drives is included.

Useful Life:
30 yearsRemaining Life:
8 years

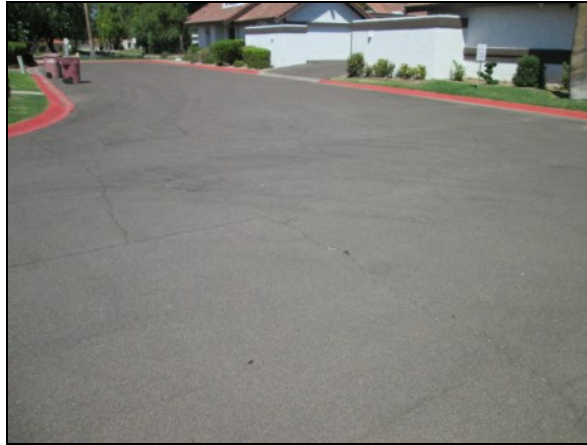
Comp #: 202 Asphalt - Seal/Repair (2023 & 2027)

Useful Life:
4 years

Remaining Life:
0 years

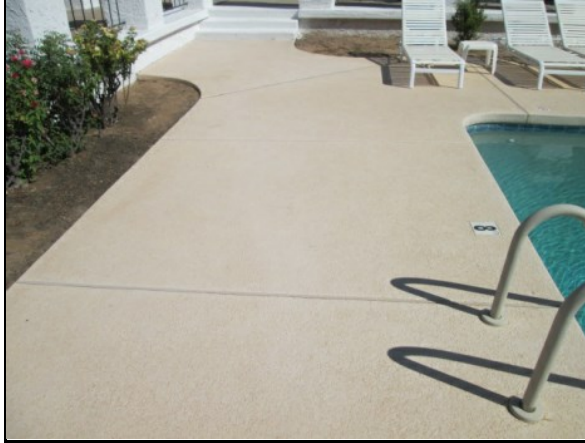
Comments: This is an acrylic coating applied to an underlying concrete deck. Appears to be generally intact and functional. Some wear and cracking noted. Surfaces near the irrigated areas and the south bridge are significantly more worn. This component funds to periodically grind off the existing deck coating and re-apply a new surface. Combined cost with the paint/seal component accounts for the total estimated resurface budget.

Useful Life:
12 yearsRemaining Life:
2 years

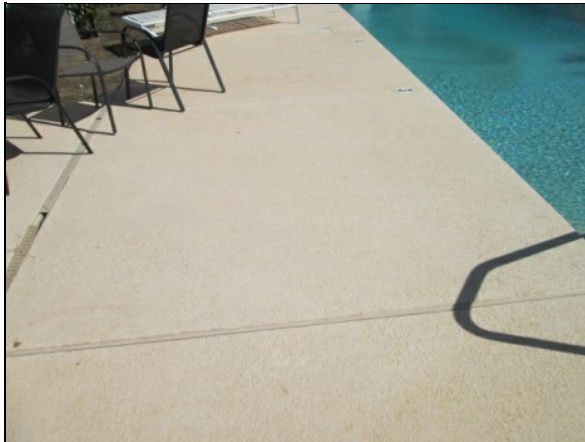
Comments: Some staining evident. This component funds to periodically patch cracks and paint/seal the deck to cover stains and restore the appearance.

Useful Life:
4 yearsRemaining Life:
2 years
