The Fairways at Los Portales *Casa Grande, AZ*

Report #: 52891-0
Beginning: January 1, 2025
Expires: December 31, 2025

RESERVE STUDY Update "With-Site-Visit"

November 27, 2024

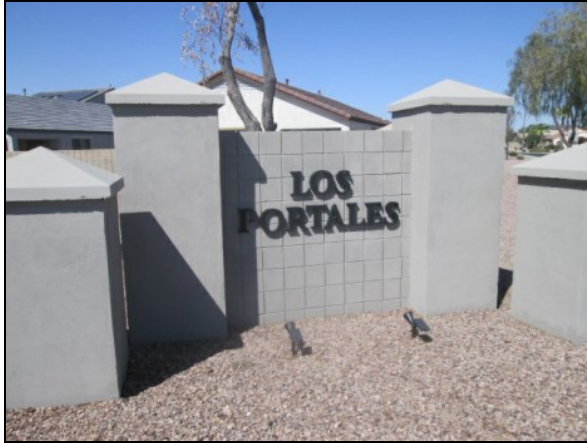
Comp #: 100 Monument - Replace**Quantity: (1) Monument**

Comments: Monument appears to be in fair condition. Surfaces exhibit some fading and weathering but no major issues were observed. This component funds an allowance to update or modernize the monument with new lettering plus repairs to the walls and landscape.

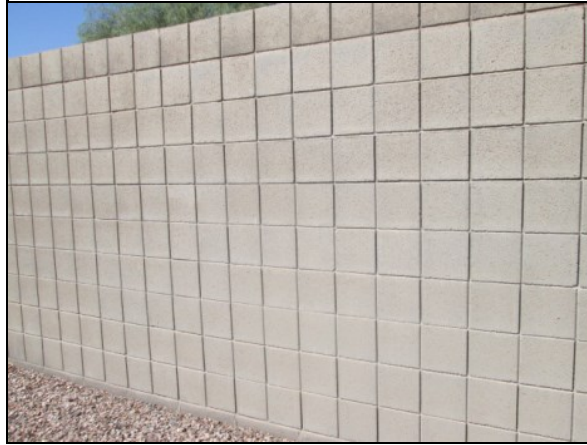
Comments: Block surfaces appeared weathered and discolored throughout. Repaint periodically to maintain the appearance and to inhibit rusting.

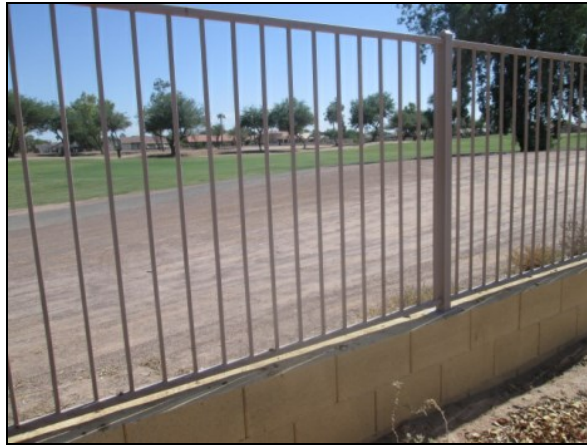
Comments: View fence is generally intact but some sections are rusted. Surfaces appear old and faded, but no major issues noted. This component funds to completely replace view fence throughout the community. Replacement cost is shared 50/50 between the HOA and lot owners, so this component only accounts for the HOA's 50% responsibility. Funding for repaint is included under Metal Surfaces - Repaint, component #550.
