Rancho Reina HOA
Tucson, AZ

Report #: 51549-0
Beginning: January 1, 2025
Expires: December 31, 2025

RESERVE STUDY
"Full"

August 22, 2024

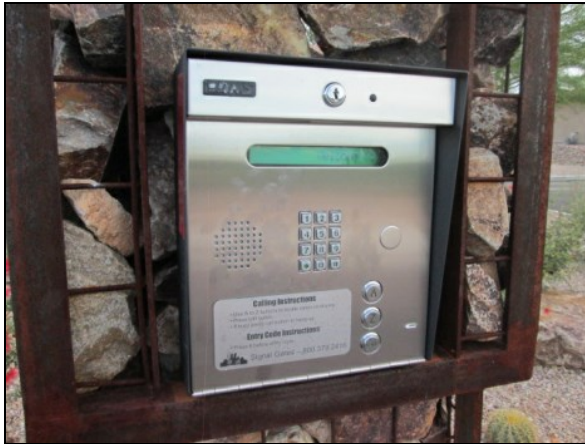
Comp #: 130 Entry System - Replace

Comments: Appears functional and in good shape. Future replacement should be anticipated.

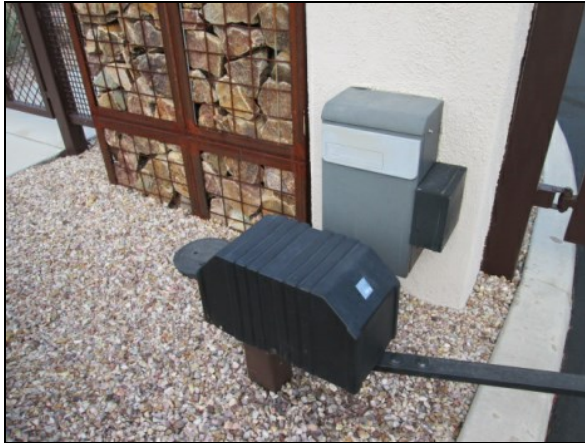
Comp #: 140 Gate Operators - Replace

Comments: No issues observed or reported. Future replacement should be anticipated.

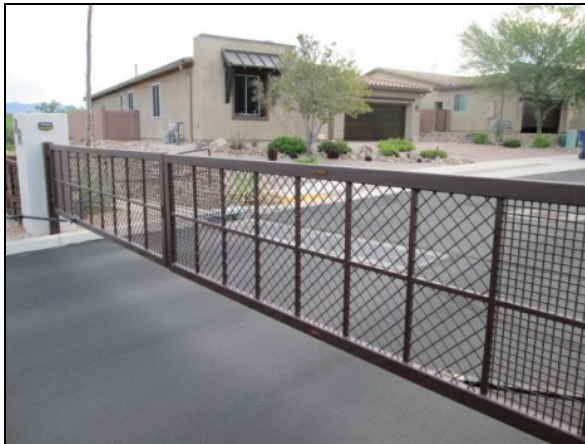
Comp #: 150 Vehicle + Ped Gates - Replace

Comments: Long life component under normal circumstances, however the HOA should still be prepared for complete replacement eventually.

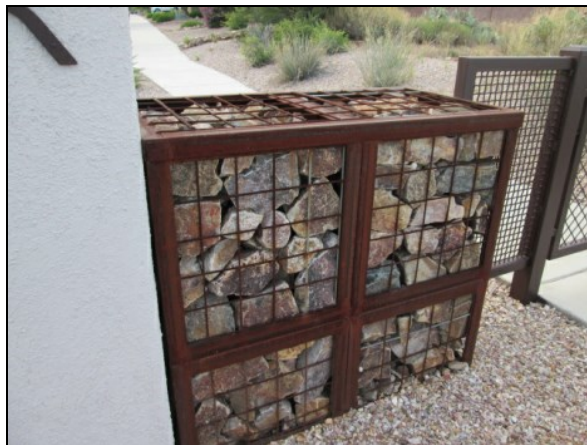
Comp #: 175 Gabion Walls + Fence - Replace

Comments: Long life component under normal circumstances, however the HOA should still be prepared for complete replacement eventually.

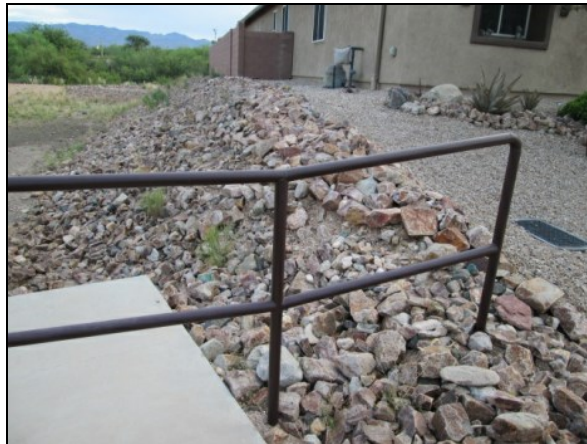
Comp #: 185 Metal Rails - Replace/Repaint

Funded?: No. There is no expectancy for replacement in the foreseeable future. Repaint periodically as an Operating expense, and/or include with other painting projects.

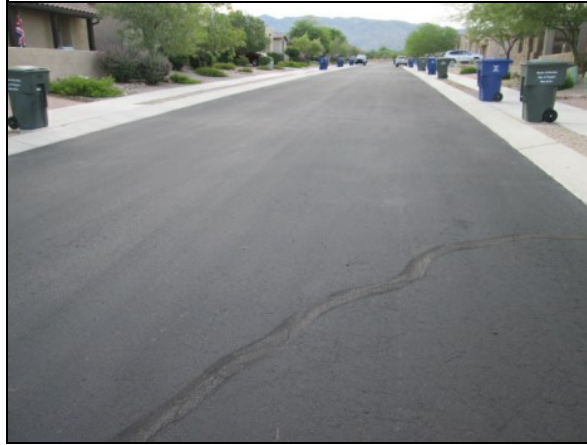
Comments: A few cracks noted, but still smooth and in good shape overall. Life span is based on periodically seal coating and maintaining the surface.

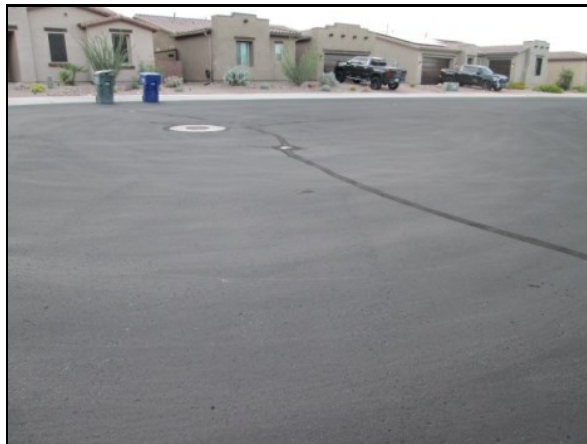
Comp #: 205 Asphalt - Seal/Repair

History: Seal coat and crack fill completed in 2023 for ~\$11,900 (cost included an additional fee of \$2,500 to perform 2 mobilizations instead of 1). Per satellite imagery, asphalt was previously sealed for the first time around 2019.

Comments: Surfaces appear dark and uniform in coverage. Seal coat asphalt surfaces periodically to prevent premature cracking and deterioration.

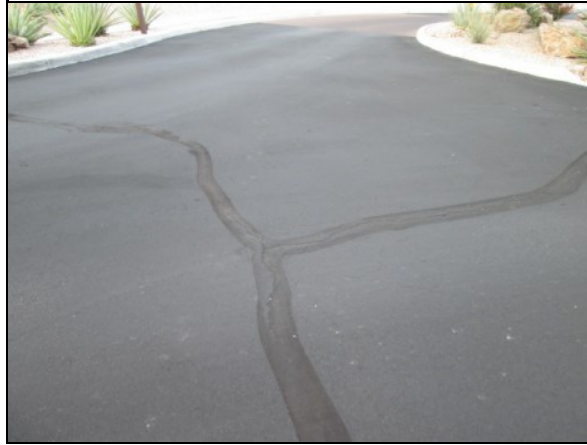
Comp #: 208 Asphalt - Crack Fill

History: Crack fill completed in 2024 for ~\$2,150. Previously completed in 2023 and 2019 as part of the seal coat projects.

Comments: This component funds to crack fill the asphalt every couple years, which includes in-between and during seal coat projects.

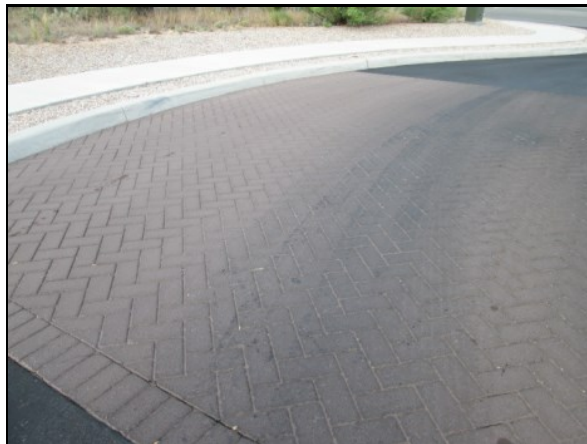
Comments: Some discoloration noted, but still intact and in good shape. Long life component under normal circumstances, however future replacement should still be anticipated. Recommend coordinating with repaving the community street. Life span assumes periodic recoating as scheduled.

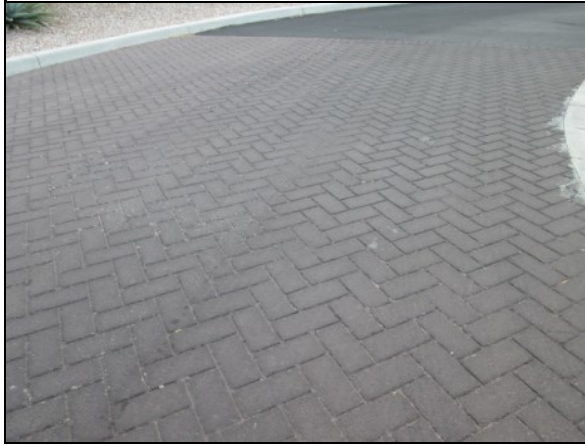
Comments: Some discoloration noted. Expect to periodically recoat the stamped asphalt to maintain the appearance and prolong the life expectancy. Recommend planning to recoat during every other seal coat cycle of the community street.

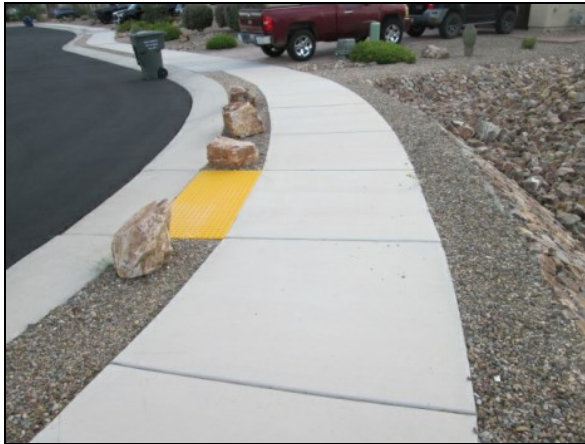
Comp #: 230 Concrete/Pavers - Repair

Comments: There is no expectancy to completely replace the concrete. This component provides an allowance for periodic repairs and/or partial replacements. Still intact and in good shape overall.

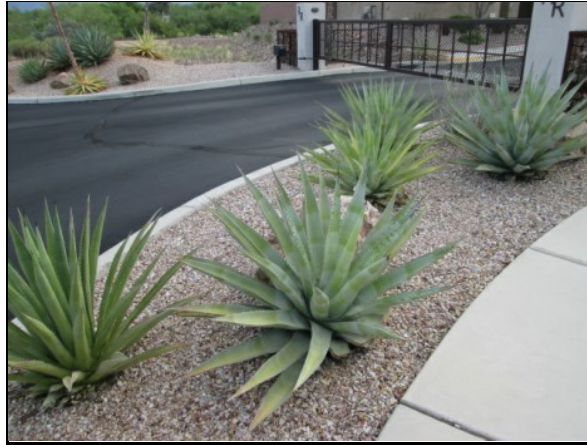
Comp #: 801 Irrigation System - Replace

Funded?: No. We assume system will be repaired as-needed using Operating funds.
