June 01, 2013

PROPERTY ASSET EVALUATION

ZAHARA AT LAS SENDAS

Mesa, Arizona

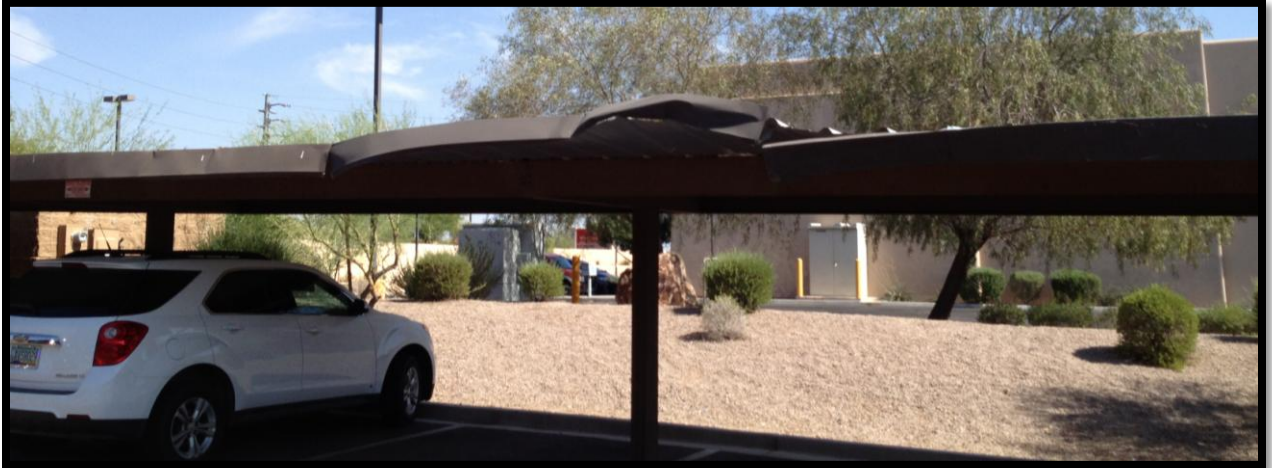
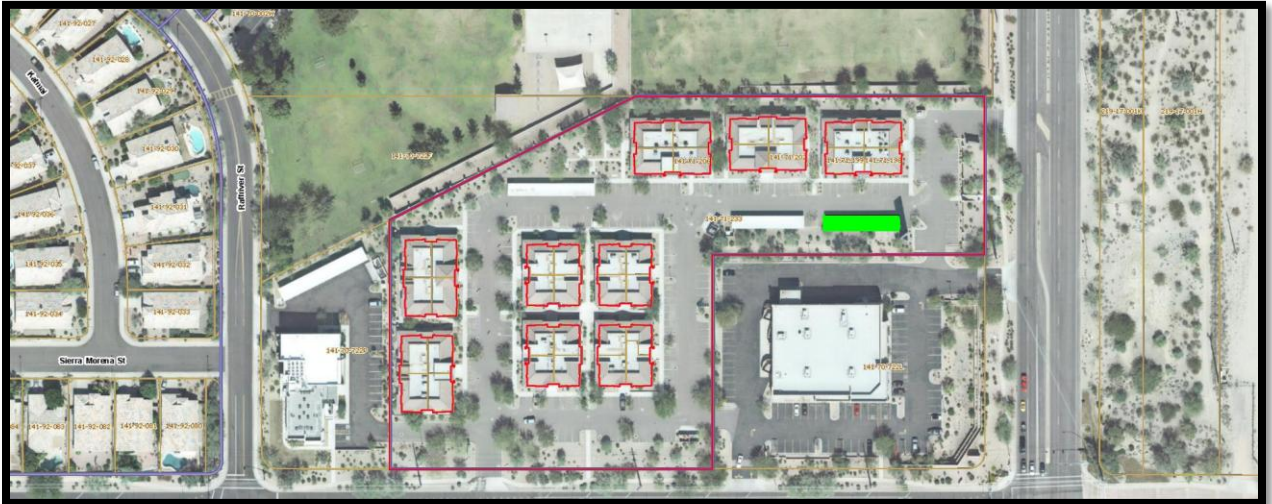
1. Damaged Carport, marked in green on the second photo. We did notice new construction on one of the building adjacent to the carport. This may be the cause of the damage as large equipment is used for delivering materials and delivering and picking up roll off containers.

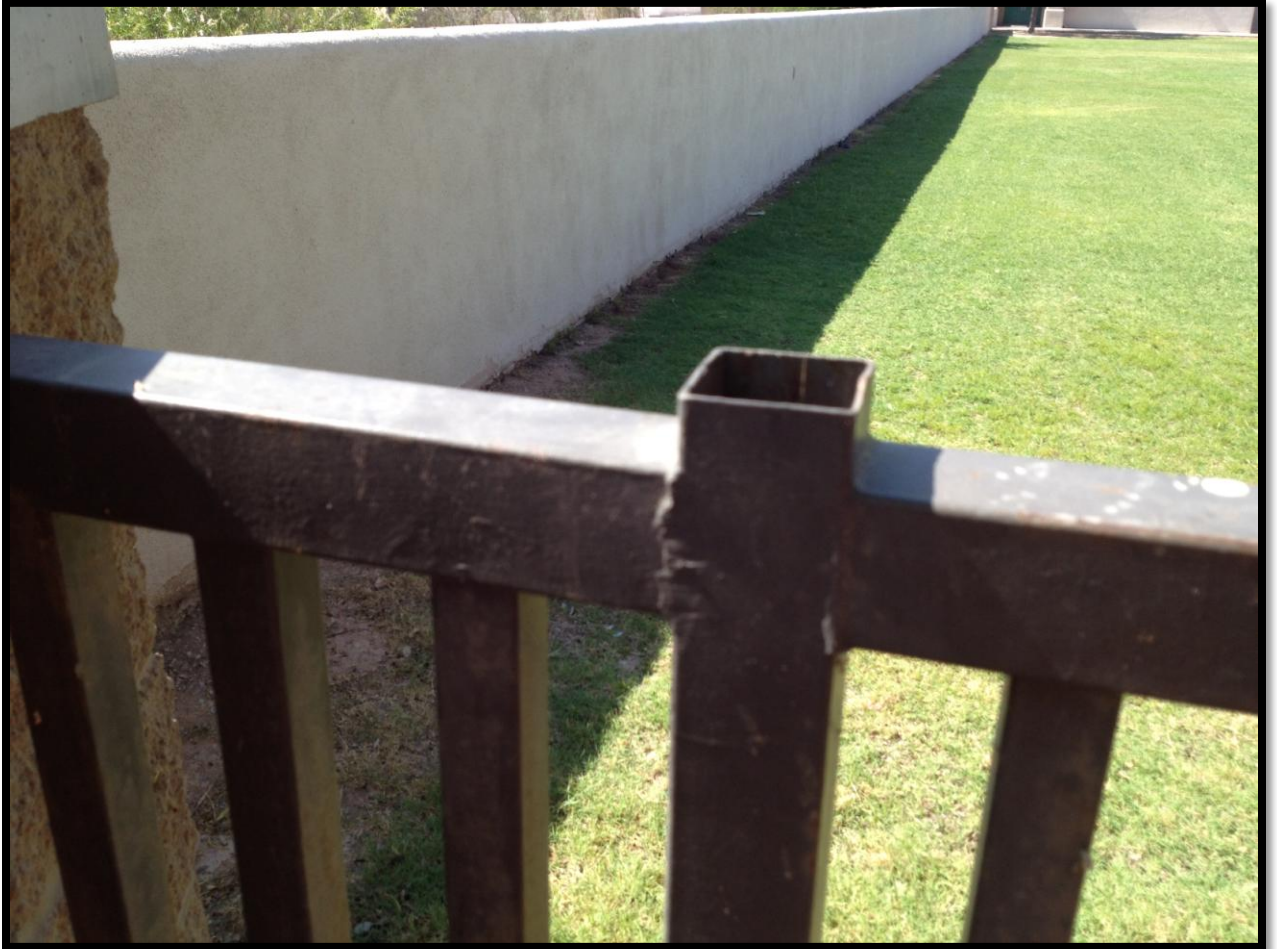
2. There are a few missing plastic caps on the wrought iron posts along the north and northwest perimeter. These caps protect the inside of the steel from moisture and rust while serving as a safety feature as well.

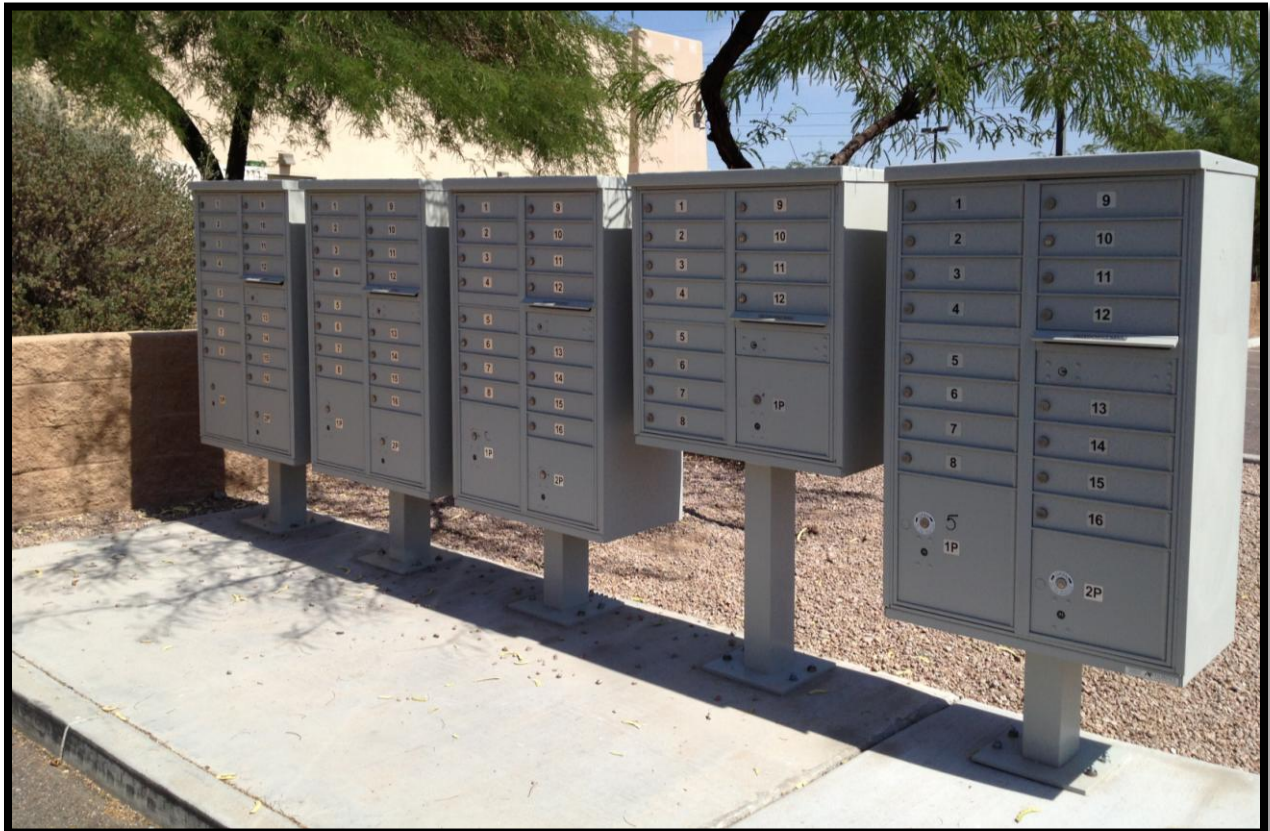
Asset #100	Mail Boxes	Quantity	CBU's
Constructed	2006	Current Cost to replace	\$11,300.00
Useful Life	20 years	Cost to replace 2026	\$16,594.00
Years Remaining	13 years		
Replacement	20 26

The cluster box units in Zahara at Las Sendas are owned and maintained by the Association. The useful life for this component averages at 20 years based on use and exposure. The material cost information was provided by AF Florence Manufacturing. We have added shipping and handling, installation and disposal of existing units.

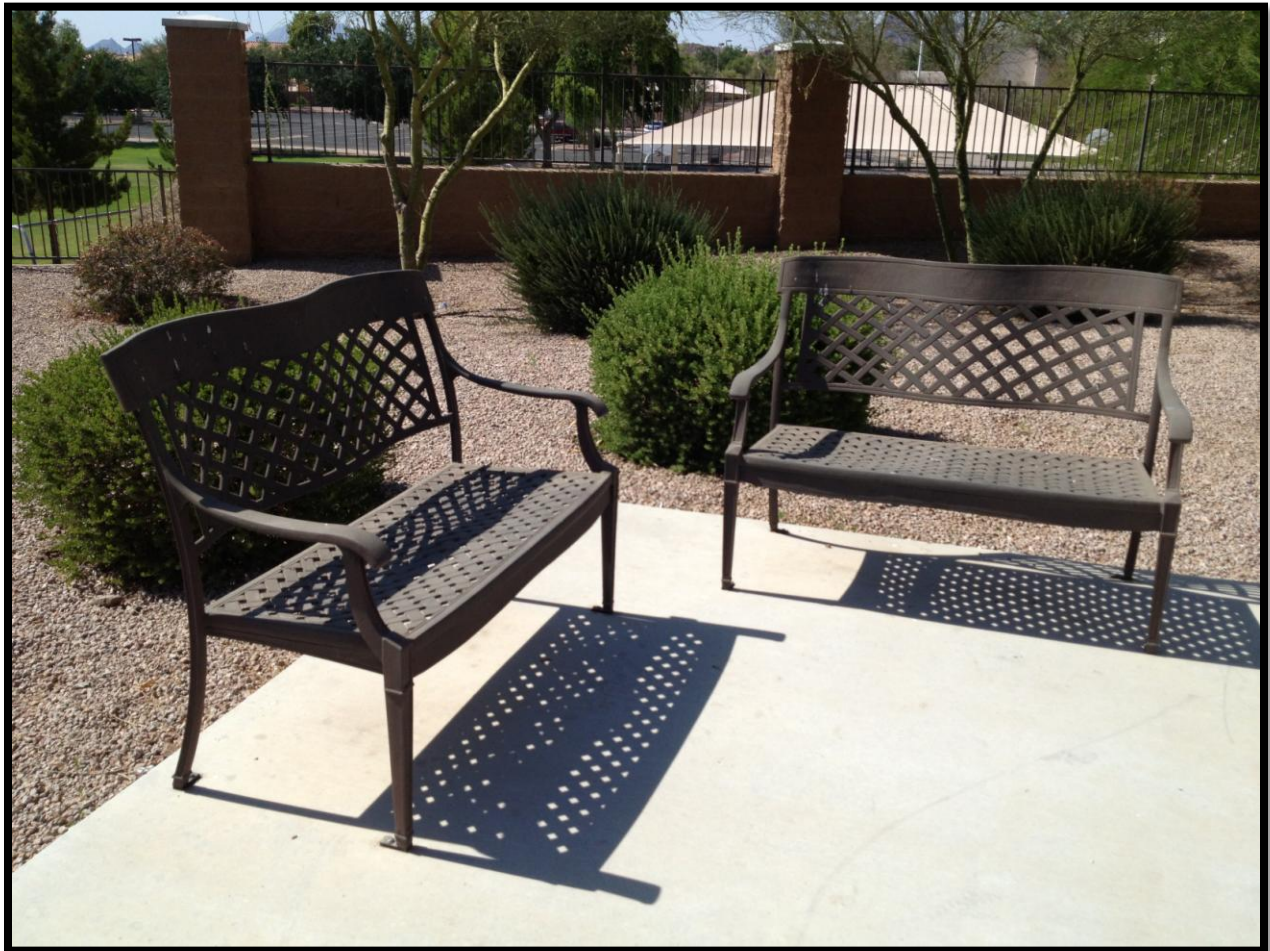
Asset #114	Bench Replacement	Quantity	8
Constructed	Assumed 2012	Current Cost to replace	\$4,800.00
Useful Life	10 years	Cost to Replace 2022	\$6,263.00
Years Remaining	9 years	Cost to Replace 2032	\$8,417.00
Replacement	2026	Cost to Replace 2042	\$11,312.00

The benches appear to be new and of mixed variety and material. The concrete and recycled plastic bench will last longer than the cast aluminum benches. As a result we have funded a budget for replacement every 10 years. We strongly encourage the Association to only purchase commercial grade benches.

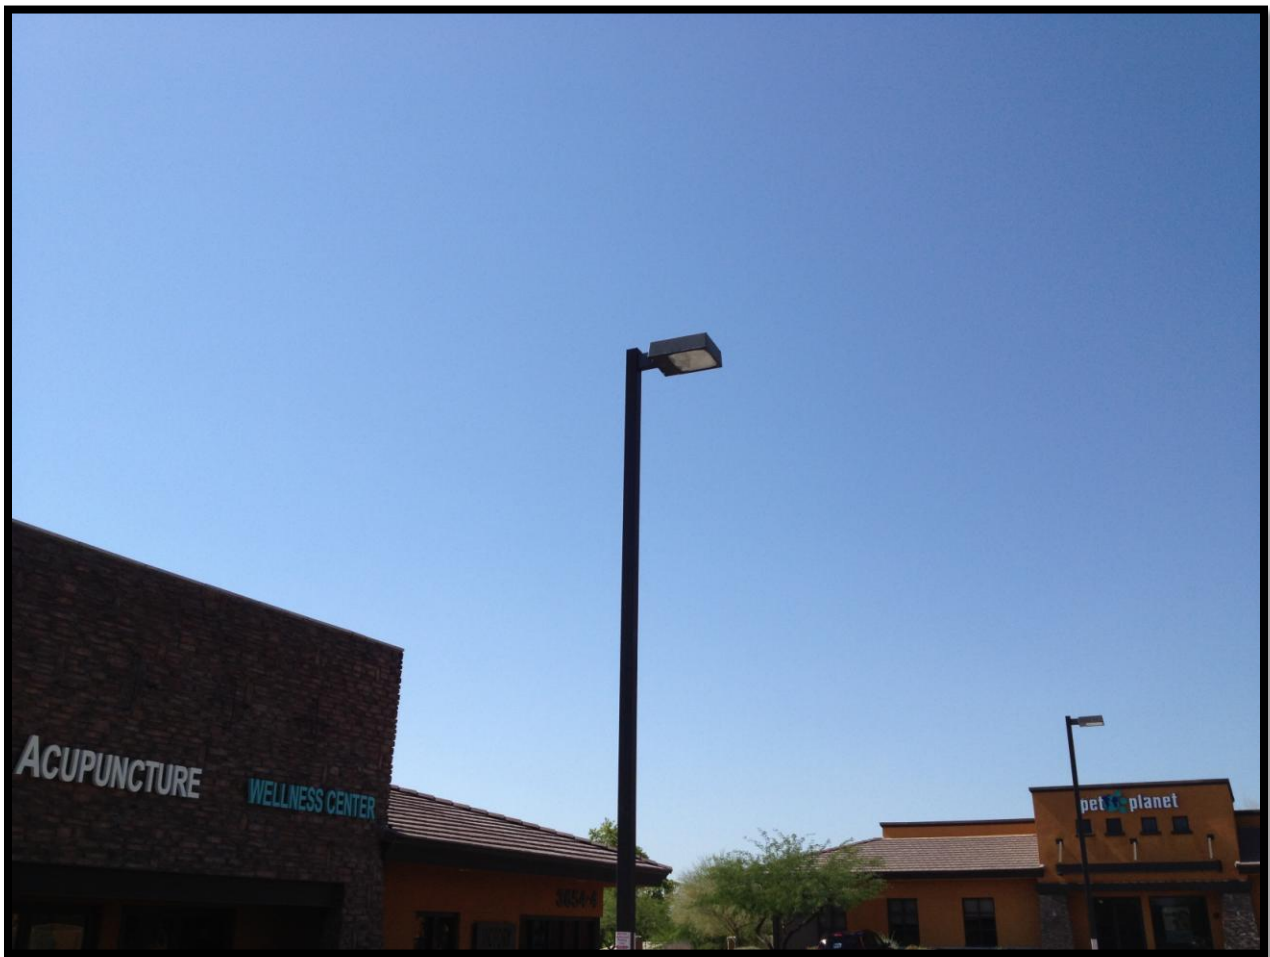
Asset #114	Pole Lighting Fixtures	Quantity	14
Constructed	2006	Current Cost to replace	\$14,000.00
Useful Life	20 years	Cost to Replace 2026	\$20,559.00
Years Remaining	13 years		
Replacement	2026

The Pole mounted light fixtures on the property light the parking areas and are owned by the association. The manufacturer information is not legible so we have used pricing based on a GE product commonly used by APS and SRP.

We have funded for the fixture replacement only and have given the fixtures the maximum useful life of 20 years. This includes the single wall mounted fixture over the exit lane of the parking garage as well.

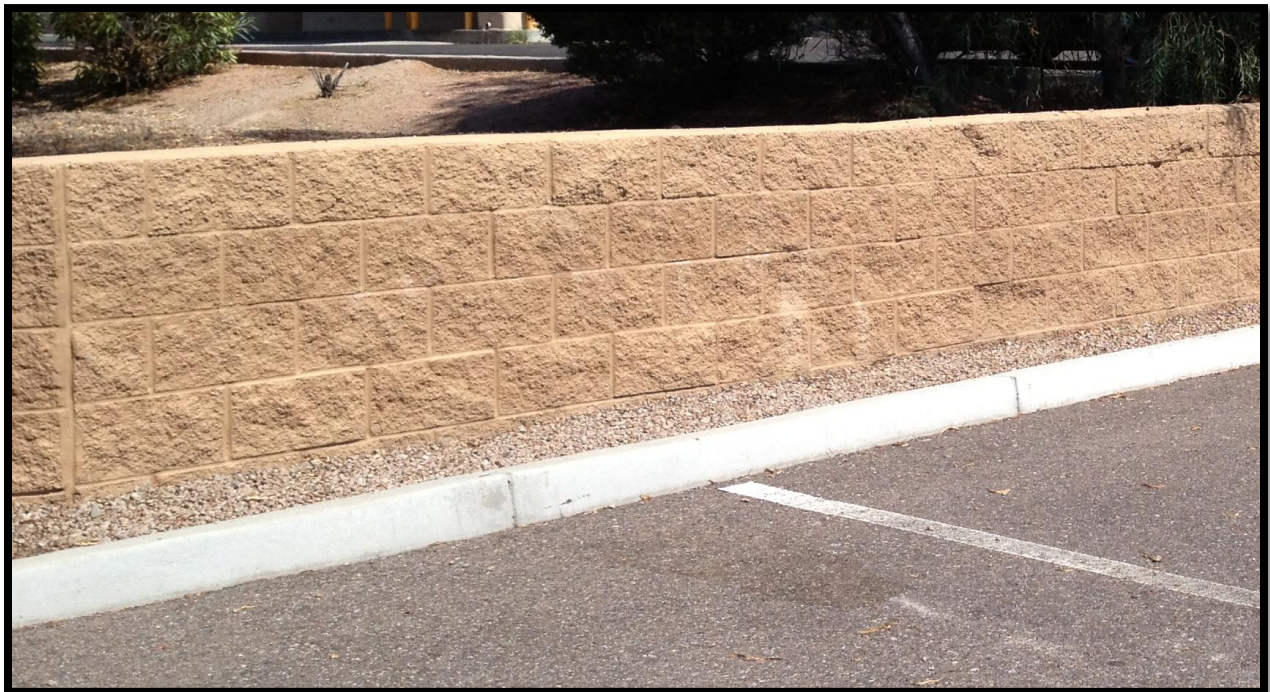
Asset #118	Concrete Component Maintenance	Quantity	See Below
Constructed	2006	Current Cost to Maintain	\$12,997.00
Useful Life	15 year maintenance schedule	Cost to Maintain 2036	\$25,651.00
Years Remaining	23 years		
Replacement	2036

The sidewalks have some minor cracks that are within the Maricopa Associated Government (MAG) standards of acceptance and these types of cracks are to be expected. As this product has a useful life that should last the life of the community, the dollars reflected in the reserve study are typically for maintenance and upkeep every **15 years** starting in year 30 when the asphalt will need to be replaced or milled and overlaid. It should be expected that any safety hazards be repaired immediately. Funding is based on 10% of the total replacement cost and not all concrete components will need replacement. We strongly recommend that an inspection of this asset be performed by a professional no less than one time per year. This is a service we offer and will provide for you with a detailed report, photos of the necessary repairs, and proposals for the replacement or repair. We recommend that a minimum of 410 square feet of concrete be removed and replaced at any one time as the concrete material providers charge a 5 cubic yard minimum delivery charge to the contractors. 410 square feet at 4" depth is 5 cubic yards, thus maximizing the use of your funds.

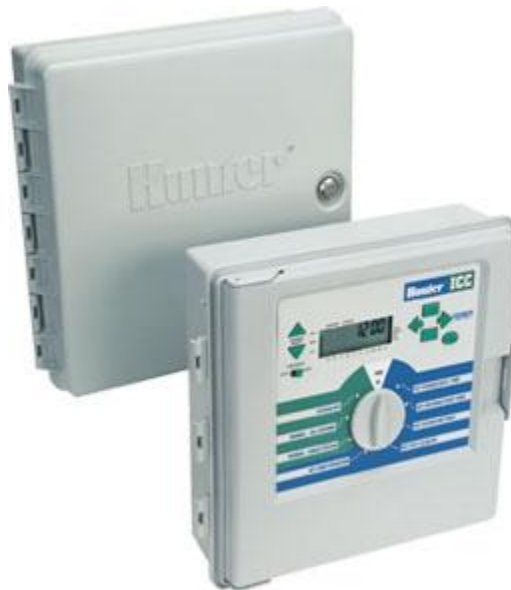
Asset #119	Irrigation Controllers	Quantity	2
Constructed	2006	Current Cost to replace	\$600.00
Useful Life	12 years	Cost to Replace 2018	\$696.00
Years Remaining	5 years	Cost to Replace 2030	\$992.00
Replacement	2018, 2030 and 2042	Cost to Replace 2042	\$1,414.00

This component was not accessible at the time of inspection. The count and size of controllers was estimated based on the number of valves and location. This component has a useful life ranging from 8 to 15 years depending on use and exposure. We have estimated the useful to be 15 years as the controllers are high quality and typically come with a 10 year warranty on parts.

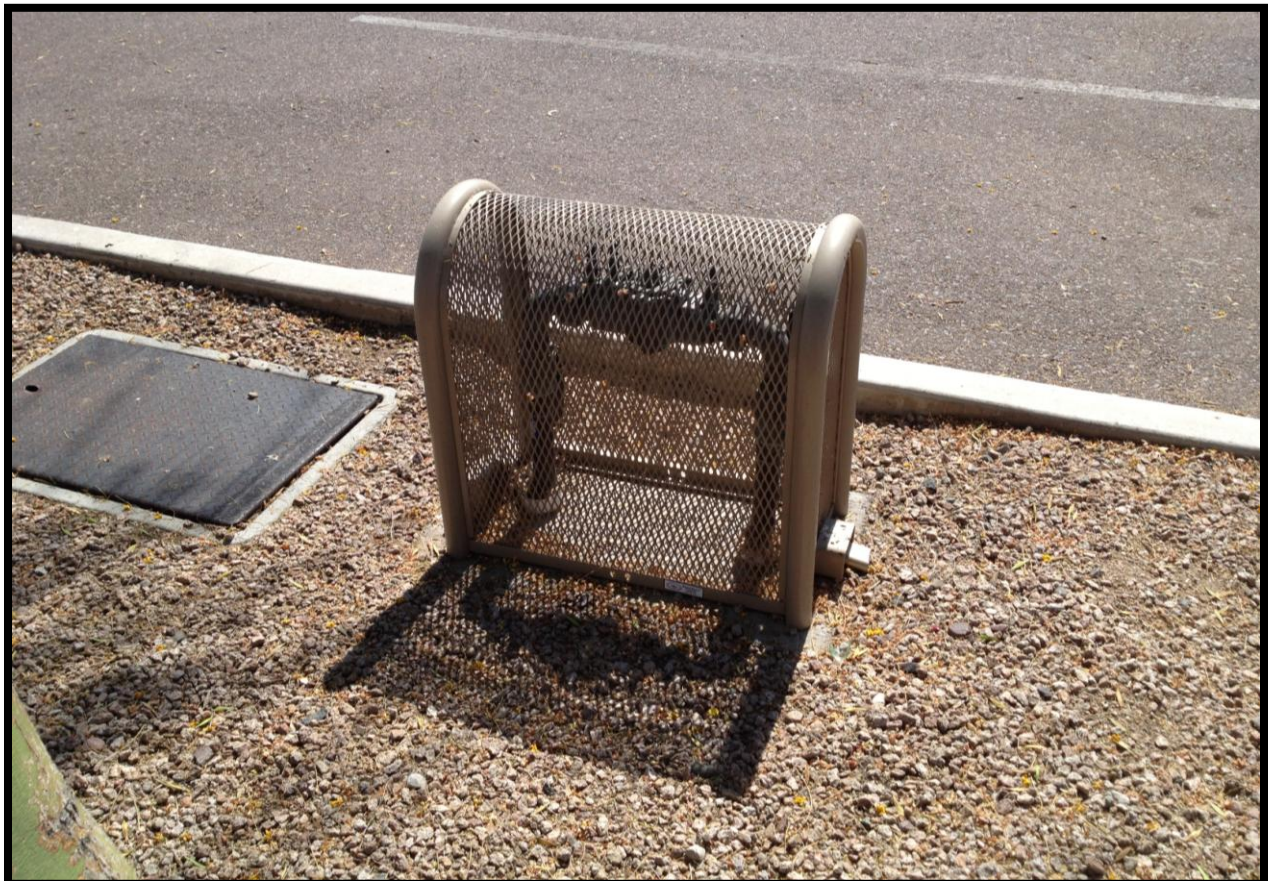
Asset #120	Backflow Preventers	Quantity	9
Constructed	2006	Current Cost to replace	\$8,400.00
Useful Life	15 years	Cost to Replace 2021	\$10,641.00
Years Remaining	8 years	Cost to Replace 2036	\$16,578.00
Replacement	2021and 2036

This component separates the potable drinking water from the landscape water preventing backflow of stagnant water that carries harmful bacteria in to the city water. These components have a useful life of 15 years before needing replacement. We are not sure when this component was last replaced but we are assuming they have been replaced at least one time since the community has been in service.

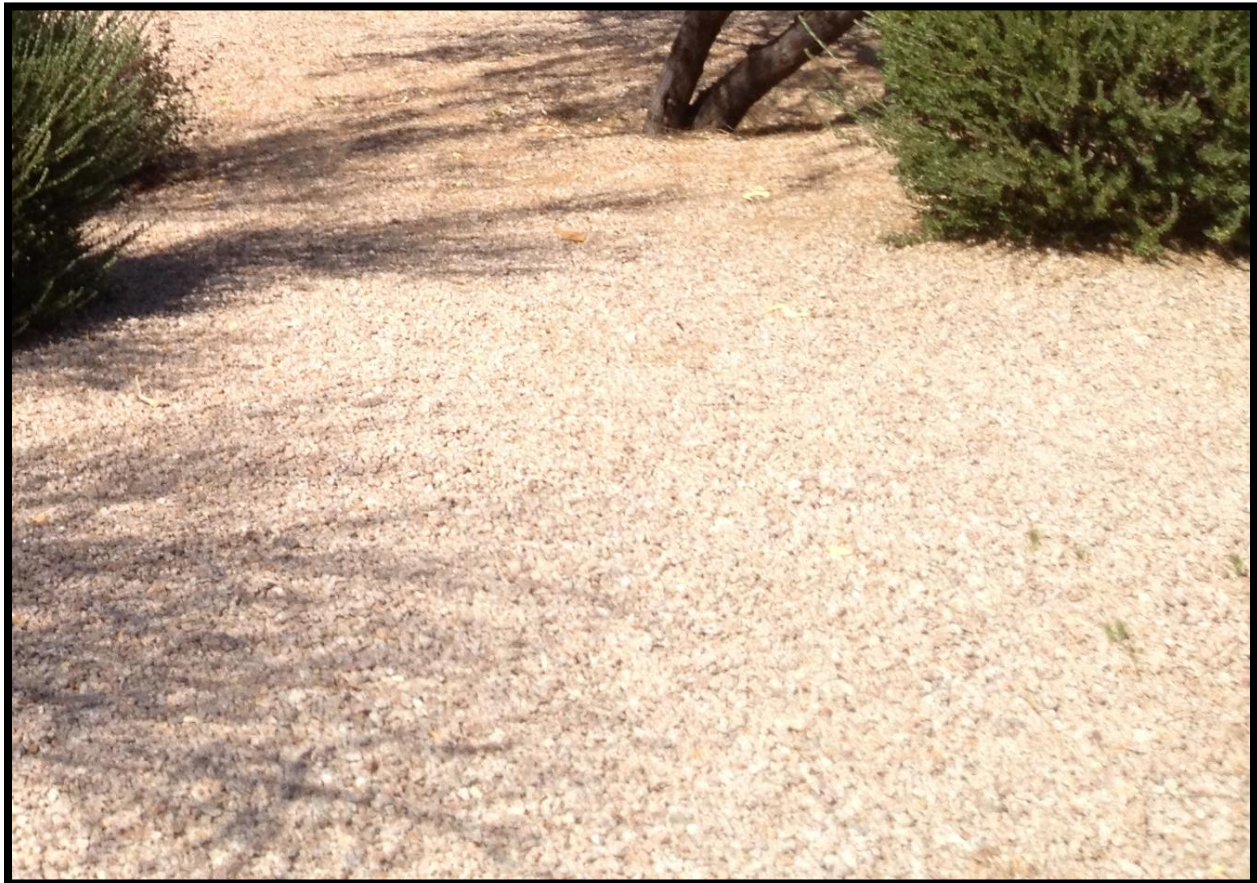
We recommend replenishing 30 Tons of landscape granite in 2015 to cover the areas where granite is missing and to fill in some of the trip hazards adjacent to the concrete walk ways. After that we have funded for 30 tons of landscape granite every 5 years for maintenance purposes. The granite should be regularly maintained by the landscape maintenance contractor and any replenishment should be preformed prior to the scheduled pre-emergent treatment to avoid duplicate efforts and cost.

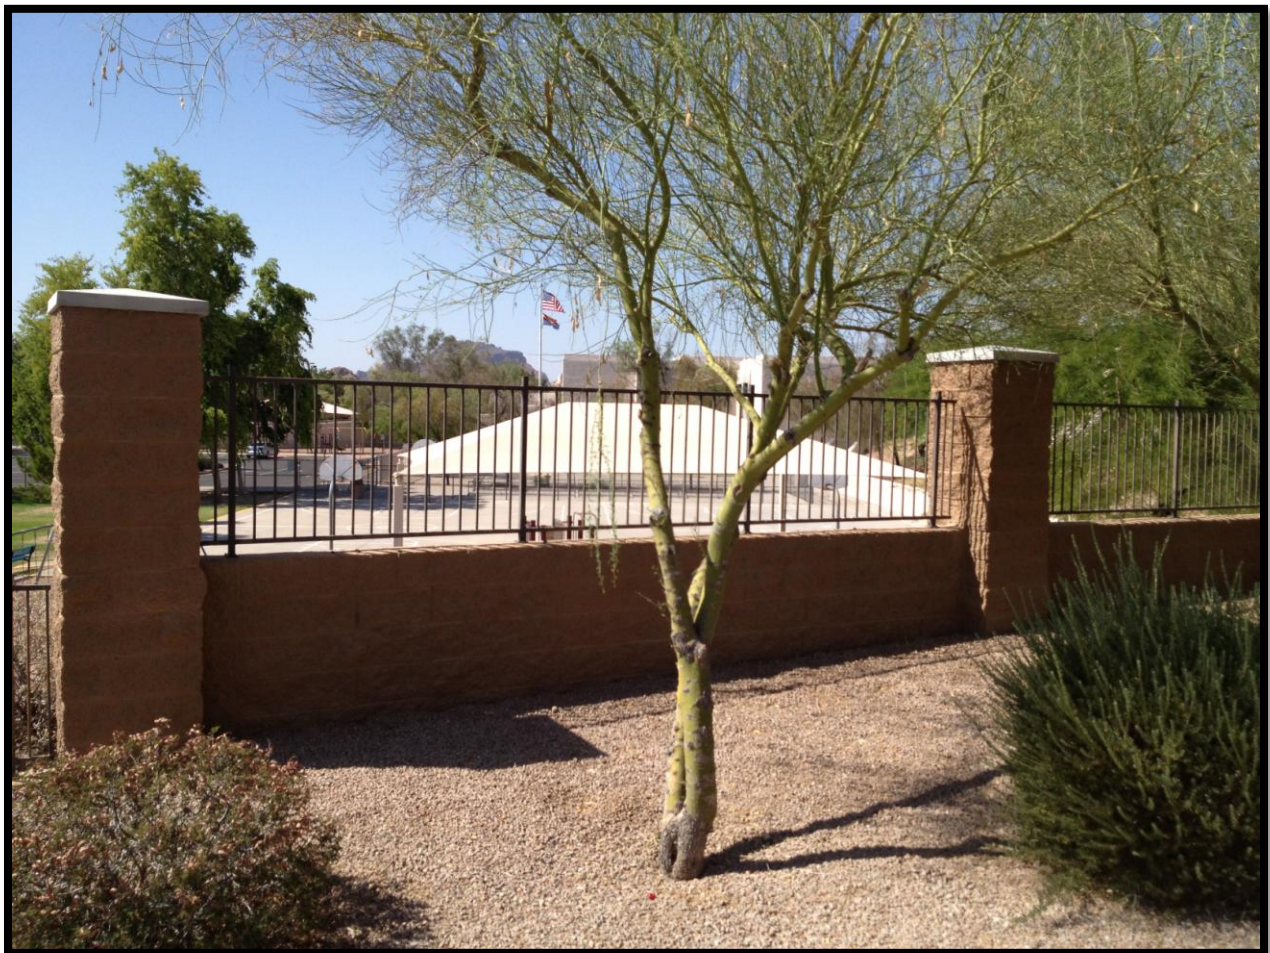
Asset #125	Masonry Wall	Quantity	NA
Constructed	2006	Current Cost to Repair	NA
Useful Life	NA		
Years Remaining	NA		
Repairs	NA

The masonry wall in this community is made of an 8”X6”X16” or 8”X8”X16” masonry block, fully grouted with concrete and rebar /bond beam reinforced. Due to the construction specs of this component it should last the life of the property providing it is maintained as needed. As the masonry block is not directly in contact with excessive irrigation water, combined with its structural integrity, we have not funded for the repair or replacement of this component.

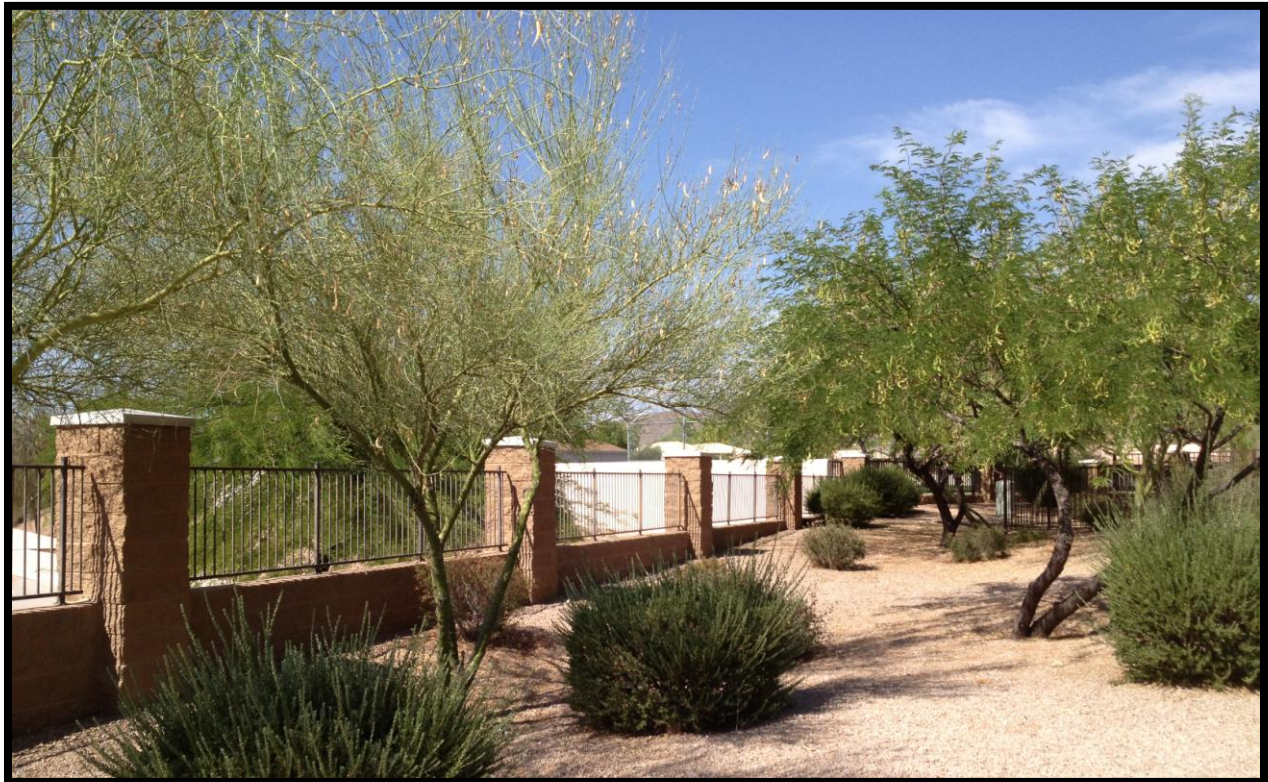
Asset #126	Wrought Iron Replacement	Quantity	See Below
Constructed	2006	Current Cost to replace	\$27,300.00
Useful Life	30 years	Cost to Replace 2036	\$53,879.00
Years Remaining	23 years		
Replacement	2036

The wrought iron is in good condition and should reach a useful life of 30 years providing it is maintained and painted as needed. We are not sure when this component was last painted and have estimated a time frame beyond the useful life of the paint and the iron is starting to rust. The trash enclosure gates are not funded as they should last the life of the property and not need replacement due to expiration of useful life. Typically assets like these are damaged by collision which can be recovered through insurance.

Improper use, such as climbing, vehicle damage or vandalism will contribute to the degradation of this component. We recommend that these components be inspected by a professional on an annual basis to ensure appropriate maintenance is being scheduled.

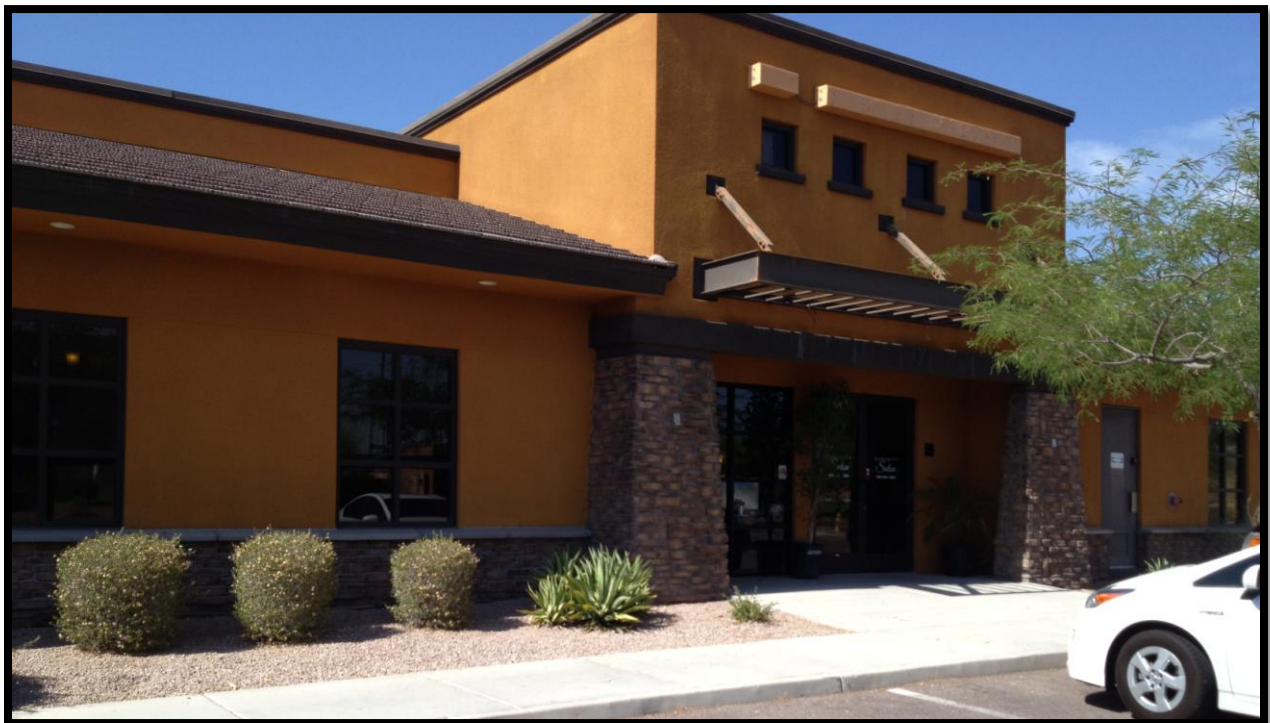
The perimeter walls and stucco walls should be inspected on an annual basis to ensure repairs are made in a timely manner in an effort to extend the life of the paint and the wall itself. The masonry component, to include stucco, will not last the life of the community if it is not painted and maintained when needed. Please be sure to include any crack repair to the block wall or stucco in the scope of work for the painting company as this is a necessary practice prior to painting. Please ensure all wall repairs are made prior to painting to avoid duplicate efforts and costs. We recommend the use of high quality exterior paint to ensure longevity. We have provided funding for airless spray paint application with prep and minor crack repair

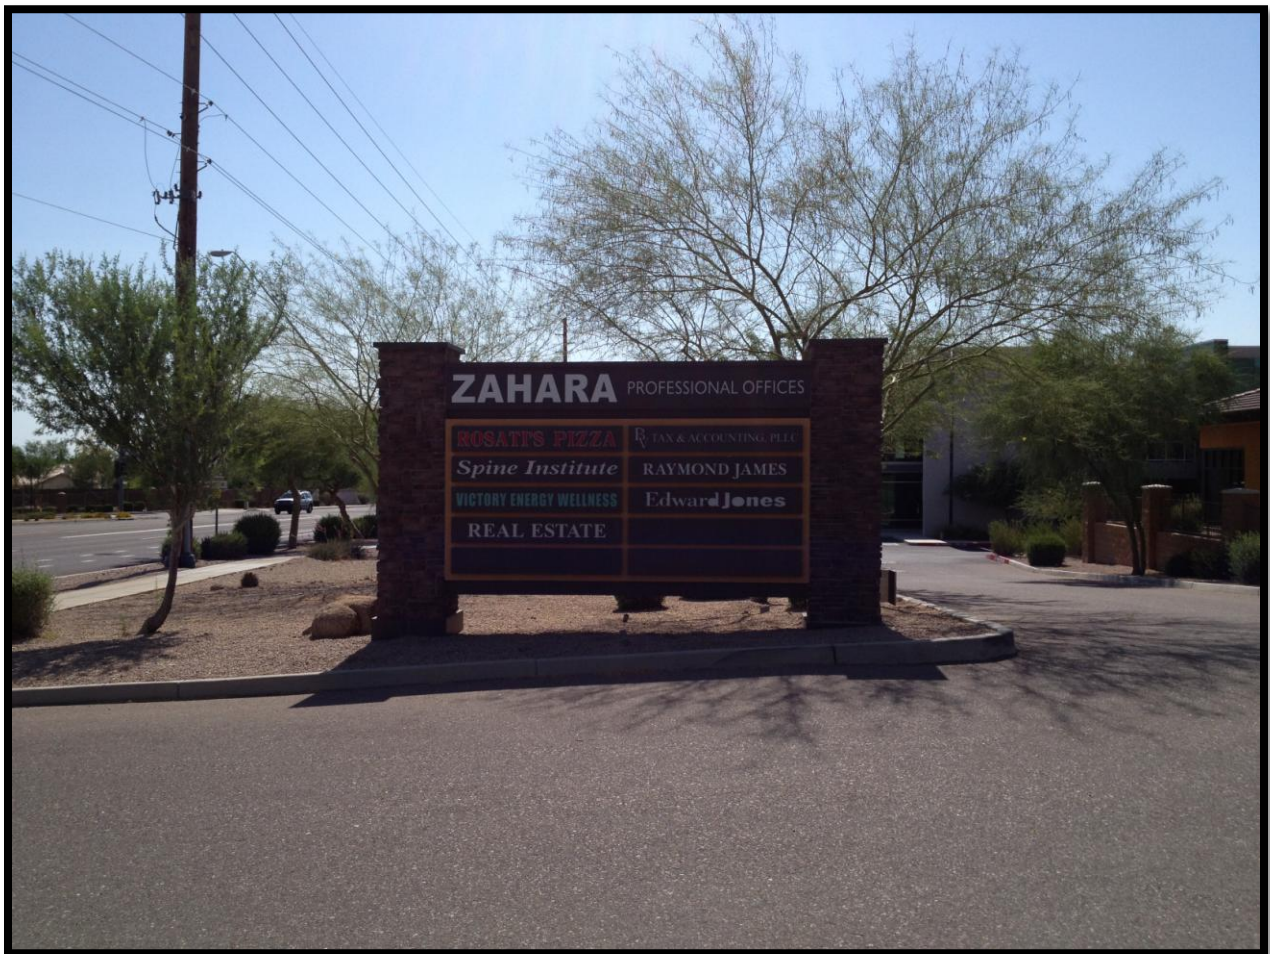
Asset #135A	Kiosk Replacement	Quantity	2
Last Installed	2006	Current Cost to Replace	\$64,000.00
Useful Life	NA		
Years Remaining	NA		
Replacement	NA

The Kiosk is in new condition and shows no signs of needed repair. This component is made of coated aluminum and should last the life of the complex and not need replacement or major repair unless damaged by collision, vandalism or acts of nature. We have estimated the replacement value for these components to be \$32,000.00 each for insurance purposes.

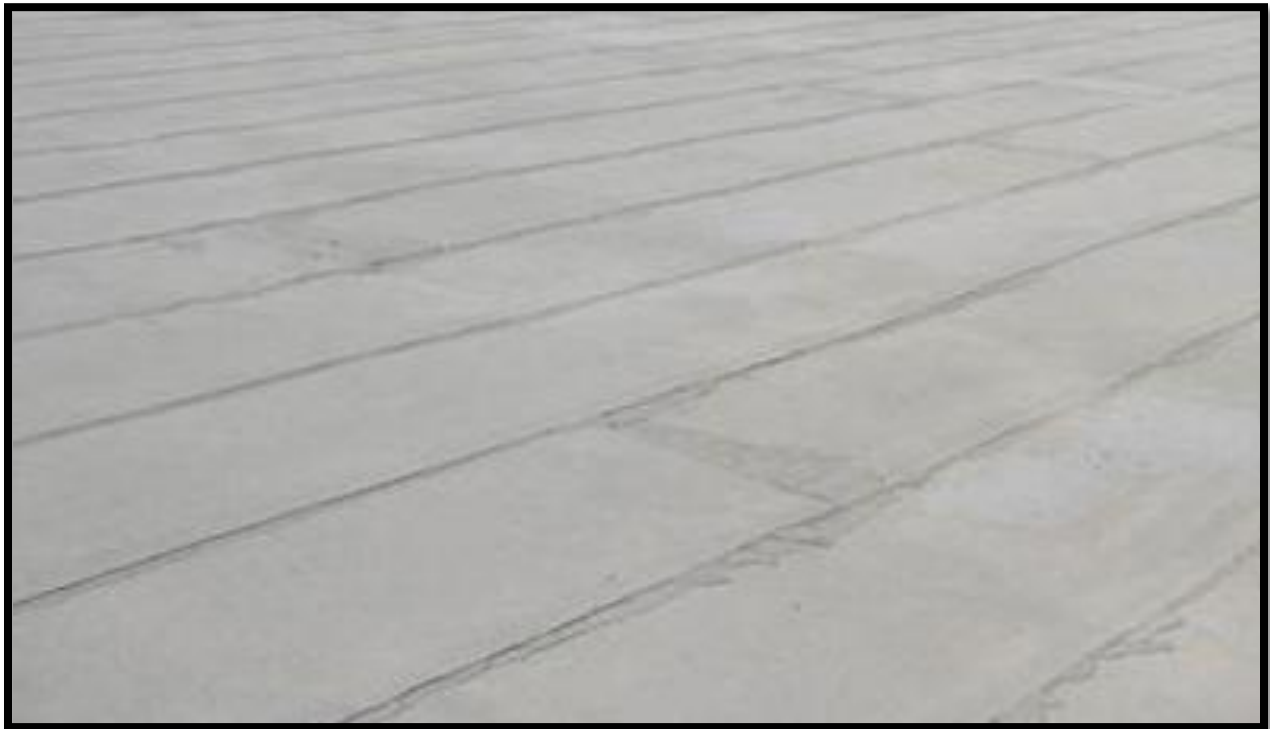
Asset #404	Flat Roof Replace	Quantity	20,182 sq ft
Constructed	2006	Current Cost to Replace	\$76,692.00
Useful Life	12 years	Cost to Replace 2018	\$86,318.00
Years Remaining	5 years	Cost to Replace 2030	\$126,760.00
Resurface	2018, 2030 and 20 42	Cost to Replace 2042	\$180,760.00

Built up roofing has a useful life ranging from 10 to 25 years. The built up portion of your roofing has an estimated useful life of 12 years. All roofing information was provided by Roofing Southwest. We strongly encourage the association to have the roof inspected and cleaned a minimum of one time per year and have repairs made as needed to ensure and possibly extend the life of the roof.

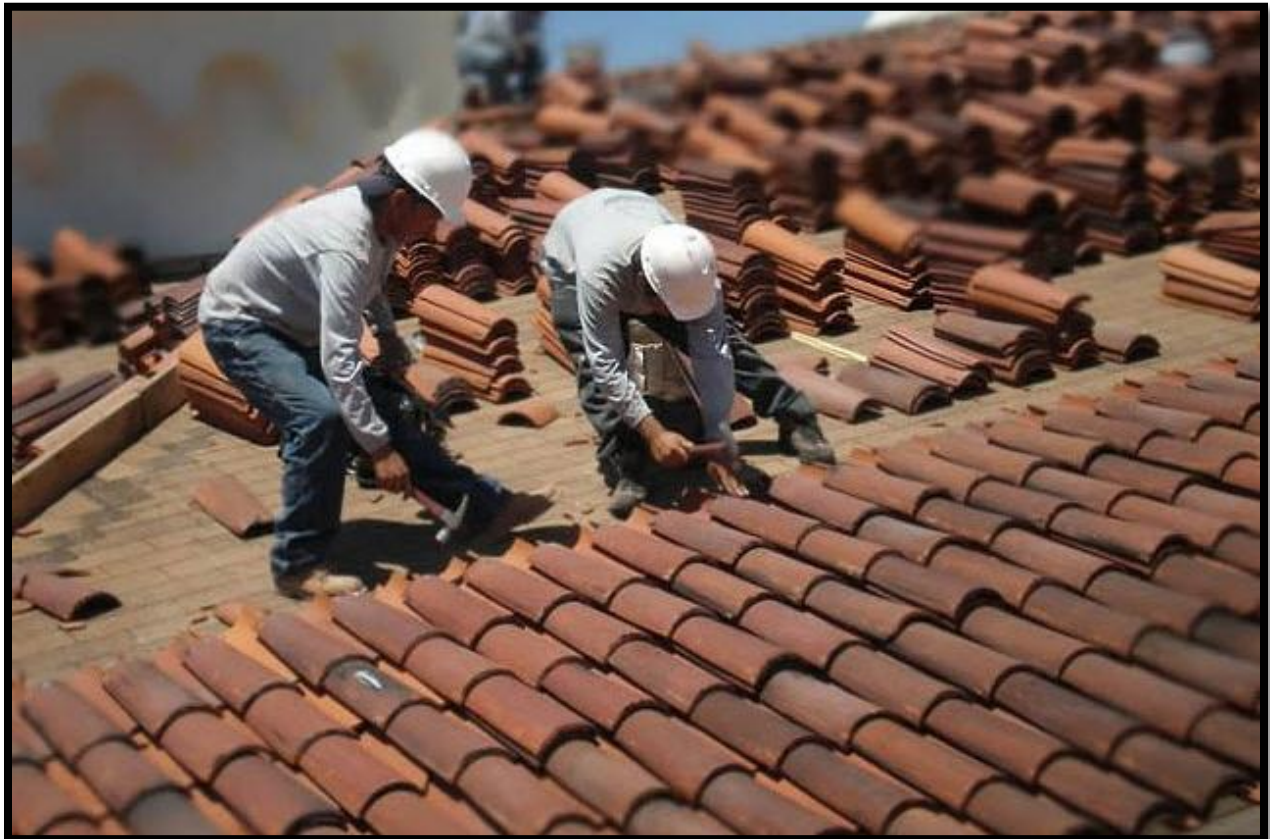
Asset #404 B	<u>Tile Roof Underlayment Replacement</u>	Quantity	<u>39,978 sq ft</u>
Constructed	<u>2006</u>	Current Cost to Replace	<u>\$139,923.00</u>
Useful Life	<u>20 years</u>	Cost to Replace 2026	<u>\$205,482.00</u>
Years Remaining	<u>13 years</u>		
Resurface	<u>2026</u>

Tile roofing systems have 2 separate components that have different useful lives. The underlayment has an average useful life of 20 years while the roofing tiles can last longer than 50 years. The useful life of the underlayment can be extended by implementing a maintenance plan causing the roof to be inspected and repaired at a minimum annual occurrence. We have extended the useful life of this component based on the assumption the association will initiate a maintenance program. It is critical to have the roofing cleaned and maintained as needed. We have provided a separate roofing inspection along with a proposal for repairs and maintenance.
