February 01, 2010

## **COMMUNITY ASSET EVALUATION**

# Millstone

Tempe, Arizona

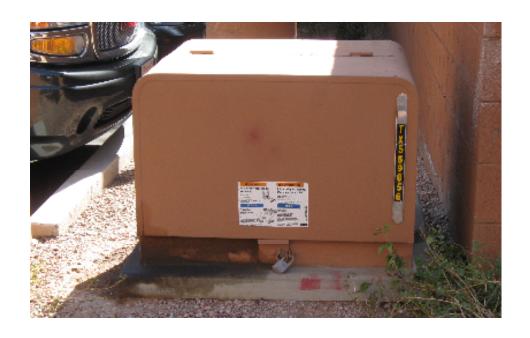
The only real safety concern we found was an APS Electrical Power Transformer leaking oil. Oil
is a cooling component for the transformer and repair is needed. We called and left a message
for APS, giving the location, the problem and the address on the box, TX569056. If there is no
change, someone should follow up with APS to ensure repair was made. The local APS office
number is 480-350-3137. Please see the photo on the next page for reference.

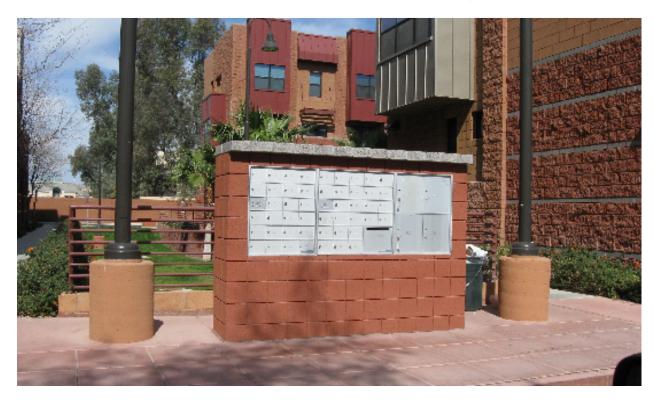
| Asset #100 | Mail Boxes | Quantity | CBU's |

As we could not find any identifying markings that would identify post office maintenance requirements we have assumed the Cluster Box units are the responsibility of the association. These boxes appear to be in good condition but we are not sure they are intended for external use as we could not open the boxes to see if weather barrier's are in place. Removal and disposal have been included in the replacement cost.

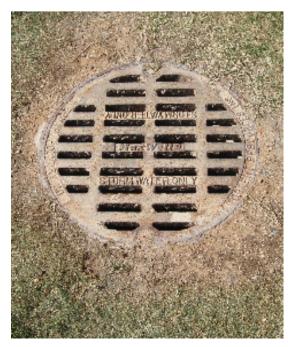
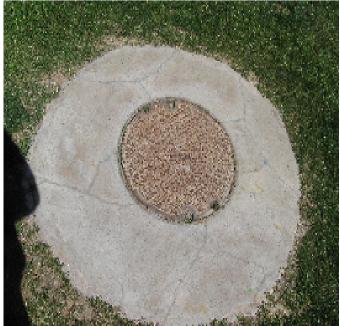
| Asset #101 | Dry Wells | Quantity | 2 |

The Maxwell IV Dual Chamber systems that are in your community should last the life of your community and not need replacement. They were designed and installed by Torrent Resources, 602-268-0785. Torrent Resources is currently offering free inspections, Per Neva Andrada at Torrent Resources. The current cost to replace the drywells are 2 units at \$20,000.00 each totaling \$40,000.00. It is recommended that the drywells are inspected annually and cleaned/ repaired as needed. The maintenance funding provided is estimated at a current need of \$3,000.00 every 4 years starting in 2012 with the adjusted inflation estimate. When considering adding a drywell due to slow percolation, please make sure the dry wells you have are properly cleaned out before making the decision to spend thousands of dollars. In most cases the dry wells have a 2", or more, clay build up which can slow or stop the drywell from performing its intended duties and a simple cleaning can take care of the problem.

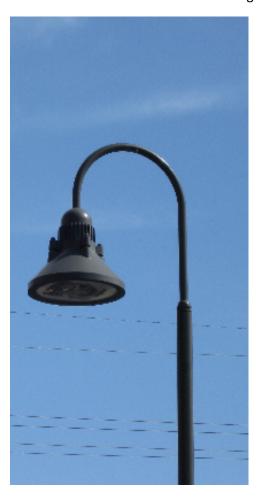
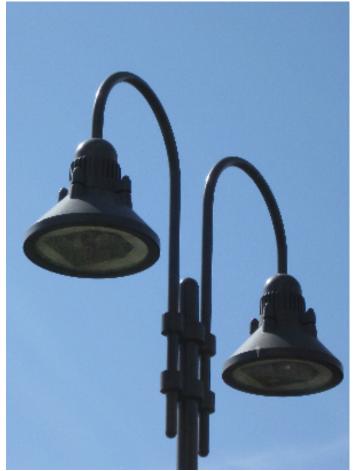
| Asset #114 | Street Lighting Fixtures | Quantity | (See Below) |

These components light the parking area and court yard. They have a useful life of 6 to 15 years depending on elemental exposure and use. The poles have not been figured in for replacement as they should last much longer than the time frame in this report.

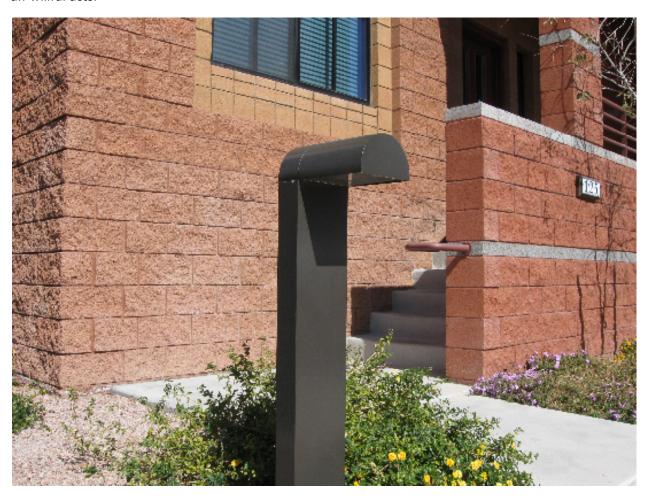
| Asset #114A | Pathway Lighting | Quantity | 28 |

We have estimated these components to have a useful life of 10 years based on exposure. These components can last longer than the 10 year estimation providing they are not damaged by willful or un-willful acts.

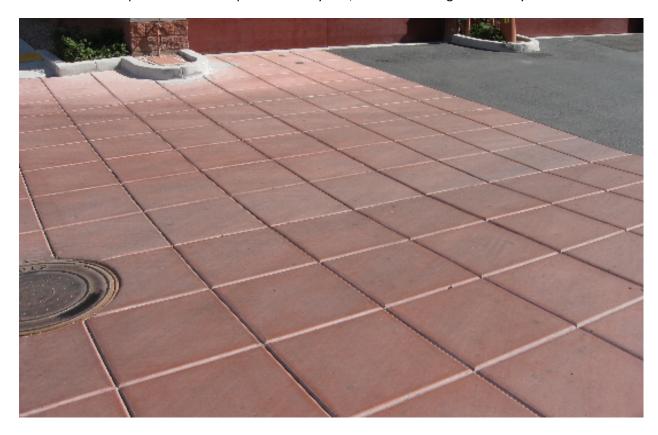
| Asset #118 | Concrete Components | Quantity | See Below |

The sidewalks have some minor cracks that are within the Maricopa Associated Government (MAG) standards of acceptance and these types of cracks are to be expected. As this product has a useful life that should last the life of the community, the dollars reflected in the reserve study are typically for maintenance and upkeep every **15 years** (at **5%** of the full replacement cost). It should be expected that any safety hazards be repaired immediately. We strongly recommend that an inspection of this asset be performed by a professional no less than one time per year. This is a service we offer and will provide for you with a detailed report, photos of the necessary repairs, and proposals for the replacement or repair. We recommend that a minimum of 410 square feet of concrete be removed and replaced at any one time as the concrete material providers charge a 5 cubic yard minimum delivery charge to the contractors. 410 square feet at 4" depth is 5 cubic yards, thus maximizing the use of your funds.

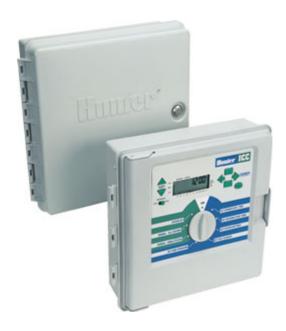
| Asset #119 | Irrigation Controllers | Quantity | 1 |

This component appears to be in good condition and has a useful life ranging from 8 to 15 years depending on use and exposure. We have estimated the useful life of this component to be 12 years. This component along with all landscape components were originally installed by Desert Systems Landscape, a company that is no longer in business. A former employee was the source of the information.

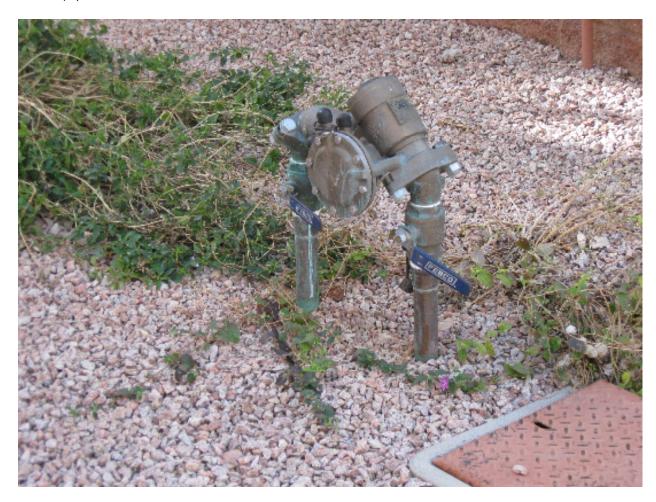
| Asset #120 | <b>Backflow Preventer</b> | Quantity | See Below |

These prices include removal of expired backflow preventer component, replacement, and testing. The backflow component facilitates water for the landscape irrigation but primarily functions as a safety device that does not allow water to backflow into the potable water system.

We encourage your community to install a protective cage as Backflow Preventers are frequently stolen for their brass and copper value. The average price, to include a concrete pad and locks should not exceed \$1,000.00.

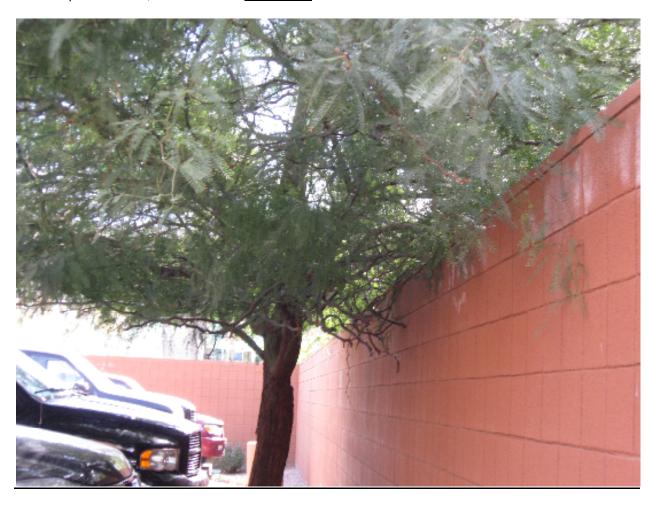
| Asset #125 | Masonry Wall | Quantity | Sq Ft |

We recommend that 25% of the replacement cost be used for maintenance purposes every 20 years based on the age of the community. The total replacement cost is based on 100% of the masonry block, paint, removals and disposal of removed material. The wall components should last the life of the community as long as they are maintained as needed. Please look at the photo below as it would suggest the Tree in the picture needs to be either trimmed or removed in the future.

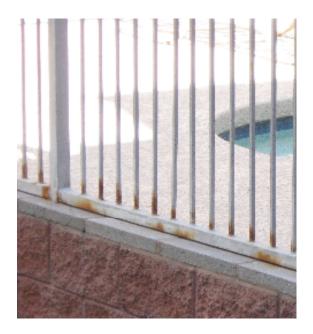
### **Pool Area Fence**

We have only provided future replacement funds in the reserve study for the 6' wrought iron at the pool area. When reinstalled, please ensure the contractor allows enough room for moisture to freely pass under the bottom rail in an effort to preserve the iron and prohibit rust as much as possible. It may be in the associations interest to speak with the builder and correcting the immediate deficiency.

Wrought iron components appear to be in good condition and appear to have been maintained on a scheduled or as needed basis. Providing that this component is inspected, cleaned and painted on a minimum 4 year reoccurrence, (Best Practice is on an as needed basis).

Improper use, such as climbing, vehicle damage or vandalism will contribute to the degradation of this component. We recommend that these components be inspected by a professional on an annual basis to ensure appropriate maintenance is being scheduled.

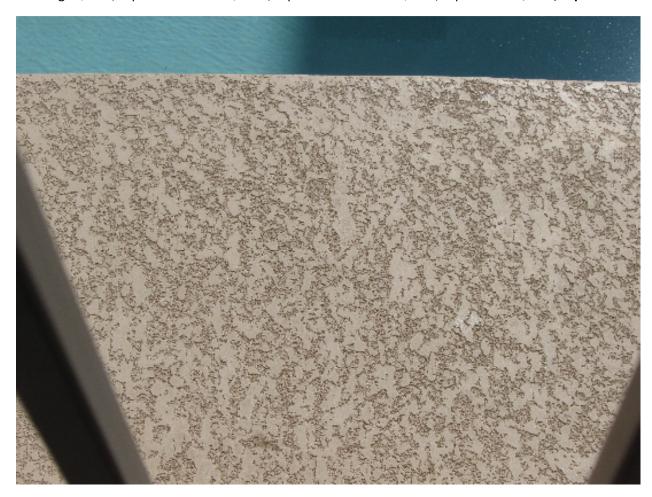
We conducted a site visit as part of this reserve study and found the cool deck to be in good condition with the exception of a few areas that were showing signs of wear but is in over all, good condition . As we do not know when the last resurfacing was done, we are estimating 2002 based on the current condition and using the maximum useful life of 15 years based on examples of other communities with
