Update "With-Site-Visit" Reserve Study

Creekwood Ranch HOA Chandler, AZ

Report #: 14356-2
For Period Beginning: January 1, 2018
Expires: December 31, 2018

Date Prepared: June 13, 2018

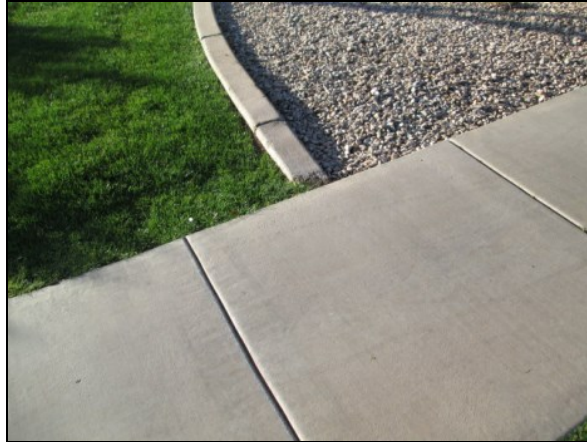
Comp #: 103 Concrete - Repair

Allowance for repairs and/or partial
replacement
