**RESERVE STUDY UPDATE  
FOR  
TEMPE VILLAGES HOMEOWNERS ASSOCIATION**

November 5, 2020

This study is an update to a previous study performed by FDReserve Studies dated 8/31/2016. This update was performed with a field visit.

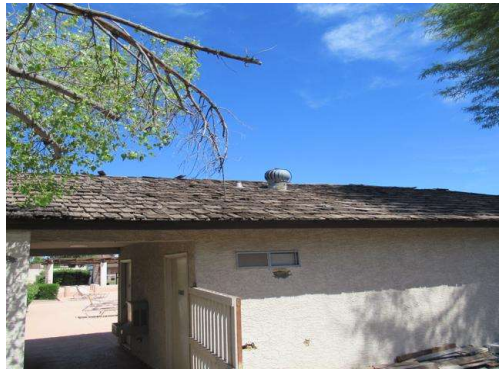
Poor condition. No signs of leaking but noticeable rolling of the shingles. Our cost is based on replacing with a composite 20 year shingle.

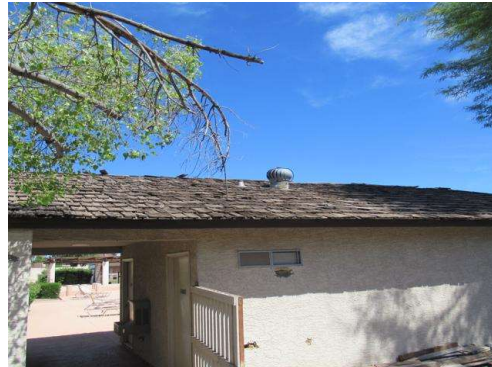
*Clubhouse & Pool Equipment Buildings - Paint continued...*

Fair to good condition. Cost to paint clubhouse and pool equipment building located in recreation/pool area. Estimate by Marcel Painting in Oct 2015. Last repaint date unknown.

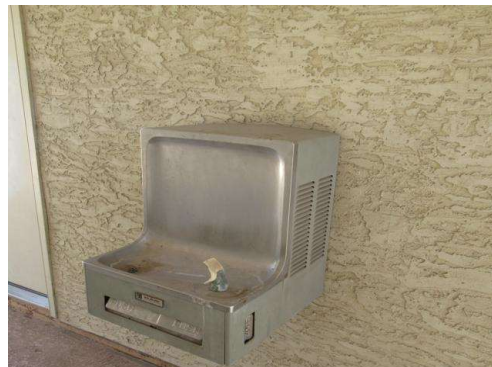
Unfunded. Do not intend to replace at this time, reevaluate on next study. Non usable condition. Broken and disconnected. Elkay.

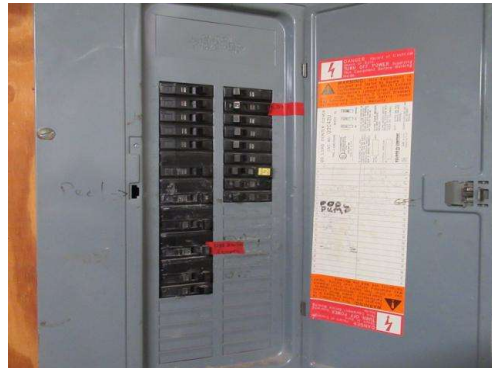
200 amp breaker box located behind pool equipment building.

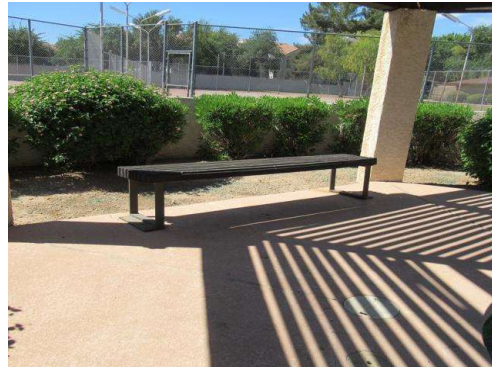
*Pool Benches - Replace continued...*

Good to fair condition. Replacement based on purchasing new thermoplastic coated 6' park benches. Noted aging and warping.

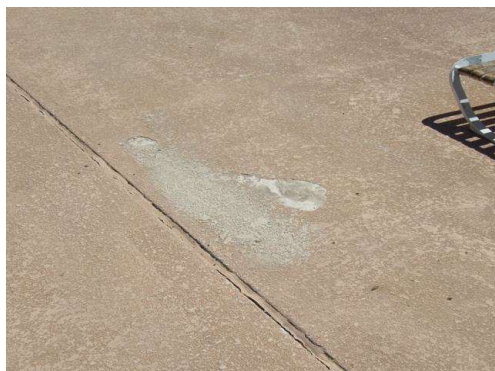
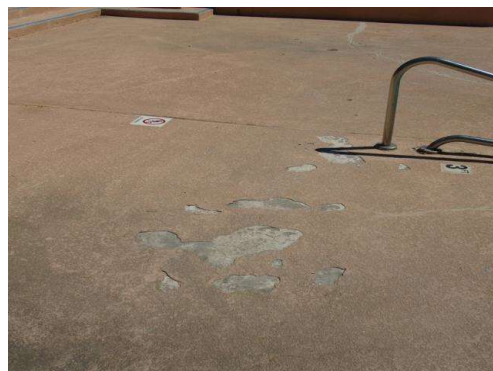
Fair to poor condition. Noted some limited cracking and chipping. Suggest cleaning. Date of last recoat unknown.

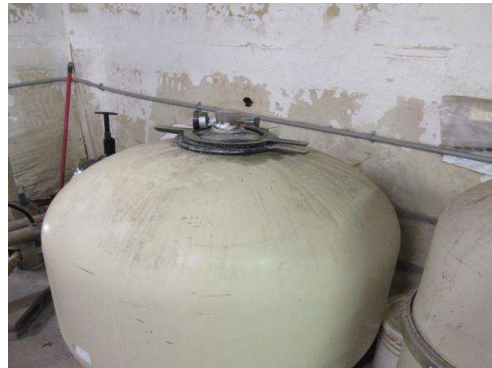
Working condition. Triton II TR-140C mfg date 1/2015. Noted leaking.

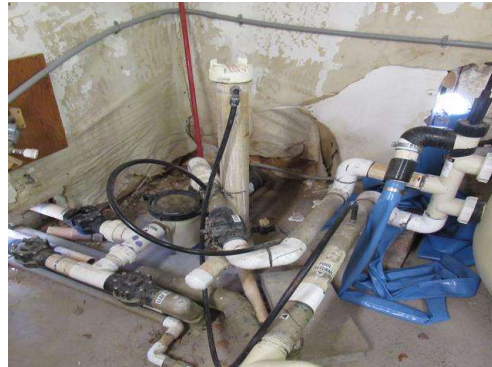
*Pool Pump & Motor - Replace continued...*

New condition. Purex Triton Whisperflow 2 hp.

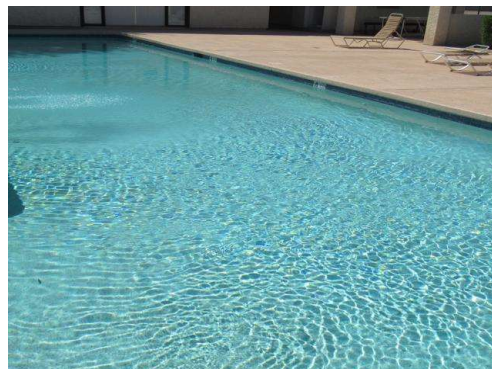
Good condtion. Pebble pool with tile. Last resurface unkown.

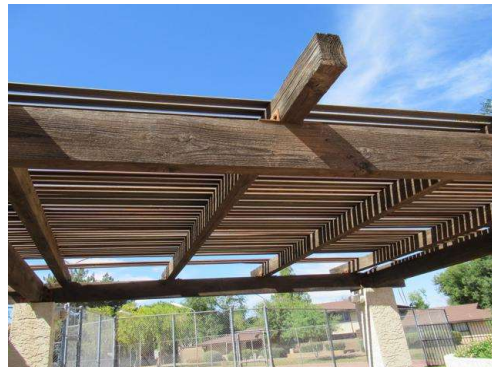
Fair condition. Stucco posts with wood supports and metal slats. Ramada next to pool equipment building in pool recreation area. Estimate wood structure to last another 5 years so long as upkeep is maintained. Noted wood deteriorating from sun and weather exposure.

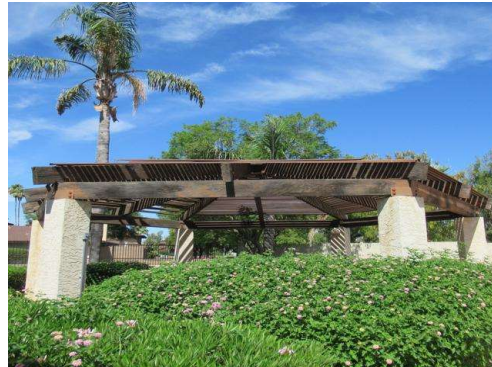
*Ramada Roof Structure (2) - Replace continued...*

Good condition. Stucco posts with wood supports and metal slats. Ramada location is covering spa in pool recreation area. Estimate wood structure to last another 5 years so long as upkeep is maintained. Noted wood deteriorating from sun and weather exposure.

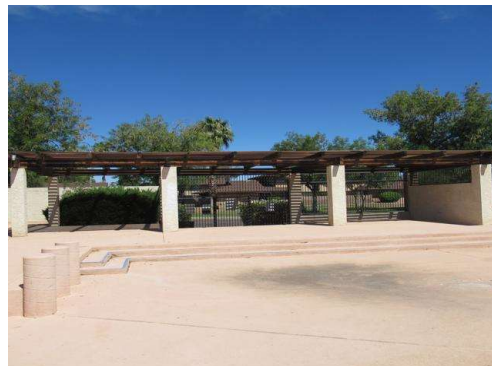
Good condition. Stucco posts with wood supports and metal slats. Ramada is at entrance to pool recreation area. Estimate wood structure to last another 5 years so long as upkeep is maintained. Noted wood deteriorating from sun and weather exposure.

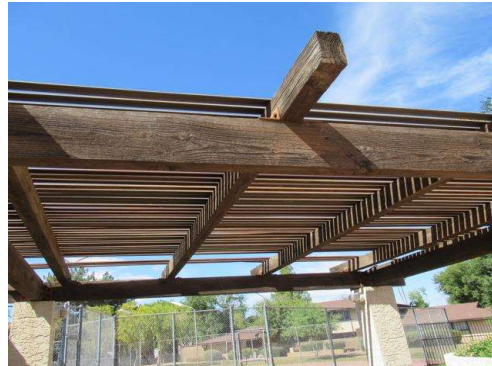
Poor condition. Lump sum cost to paint 3 ramadas located in recreation/pool area. Estimate by Marcel Painting in Oct 2015. Last repaint date unknown.

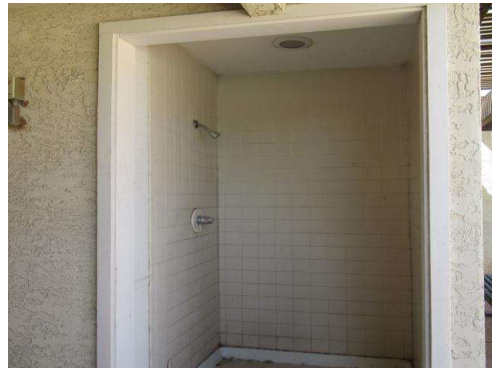
**Shower - Remodel**

Unfunded. Good condition. Needs cleaning and paint. Ceramic tile floor to ceiling above pan.

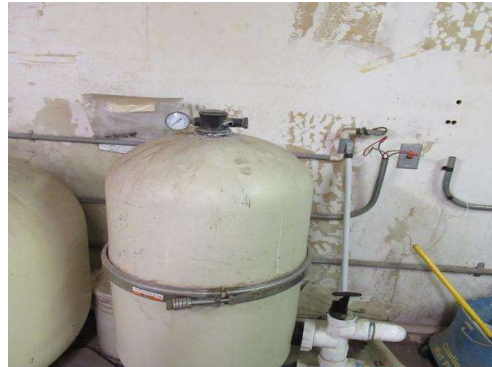
*Spa Filter - Replace continued...*

Working condition. Pentair FNS-48 DE. Diatomaceous earth filter. Last replacement unknown.

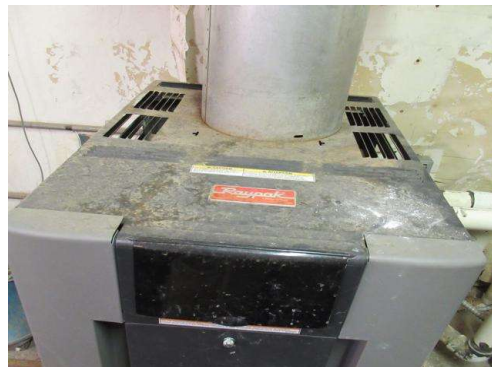
Working condition. Replaced 1/22/2016 by Aqua Patrol with Raypak 399BTU ASME NG Heater 009271 C-R406A-EN. 1 year manufacture warranty. Price includes labor.

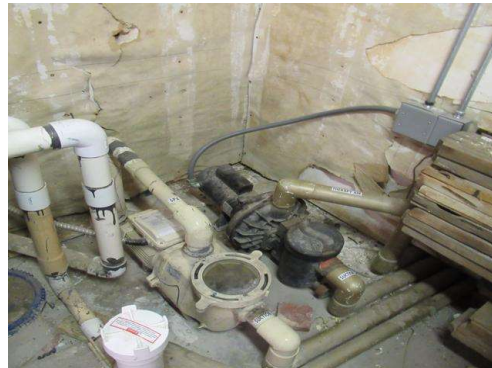
Poor condition. (1) Whisperflow 3/4 hp. Leaking. Suggest replacing along with spa motor. Last replacement unknown. (1) Whisperflow 1 1/2 hp.

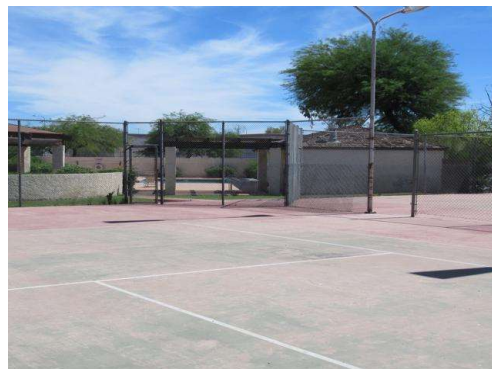
Poor condition. Will need to replace most posts. Cost anticipates reusing some fencing.

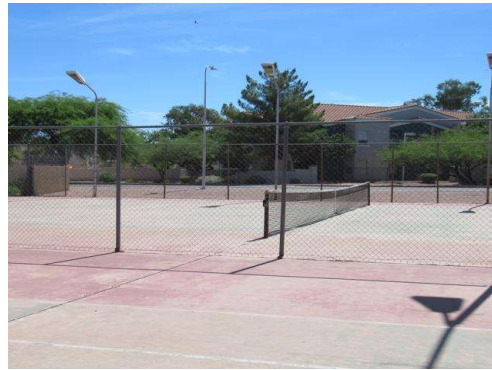
Poor condition. This is for a one time repair and resurface.

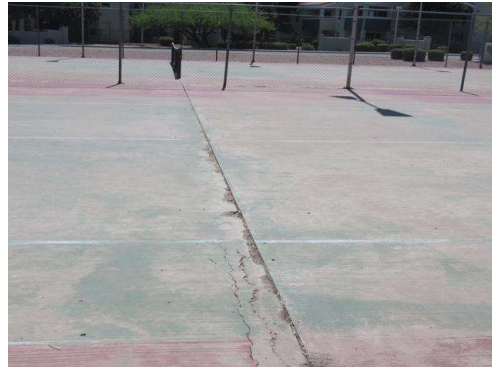
*Tennis Courts - Resurface continued...*

This is for resurfacing every 8 years after initial repairs and resurfacing are complete.

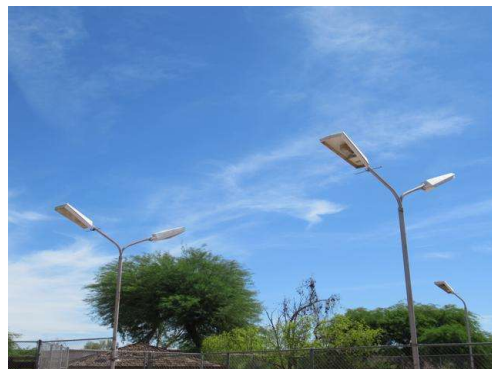
4 doubles and 8 single lights. Non working, so budgeted for full replacement.

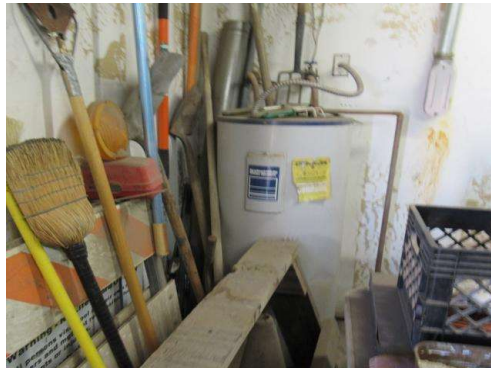
Unfunded. Non-working condition. Do not intend to replace at this time, reevaluate on next study. Stratford White 53 gallons located in pool equipment room.

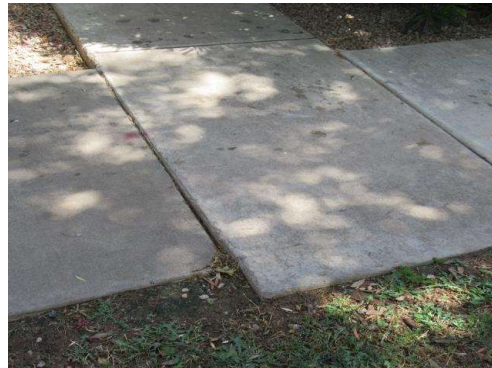
Fair condition. Noted some tripping hazards. Budget for annual concrete repair work.

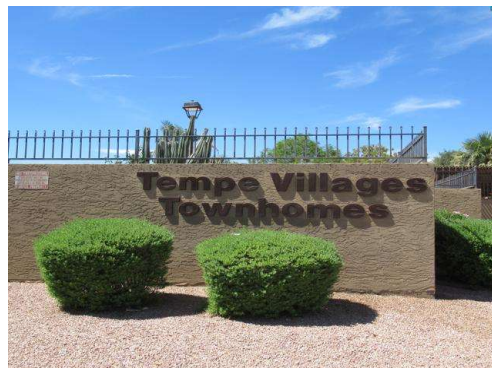
<b>Granite - Replenish</b>		1 LS	
Asset ID	1047	Asset Actual Cost	
	Grounds	Percent Replacement	100%
Category	Grounds Components	Future Cost	
Placed in Service	July 1974	Assigned Reserves	<i>none</i>
No Useful Life			
		<i>No Future Assessments</i>

Unfunded. Fair condition.

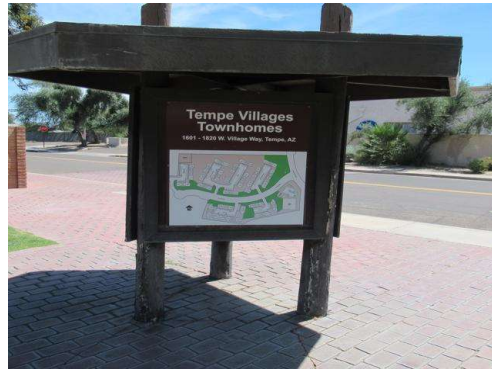
Fair condition. Roof leaning on one side.

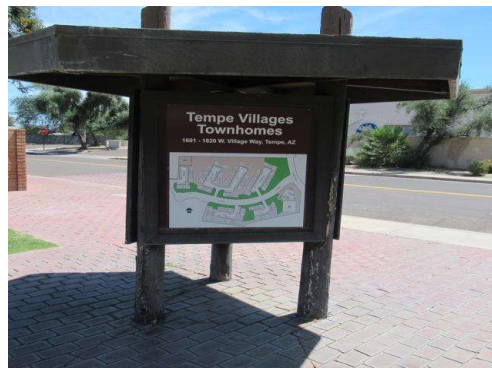
**Information Signs - Paint**

Included in exterior wall painting.

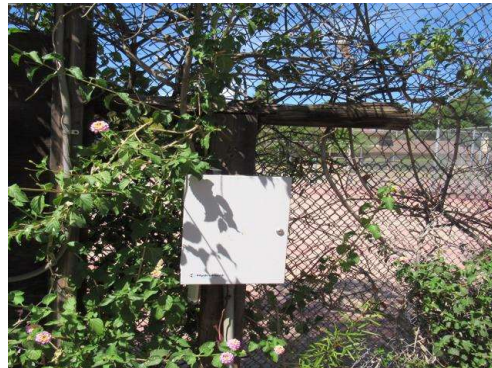
(3) Hydropoint Data Systems Inc. mfg date 2017. This includes removal of old system, installation and re-wiring.

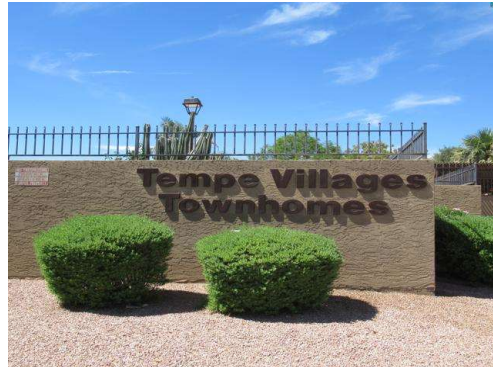
*Monument - Replace continued...*

Good condition. Metal letters painted. May need periodic painting to freshen appearance.

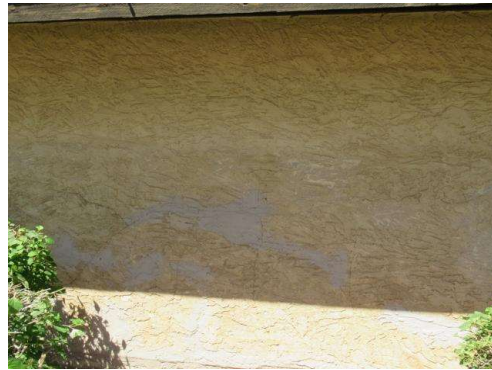
Fair to poor condition. Per the Board, current finish is pigmented stucco. Cost estimate provided by Assn for painting and facia repair.

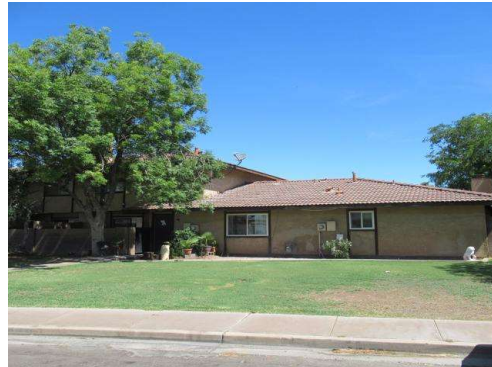
*Buildings Roof Shingle - Replace - Phase 1 continued...*

Assn indicates that the shingles are a 30 year product. Look to be in good condition. No roof leaks reported. Component budgets replacement over 3 year period.

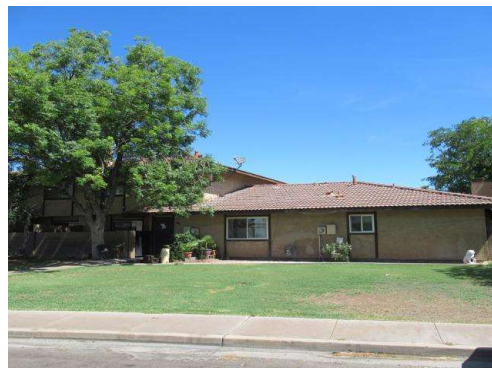
Assn indicates that the shingles are a 30 year product. Look to be in good condition. No roof leaks reported. Component budgets replacement over 3 year period.

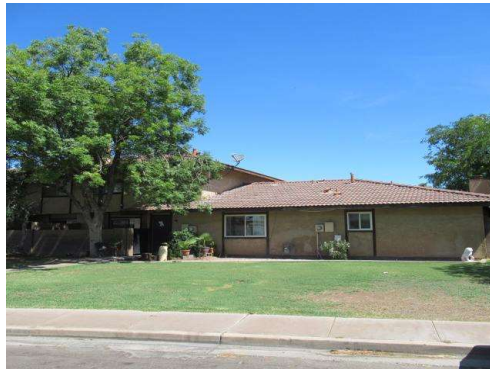
Assn indicates that the shingles are a 30 year product. Look to be in good condition. No roof leaks reported. Component budgets replacement over 3 year period.

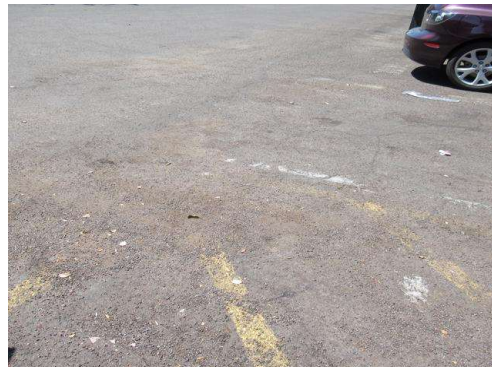
Poor to fair condition.

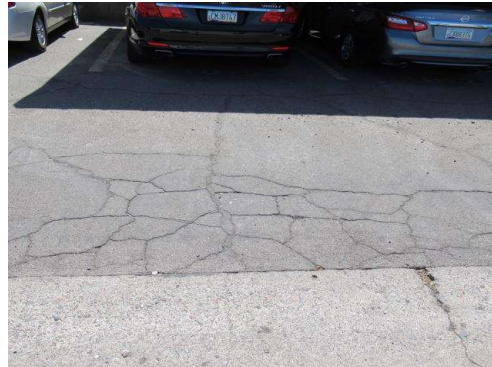
*Asphalt - Seal Coat continued...*

Poor to fair condition. This asset is to cover slurry seal areas of work performed in 2021.

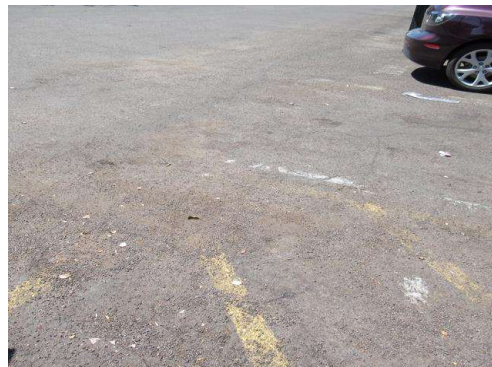
Good to fair condition. This asset is for seal coat to cover slurry sealed areas from 2020.

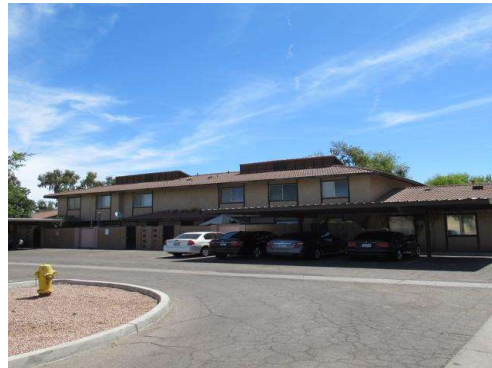
Poor to Fair condition. Recommend slurry seal of asphalt that was not sealed in 2019 to extend the life of the pavement. Should include crack sealing prior to slurry seal. One time application.

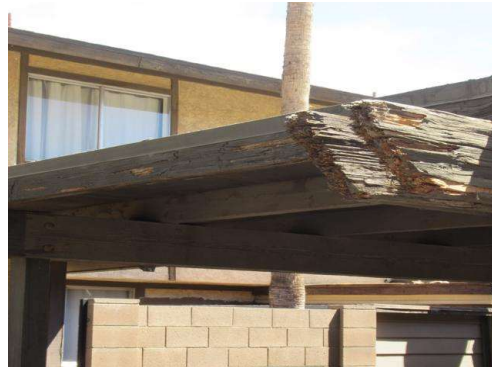
There are 79 covered spaces. Roof material is an asphalt rolled material. Wood structures are in need of repair. This component budgets \$1500/space for repairs and paint over 5 year period of 2024 thru 2028.

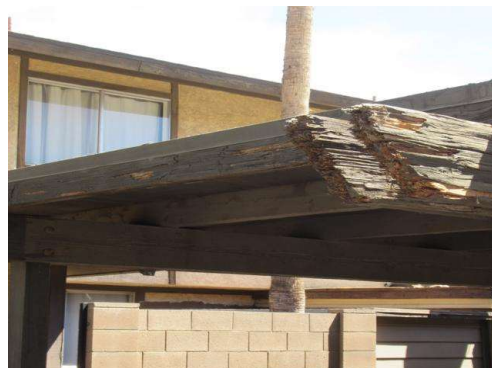
There are 79 covered spaces. Roof material is an asphalt rolled material. Wood structures are in need of repair. This component budgets \$1500/space for repairs and paint over 5 year period of 2024 thru 2028.

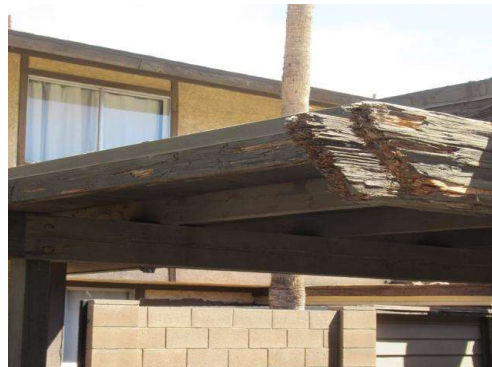
There are 79 covered spaces. Roof material is an asphalt rolled material. Wood structures are in need of repair. This component budgets \$1500/space for repairs and paint over 5 year period of 2024 thru 2028.

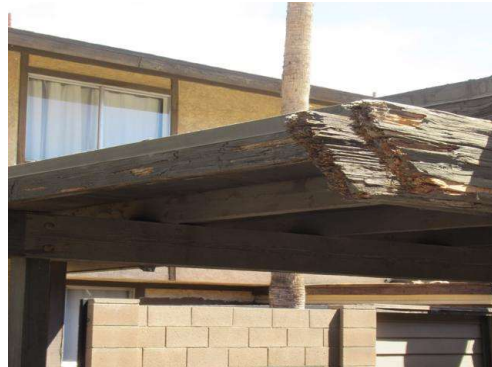
There are 79 covered spaces. Roof material is an asphalt rolled material. Wood structures are in need of repair. This component budgets \$1500/space for repairs and paint over 5 year period of 2024 thru 2028.

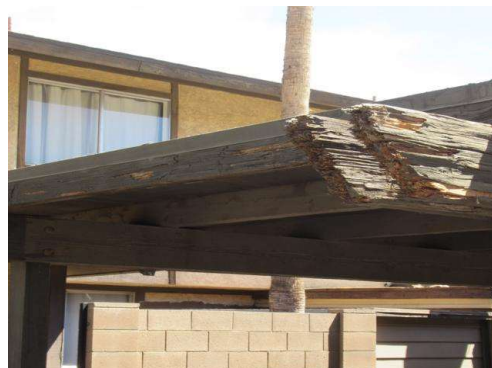
There are 79 covered spaces. Roof material is an asphalt rolled material. Wood structures are in need of repair. This component budgets \$1500/space for repairs and paint over 5 year period of 2024 thru 2028.

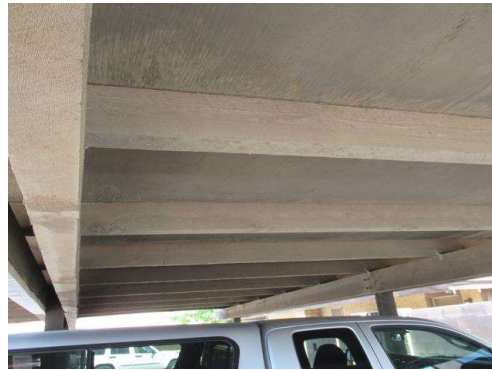
Fair to poor condition except where wood exposed (showing dry rot). Component anticipates that the structures will be painted inconjunction with repairs and then on a 7 year cycle after the last repairs are made in 2028. See asset ID 1044.

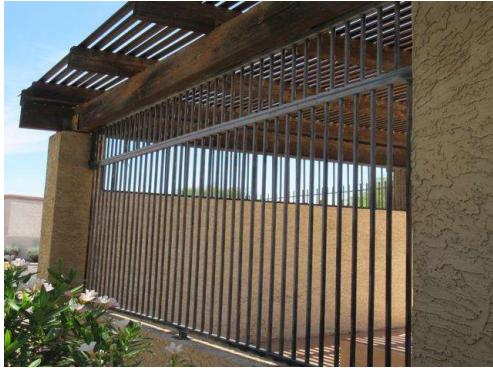
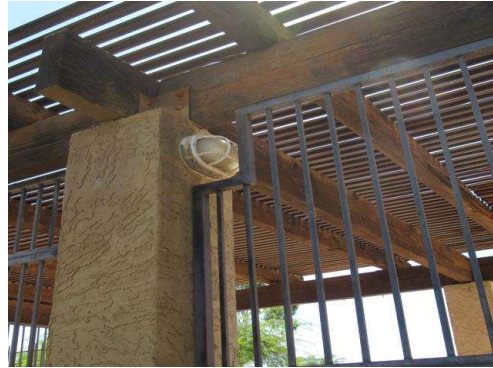
Poor condition. Surrounding pool recreation area. Rust and deterioration evident where spray irrigation hits. Last repaint date unknown. Recommend soon.

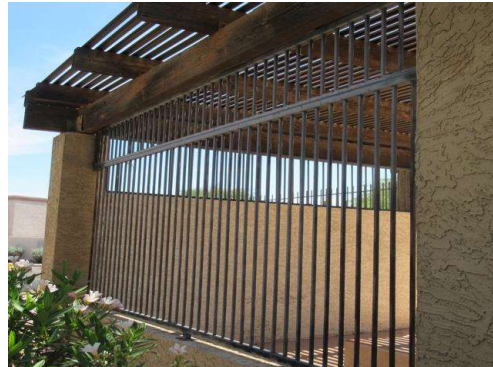
Good to fair condition. Some rusting visible at pool recreation area with some rusted out areas where irrigation hits. A budget for making wall repairs on a 5 year recurring schedule with approximate replacement of 5%. Total of approximately at approximately 1150 sf.
