April 16, 2019

PROPERTY: DOVE COVE ESTATES HOMEOWNERS ASSOCIATION
BUCKEYE, ARIZONA

SERVICE: FULL PROPERTY EVALUATION AND RESERVE FUND ANALYSIS

ATTACHMENT: FINAL REPORT

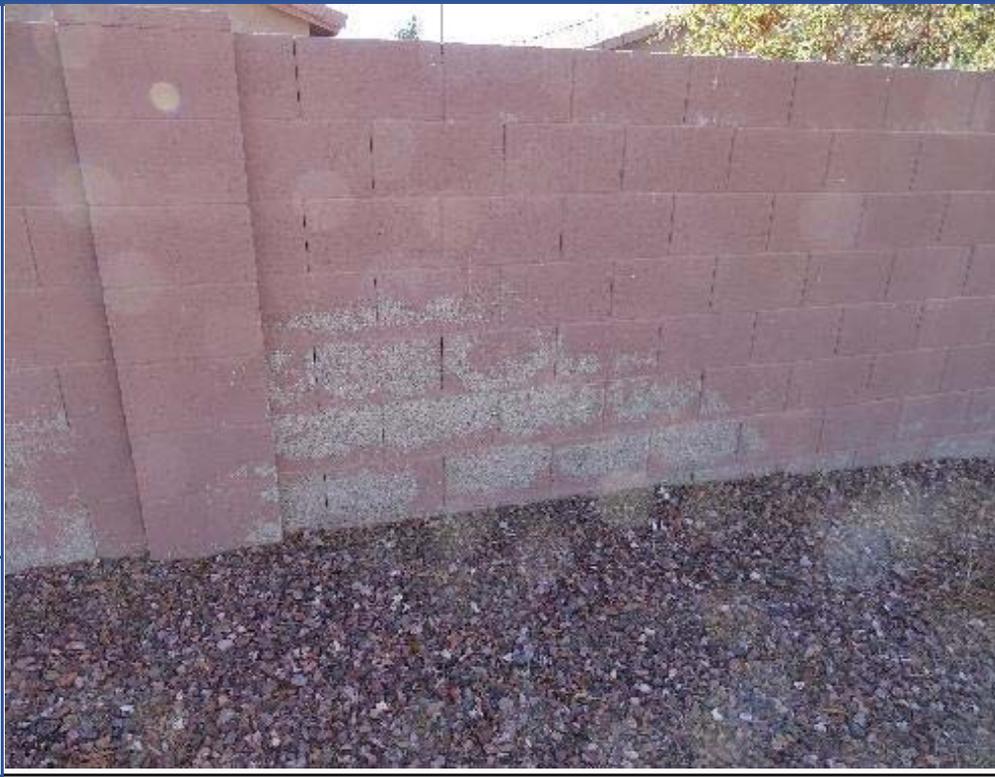
8

The network of perimeter block walls throughout the property are in generally good condition. There were areas of water damage noted in the base of the walls and the retention walls below some of the yards. We recommend conducting a wall inspection in the next year to develop a wall maintenance plan to slow deterioration of the walls and prolong the life of this asset. Funds were included in the reserve study to perform the inspection and to repair 2.5% of the block walls on a ten year cycle. This figure is based on similar projects for comparable communities. The wall maintenance plan is the largest variable cost affecting the funding of the reserve study.

Common Wall - with
water damage

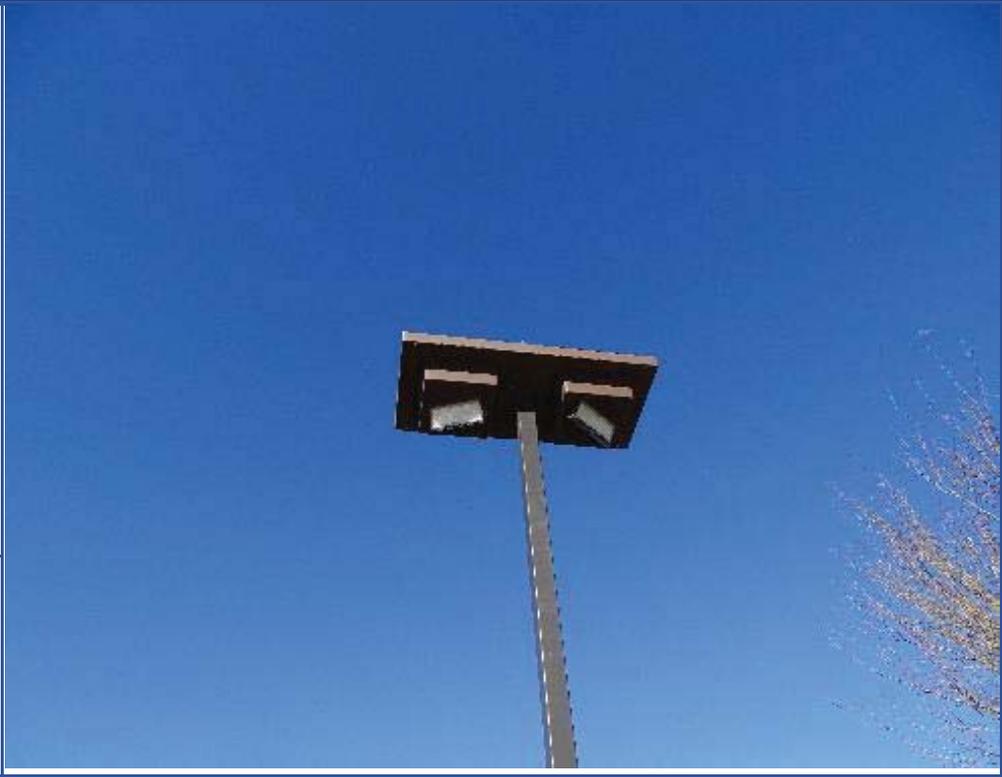
The Main Park and the Dove Ridge Park include solar lights. At the main park, the swing area is lighted in addition to the basketball court. The Dove Ridge playground includes a single light. These lights were inspected during the day and their operation was not confirmed. The reserve fund includes funding to replace the light fixture and the solar battery, not the entire mount and pole since that is outside of the 30-year study.

<p>Description:</p> <p>Main Park Solar Lights</p>
<p>29</p>

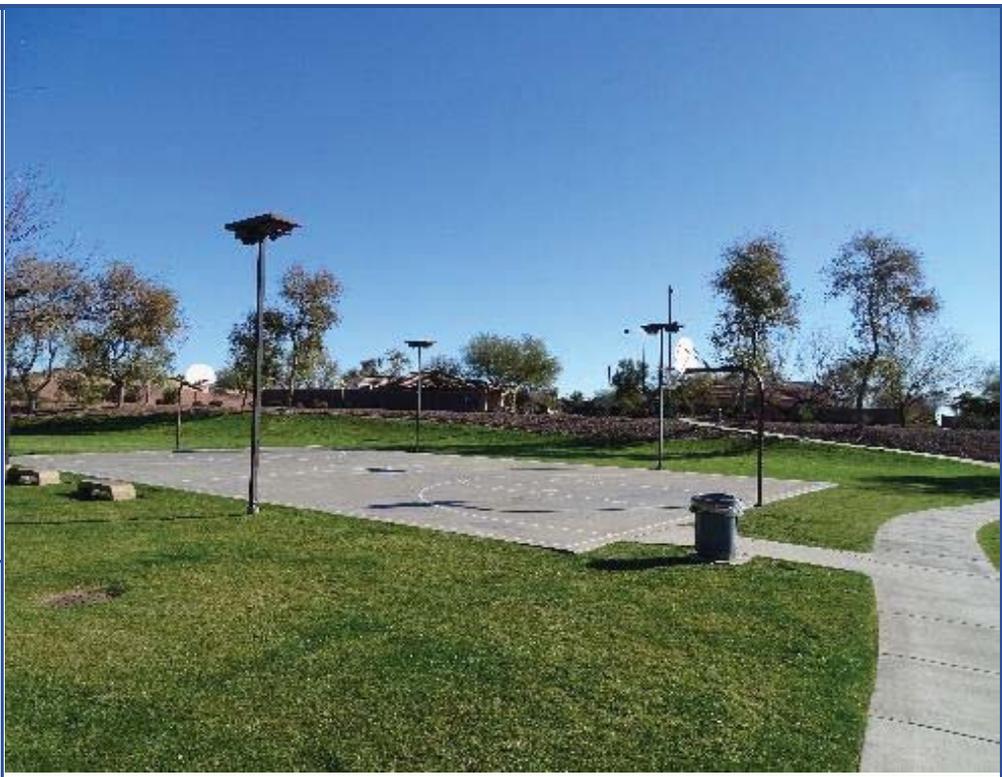
The basketball court in the main park is in good condition. The court has been repainted in the recent past. The backboards and chain nets are in good condition.

<p>Description:</p> <p>Main Park Basketball Court</p>
<p>30</p>

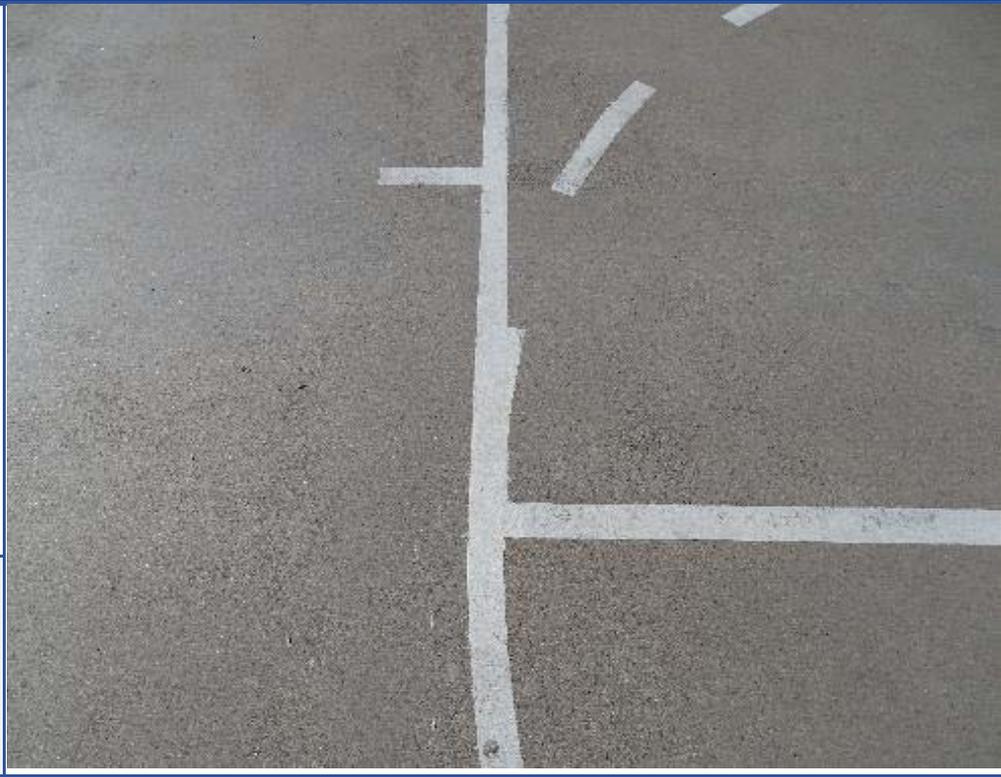
<p>Description:</p> <p>Basketball Court Surface</p>
<p>31</p>

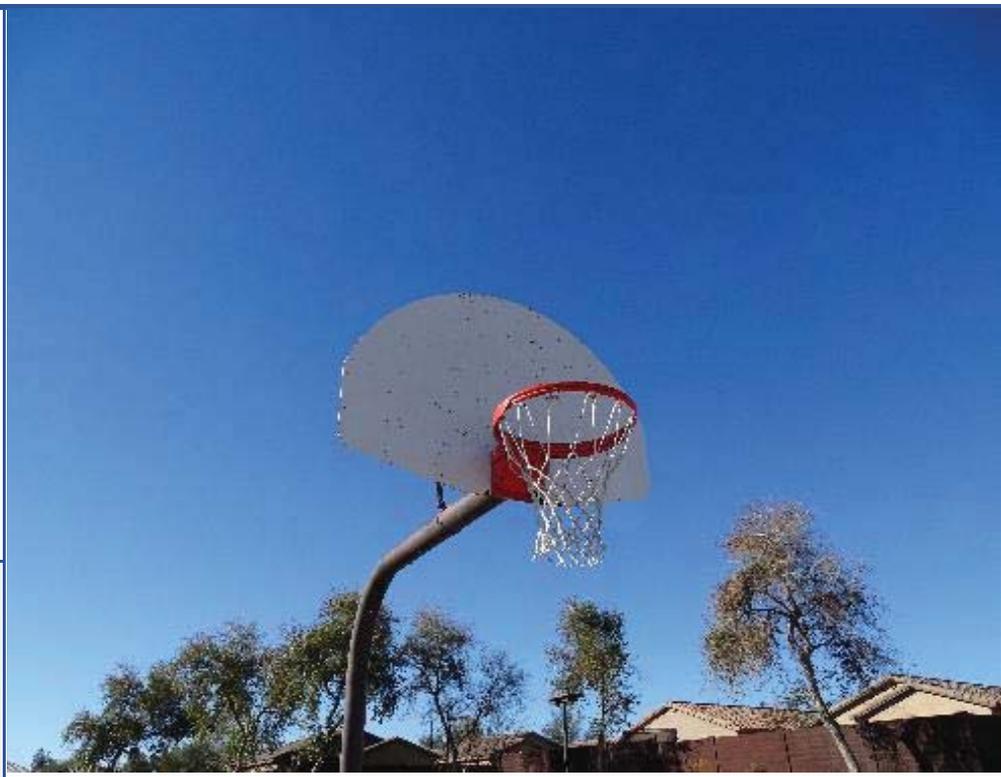
<p>Description:</p> <p>Basketball Backboards</p>
<p>32</p>
