PROPERTY: SOUTHERN ENCLAVE HOMEOWNERS ASSOCIATION
PHOENIX, ARIZONA

SERVICE: FULL RESERVE FUND ANALYSIS

ATTACHMENT: 22-0081 – FINAL REPORT

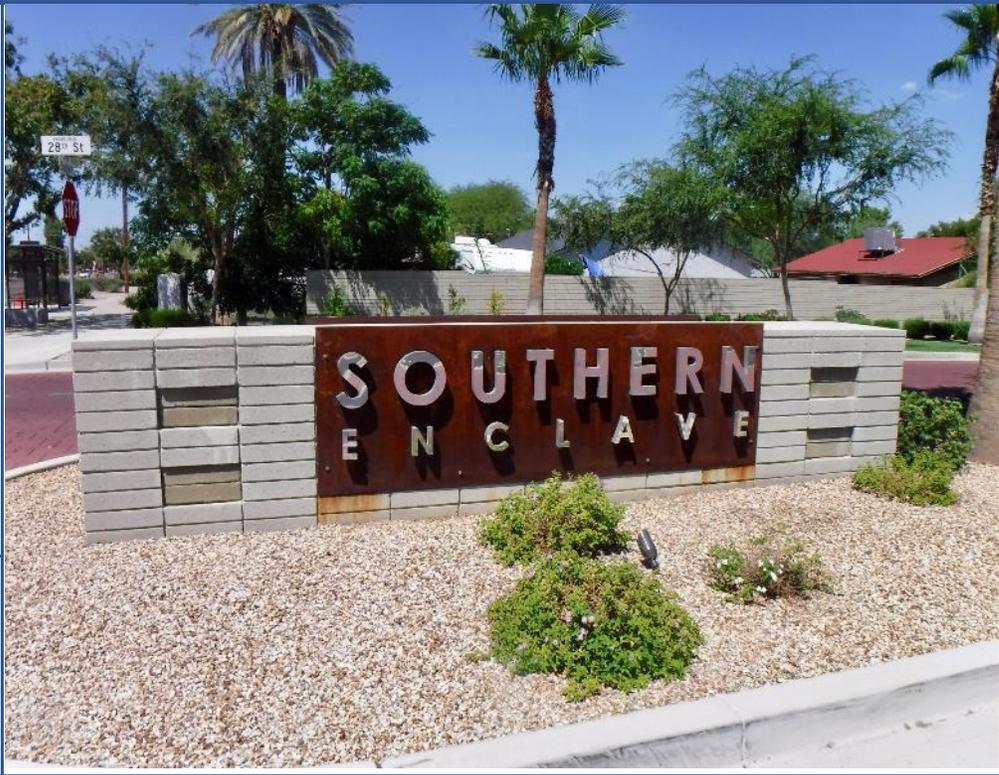
1

Main entrance monument sign

- Year 18 is skipped since the current plan calls for replacement of the mailbox kiosks
- ✓ The main entrance sign renovation is planned for year 18
 - This is not a full replacement

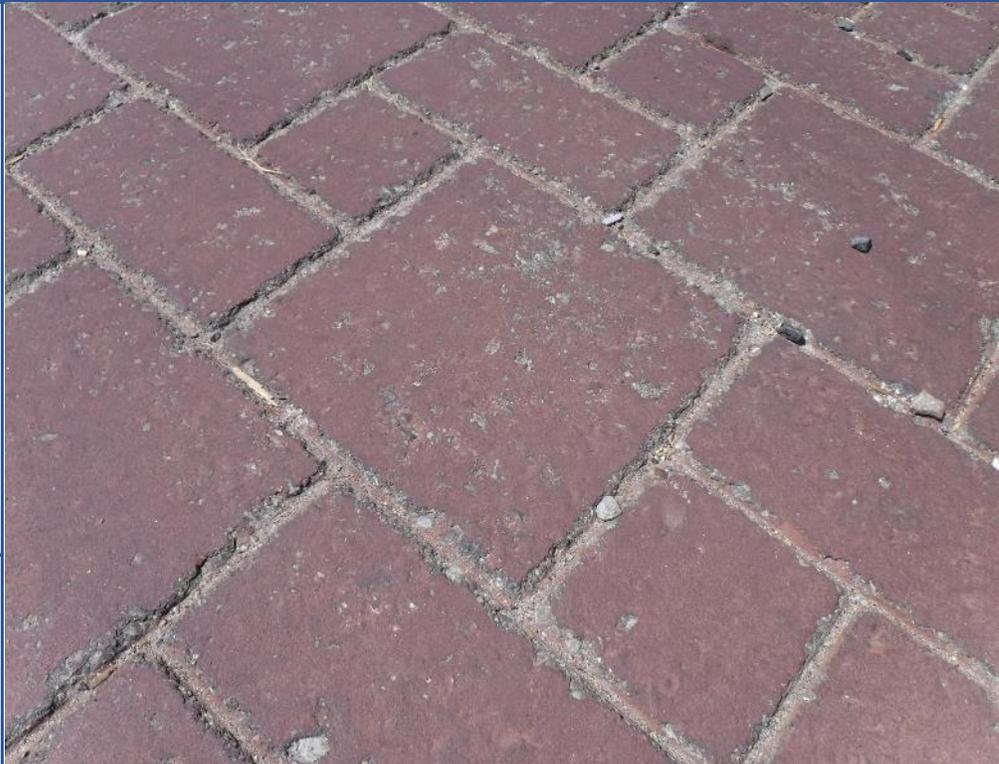
<p>Description:</p> <p>Main entrance - wear around edges of pavers</p>
<p>4</p>

- ✓ Private Stamped Asphalt Main Entrance Street – Focused rehabilitation in high wear areas in years 2, 10, and 18
 - Year 26 is skipped due to the 23 rehabilitation/seal and stamp

- This is the entrance area where the most traffic wear is visible
- ✓ Private Stamped Asphalt Main Entrance Street – Rehabilitate/seal and re-stamp in year 23

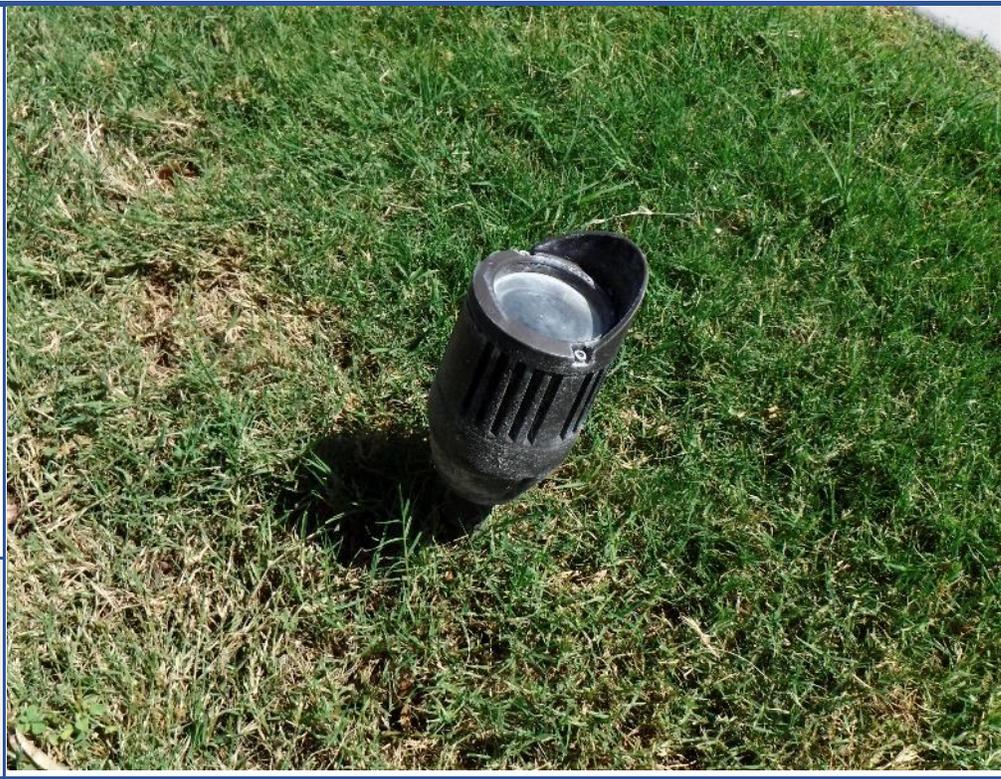
<p>Description:</p> <p>Sample up light near entrance</p>
<p>5</p>

- ✓ Bollard lights are planned for replacement in Year 13
- ✓ Up-lights at the main entrance are planned for replacement in Years 3, 13, and 23
- ✓ Mailbox kiosks are located throughout the site and are planned for replacement in Year 18

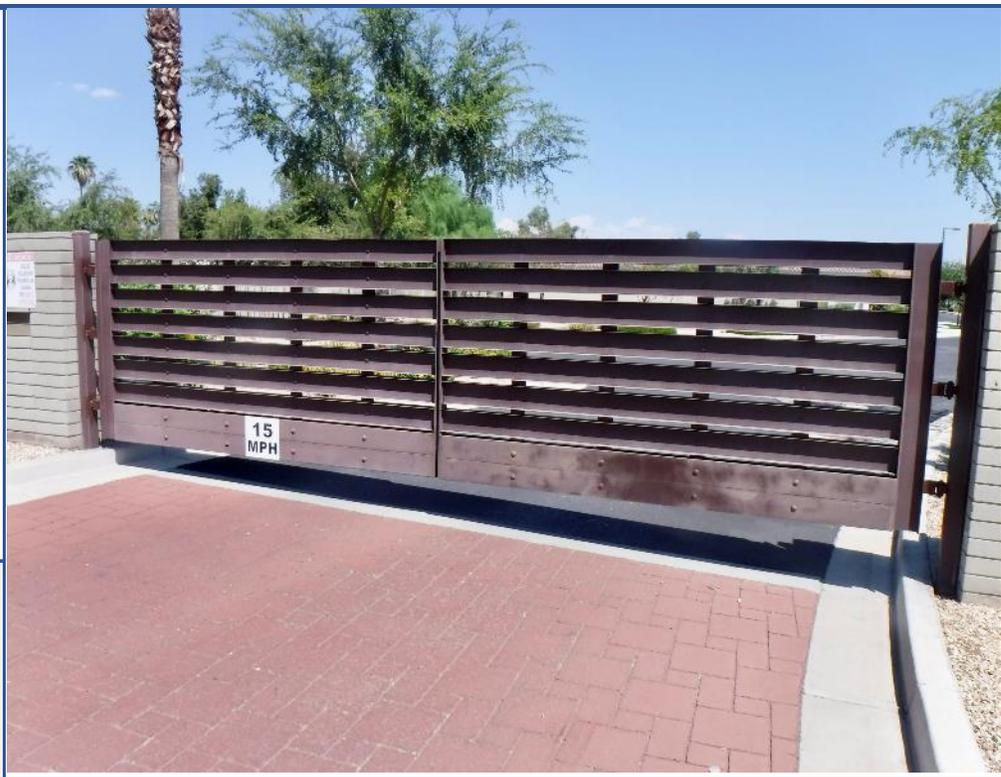
<p>Description:</p> <p>Main entrance gate #1</p>
<p>6</p>

- ✓ Main and secondary entrance gates are planned for replacement in Year 23, this includes four gates
- ✓ Main and secondary entrance gates are planned for painting in Years, 1, 9, and 17

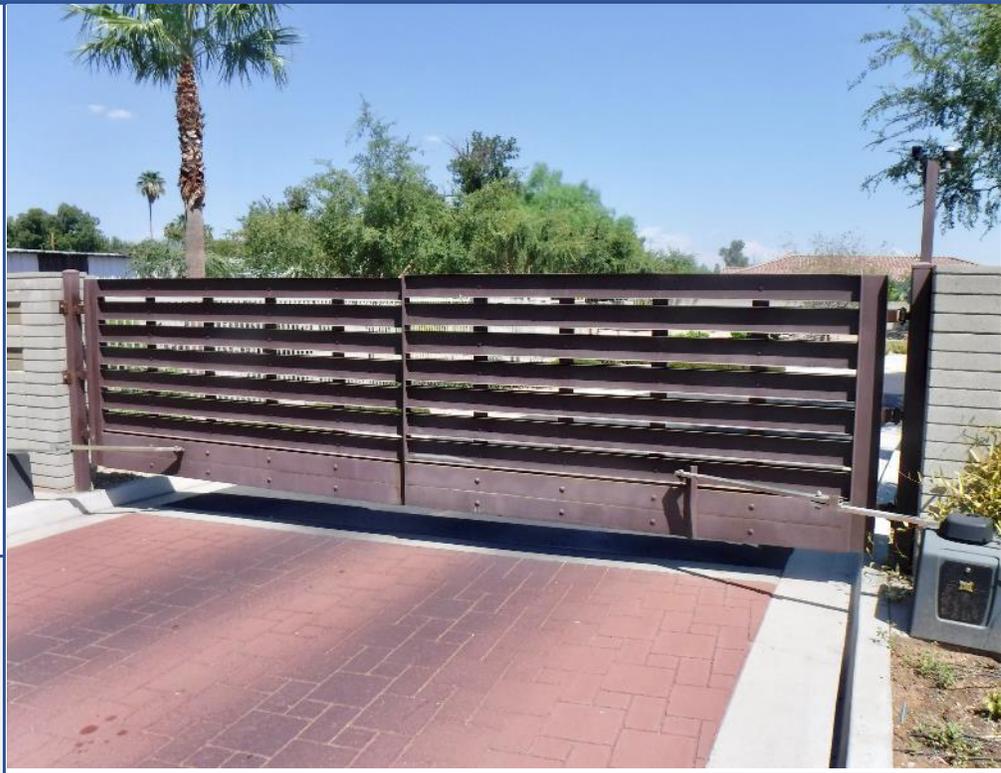
7

Main entrance gate #2

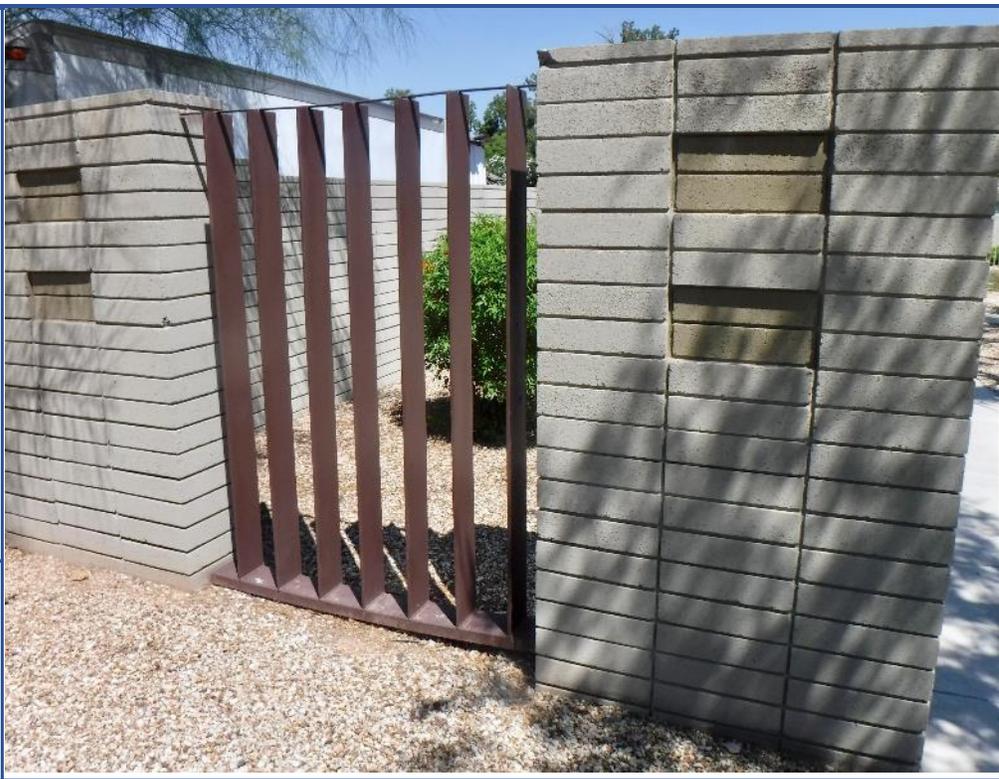
<p>Description:</p> <p>Block wall and decorative iron fencing near main entrance</p>
<p>12</p>

- ✓ Block Wall Repairs and Painting in Years 2, 10, 18, and 26
 - This includes repairing both the 2-foot and 6-foot block walls before painting
 - The 6-foot walls include budget to repair about 2.5% of the walls every eight years and the 2-foot walls include budget to repair about 5% of the walls every eight years; should the walls begin to develop issues; these numbers may need to be increased

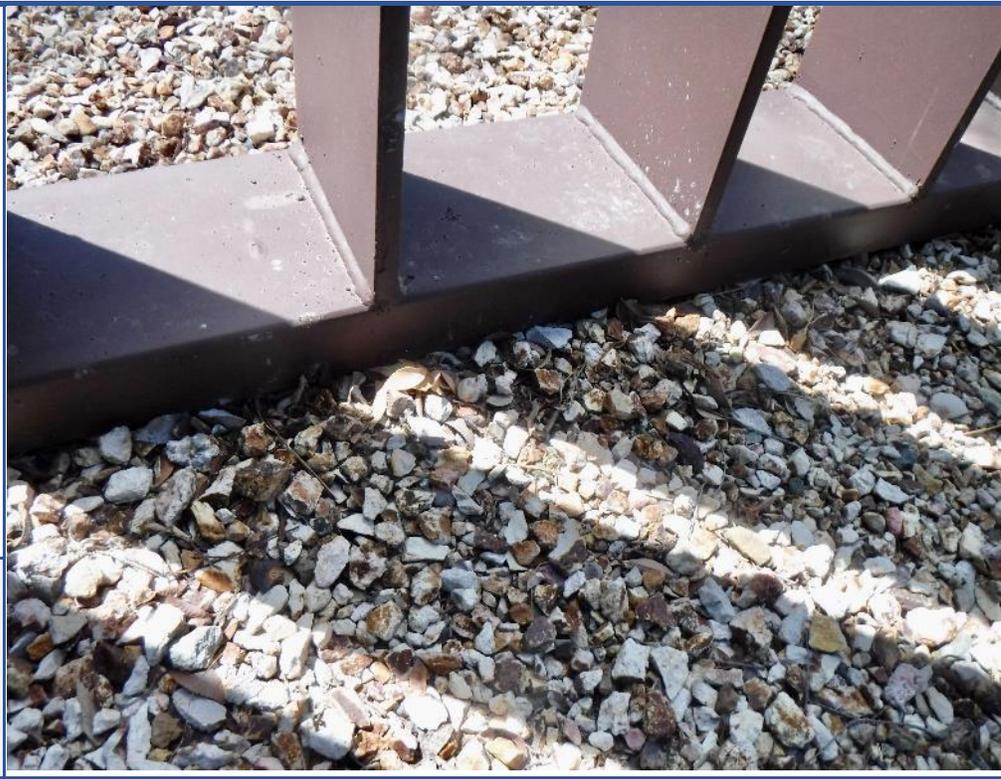
<p>Description:</p> <p>Issue - bottom of iron fencing partially under granite</p>
<p>17</p>

- ✓ Steel fence, heavy gate is planned for replacement in Year 28
 - This is a patina finish and does not require painting
 - There were sections of this fence that were buried by the gravel – this should be pulled back so that the fencing components do not deteriorate prematurely

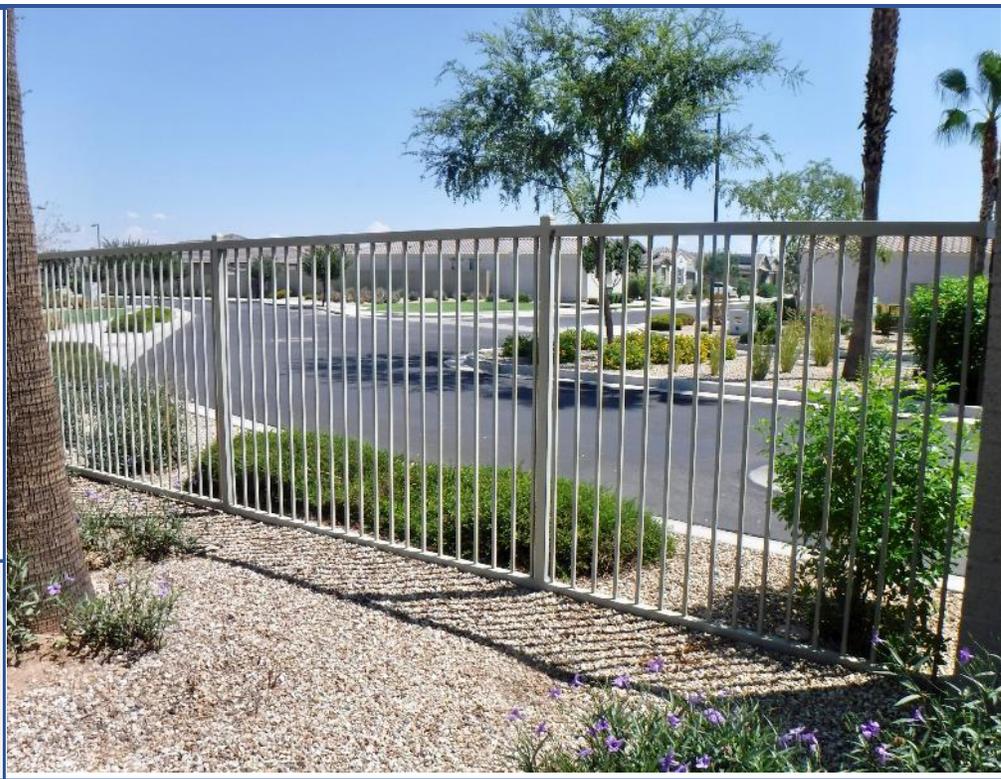
<p>Description:</p> <p>Wrought iron fencing</p>
<p>18</p>

- ✓ Wrought Iron Fence Replacement currently slated for Year 23
 - This includes both the 6-foot and the 4-foot (primarily in the dog park and along the front of the site on Southern Avenue)

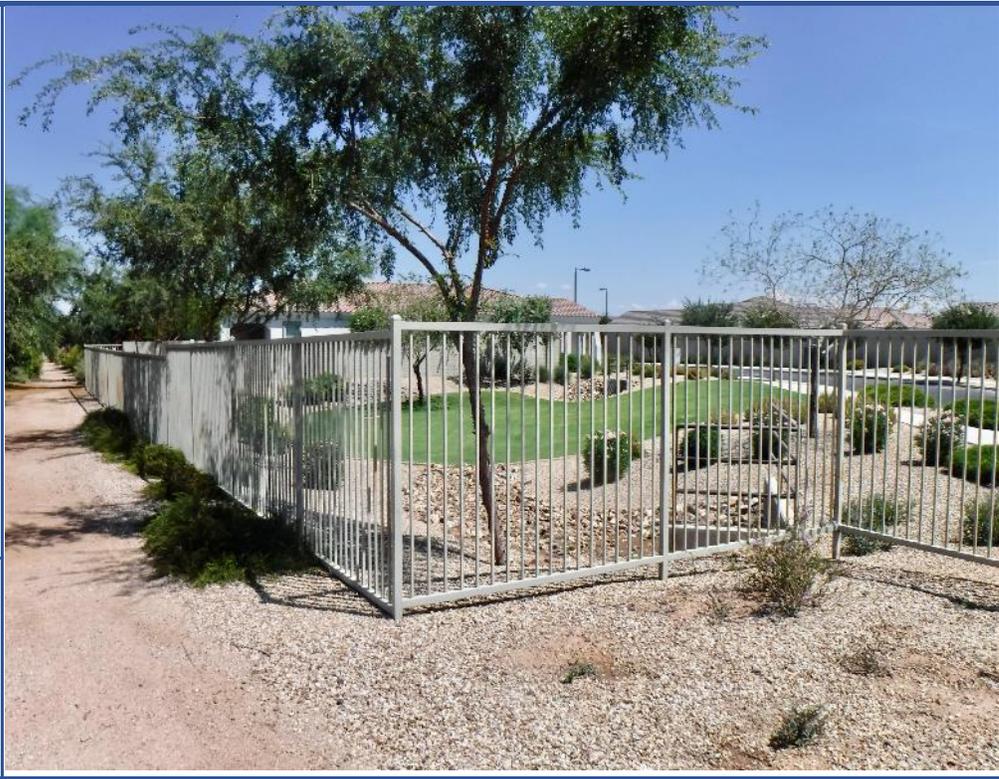
<p>Description:</p> <p>Wrought iron gate near main entrance</p>
<p>21</p>

- If the HOA treats the corrosion and repaints consistently, the remaining useful life of the wrought iron may be extended
- ✓ Wrought Iron Gate Replacement currently slated for Year 23

- This includes the 4-foot and 6-foot wrought iron gates and the patina finished gate at the southeast entrance
 - Ongoing maintenance and painting is required to achieve the remaining useful life, and as noted above for the fencing, if the HOA treats the corrosion and repaints consistently, the remaining useful life of the gates may be extended.

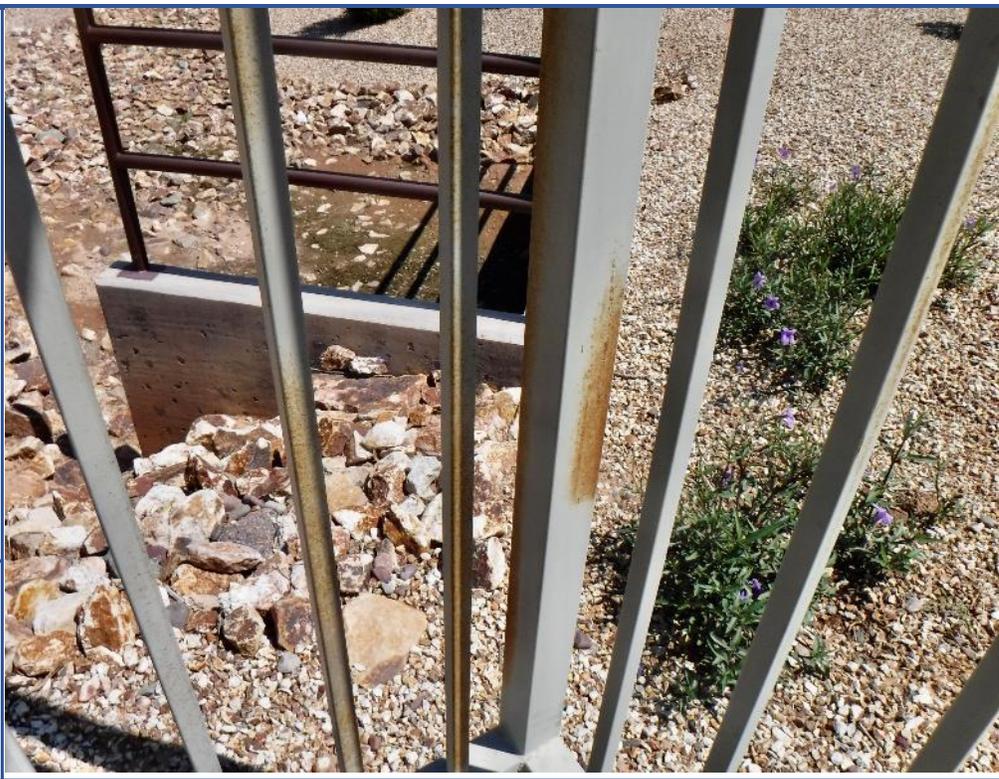
The network of perimeter block walls and view fences throughout the property is in good general condition, although many of the wrought iron fences have some corrosion and require painting.

<p>Description:</p> <p>Issues - corrosion on wrought iron fencing</p>
<p>22</p>

- ✓ Wrought Iron Fence and Gate painting slated for Years 2, 10, and 18
 - Painting is skipped in Year 26 since the fences and gates are planned for replacement in Year 23

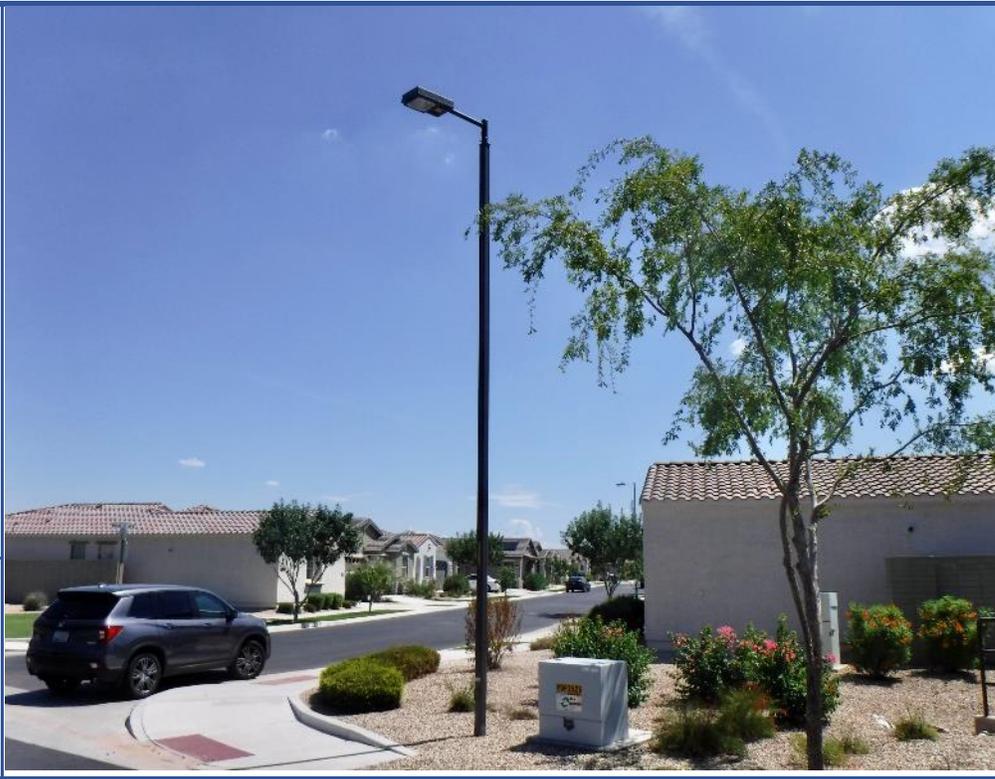
23

Street light

- ✓ Street signs are planned for replacement in Year 13; they must meet civil municipal requirements
- ✓ Street Lights, including the pole and the LED lights, are planned for replacement in Year 13

- ✓ Street Lights are planned for painting in Years 2, 10, 21 and 29
 - Skipped in year 18 due to replacement and then started the cycle over again in Year 21

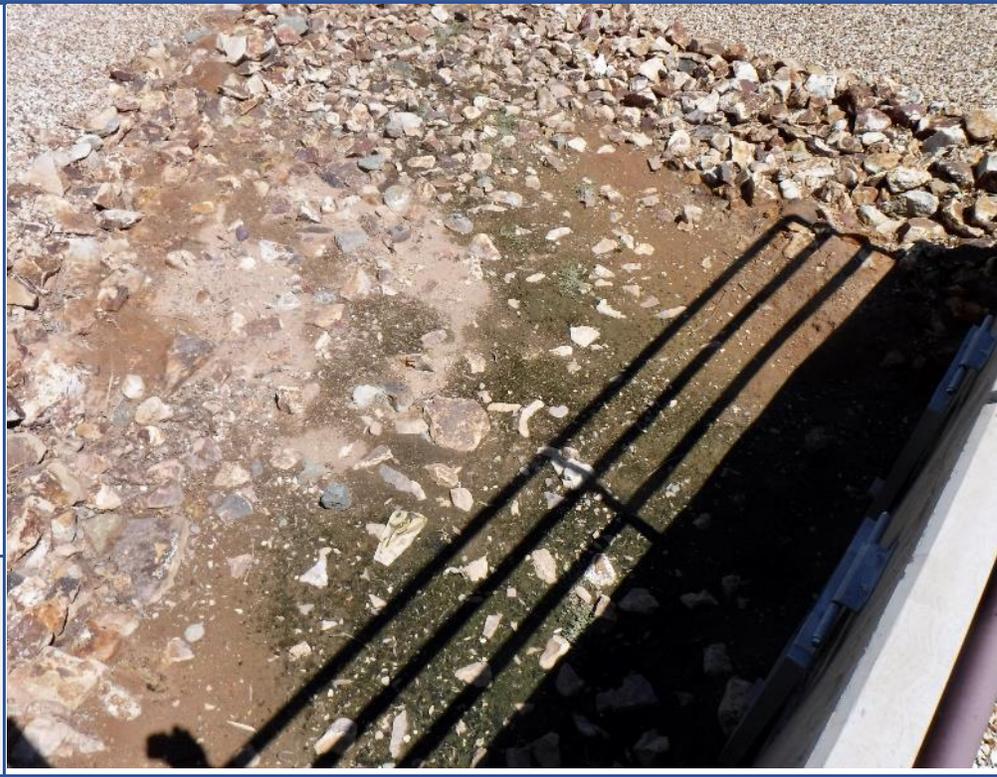
Roof and surface storm water runoff drain to on-site retention basins through gutters, downspouts, catch basins, and grass-lined drainage swales. The drainage basins located on site include one at the northwest corner, one at the northeast corner, one on the southeast, and two on the west side. Overall, the storm drainage system appears to function as designed, although several of the drainage culverts need to be cleaned and replacement of some of the angular rock.

Issue - drainage culvert requires cleaning and new angular rock

- ✓ Culvert Repairs to include cleaning debris and replacing angular rock is scheduled for Years 1, 9, 17, and 25
- ✓ Drywell Maintenance is scheduled for Years 3, 13, and 23

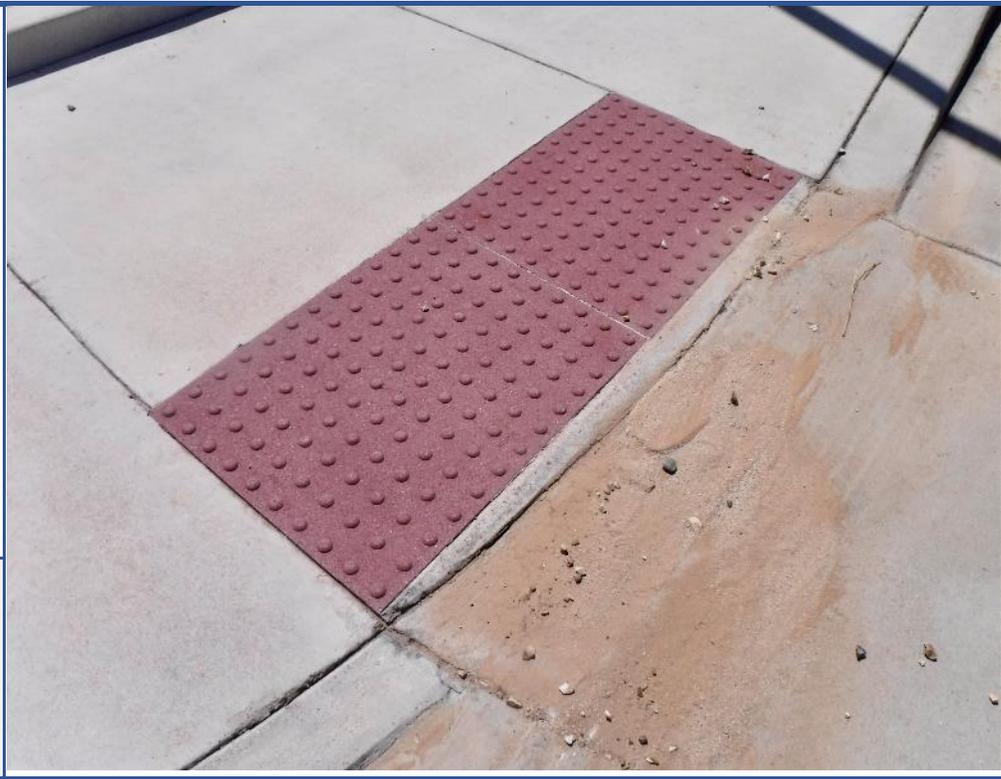
<p>Description:</p> <p>Cast-in-Place replaceable tactile detectible warning surface</p>
<p>29</p>

- ✓ Tactile detectable warning surfaces planned for replacement in Year 5, 17, and 29
 - Some of these are more worn than others and can likely be replaced intermittently as required

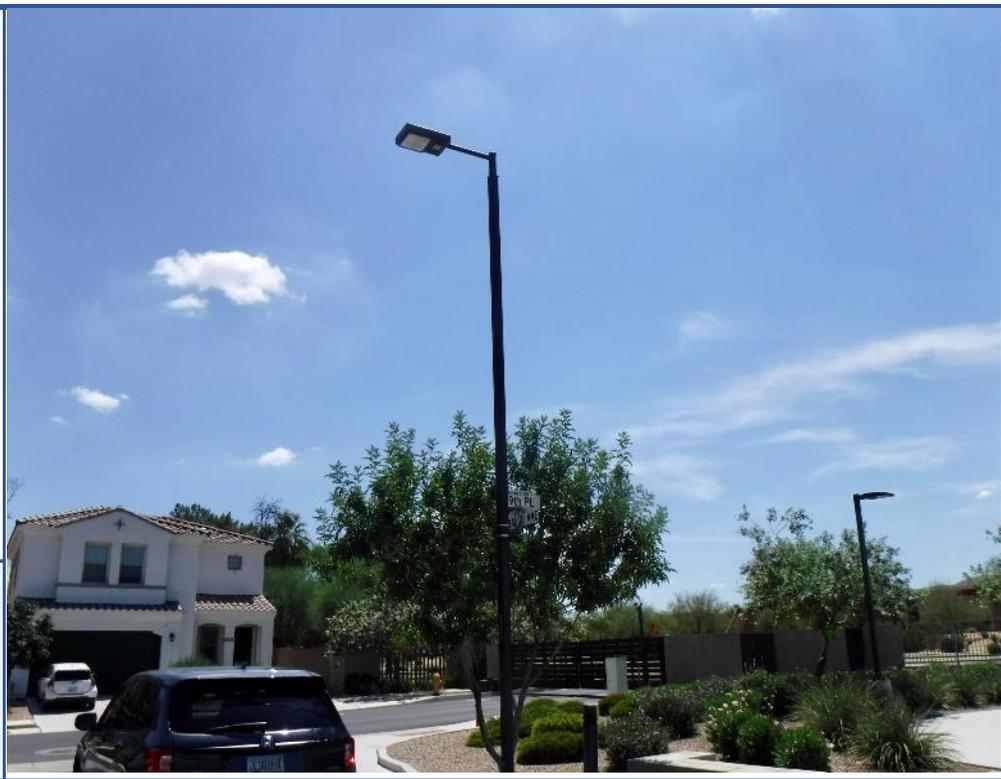
<p>Description:</p> <p>Street light - tall with LED fixture</p>
<p>30</p>

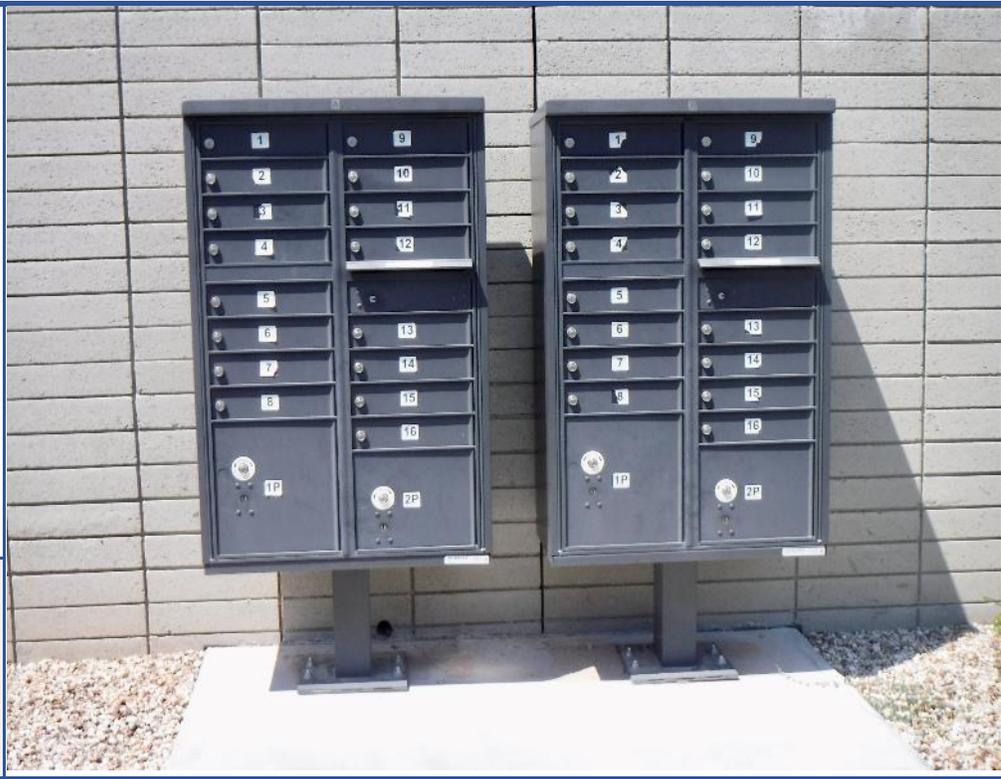
35

Mail box kiosks

- This may be extended if the Association continues to maintain the mailboxes through repairs and painting
- ✓ Painting and repair of Mailbox kiosks are in Years 2, 10, and 26

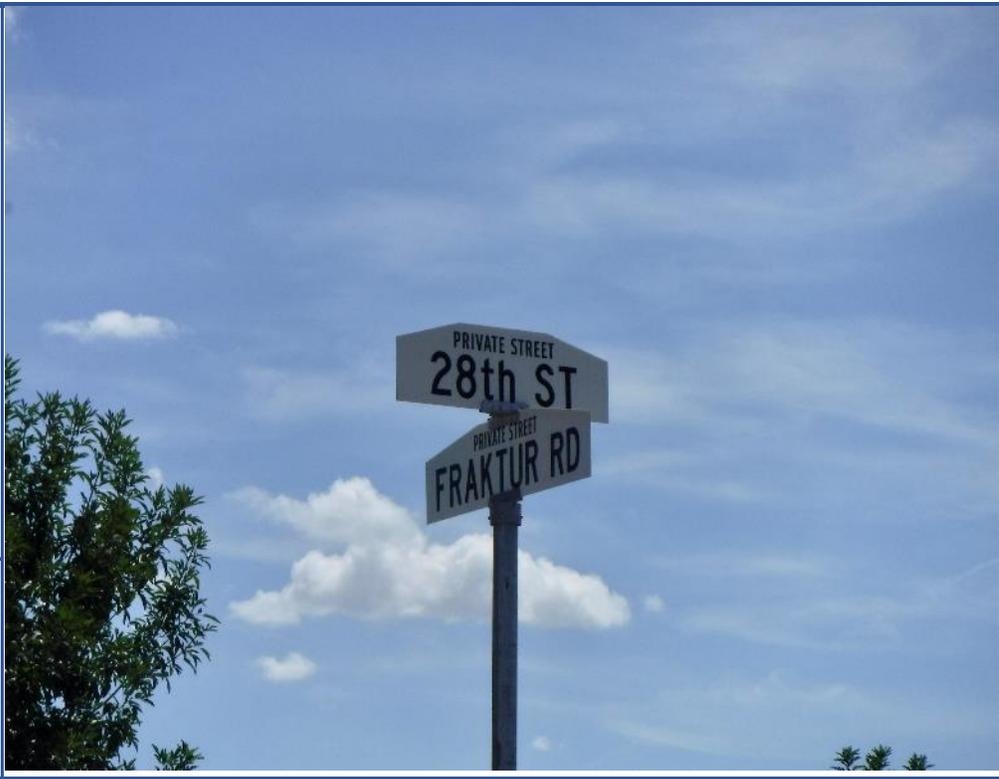
38

Street signs

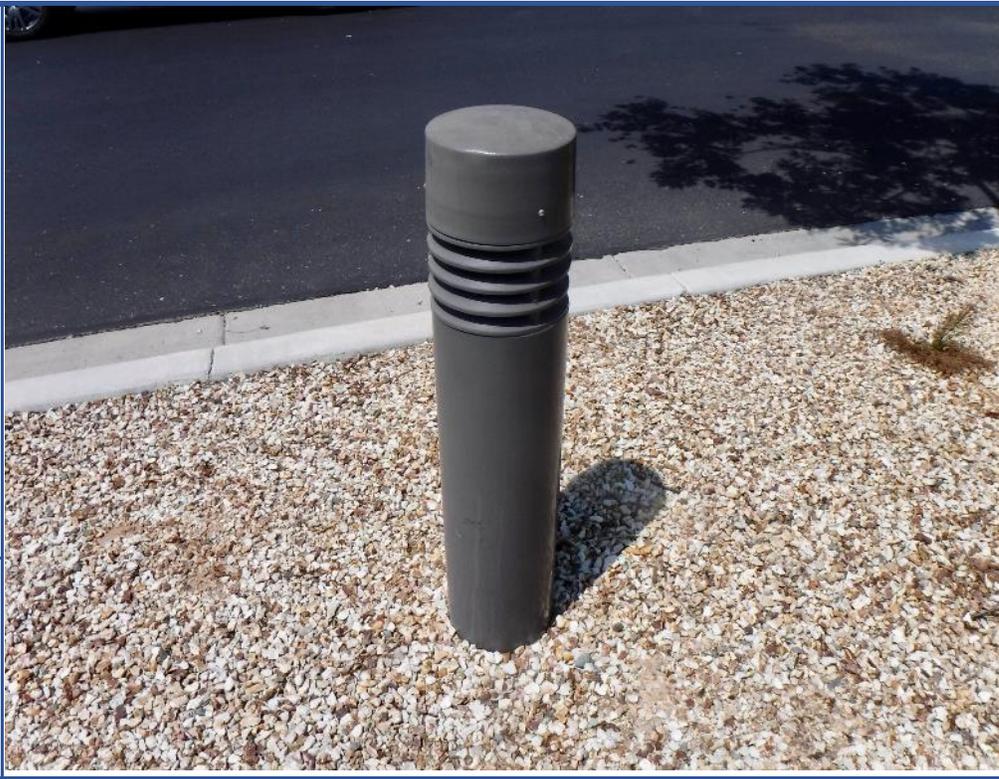
41

Bollard landscape light

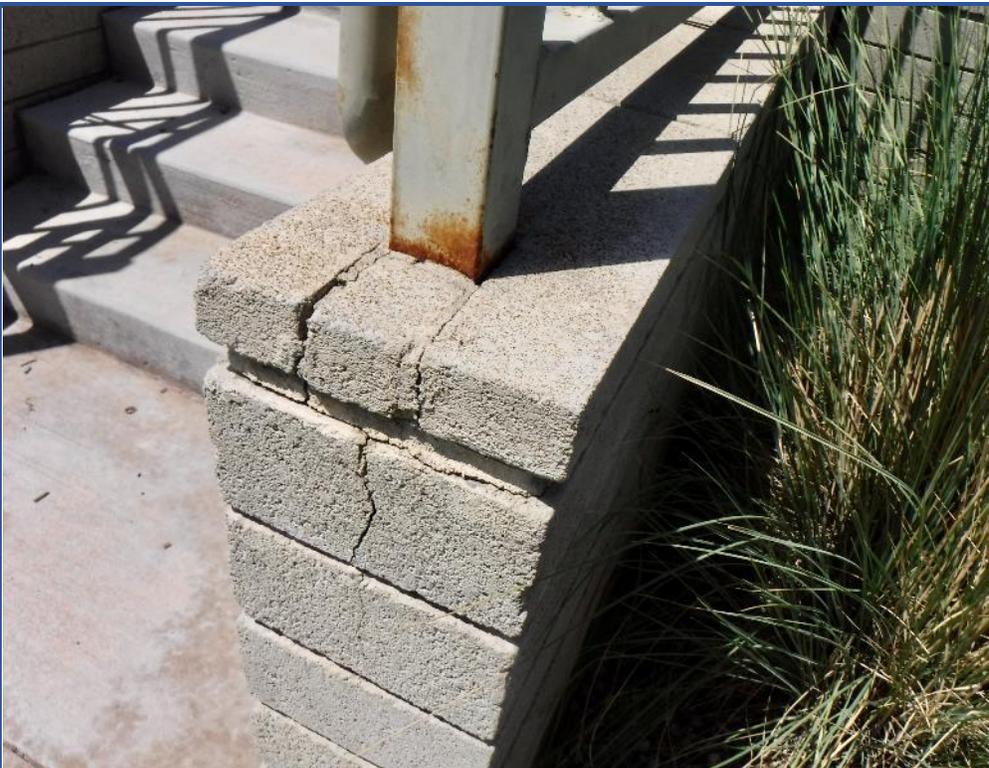
Issue - West Park -
Broken/cracked top cap
and corroded wrought
iron fencing

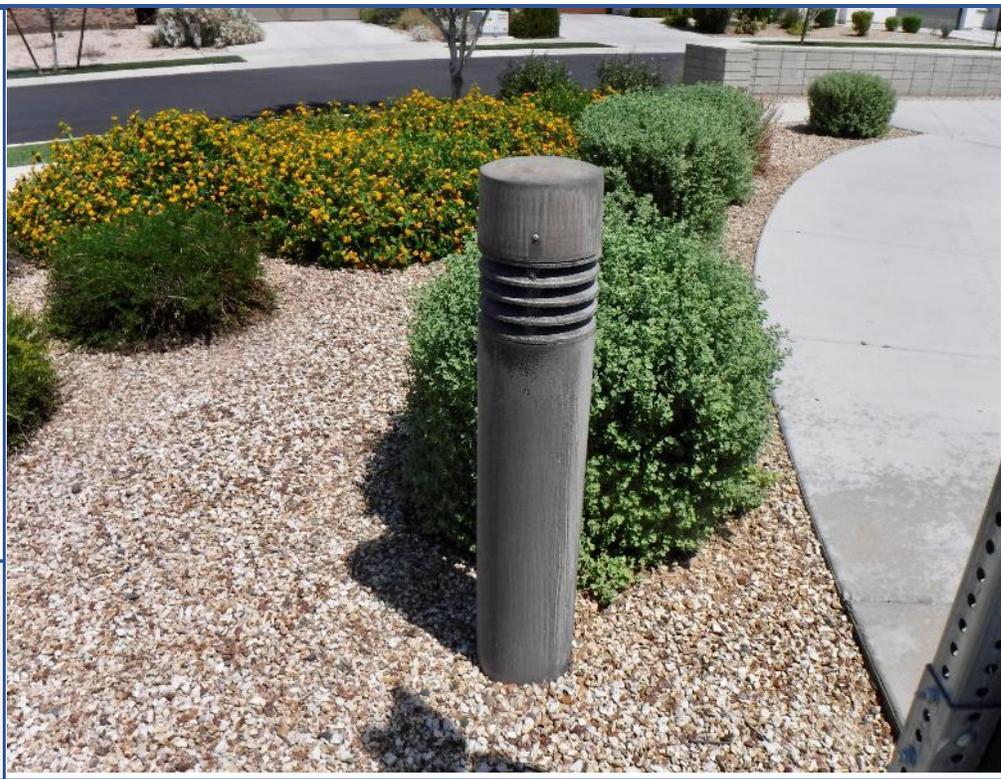
<p>Description:</p> <p>Issue - South Park - Bollard light, discolored</p>
<p>64</p>

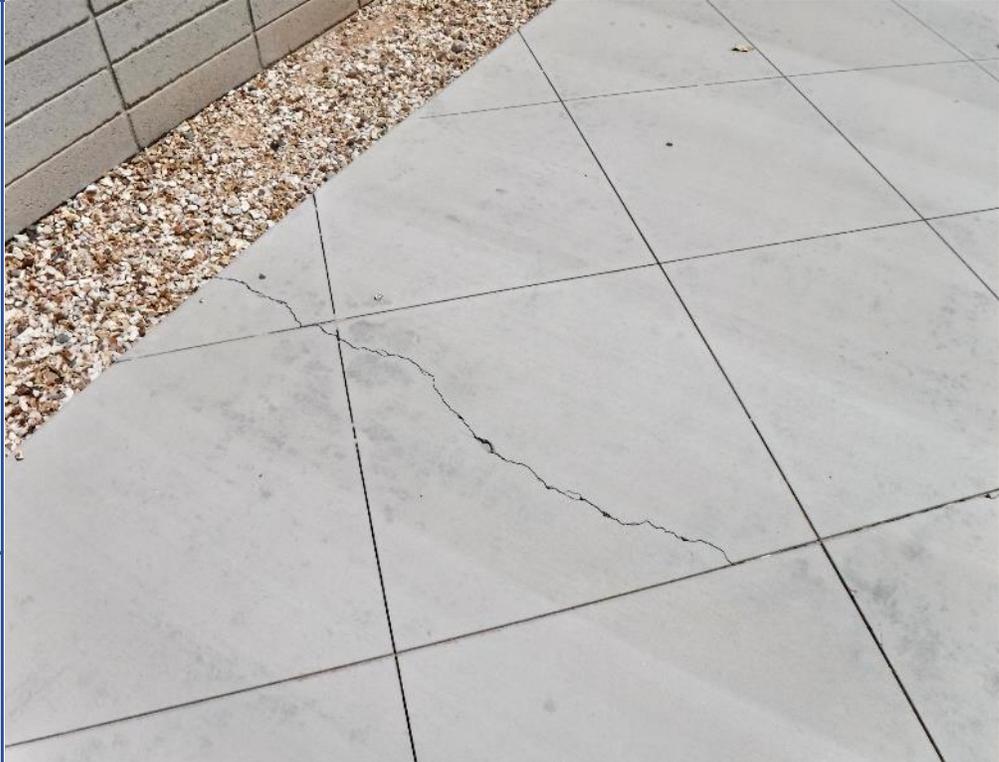
<p>Description:</p> <p>Issue - South Park - Cracked concrete pad</p>
<p>70</p>

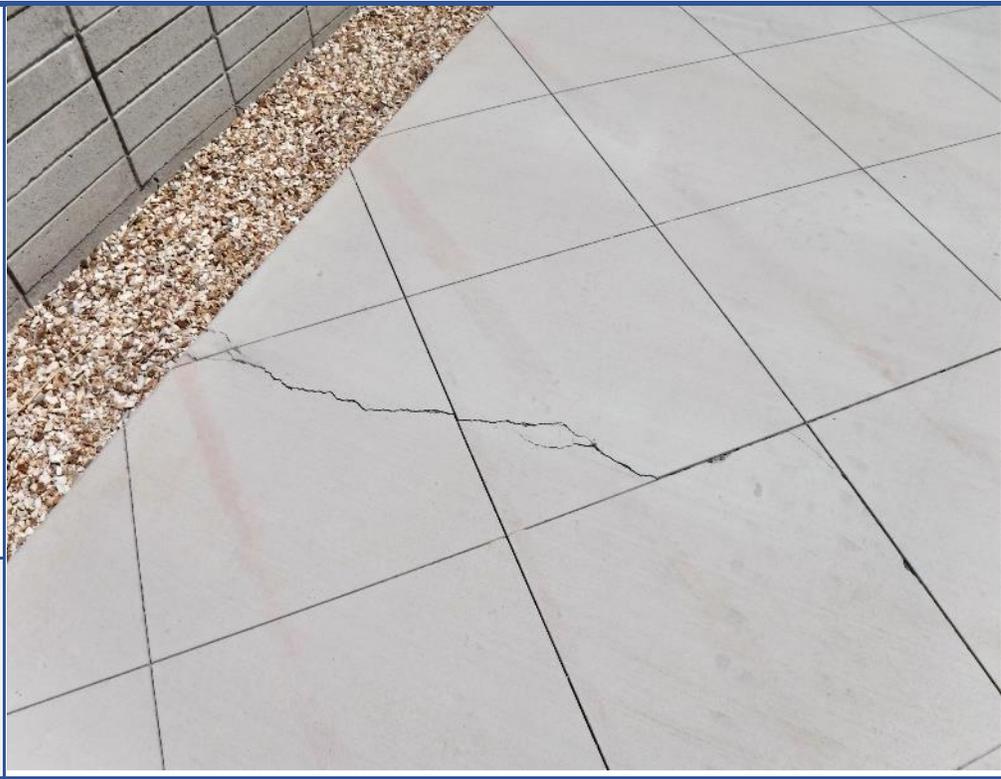
<p>Description:</p> <p>Issue - South Park - Cracked concrete pad</p>
<p>71</p>

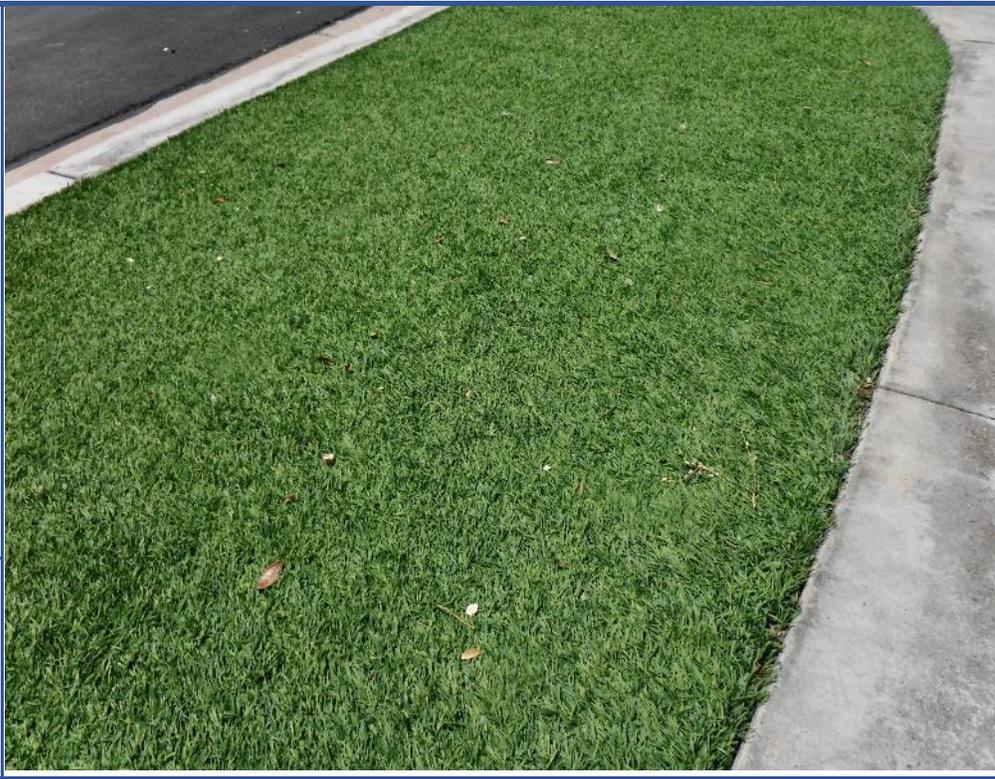
75

Artificial turf is located throughout the site between the homeowner front yard and the streets. Several sections of artificial turf are well worn, but overall it is in good general condition.

Issue - worn artificial turf

- ✓ Artificial Turn: Replace in Years 8 and 22
 - Provide interim replacement of artificial turf in high wear areas in Years 1, 15, and 29; the HOA may want to consider replacing these areas with pavers since after six years, the traffic patterns within the community are now apparent

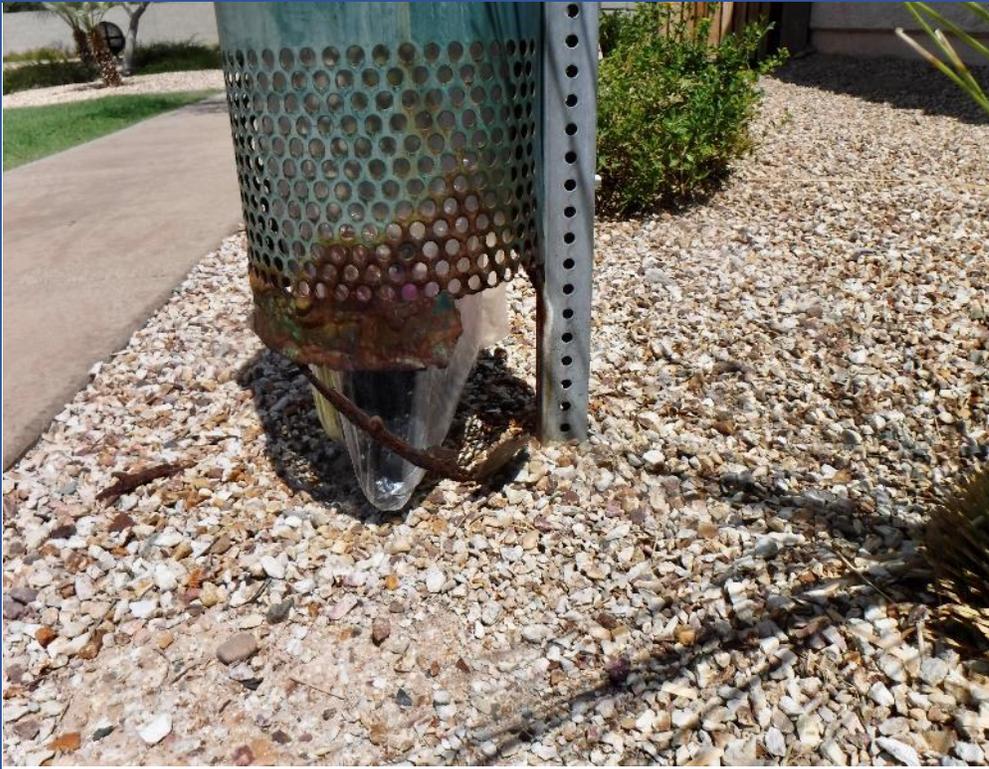
Issue - corroded doggie station

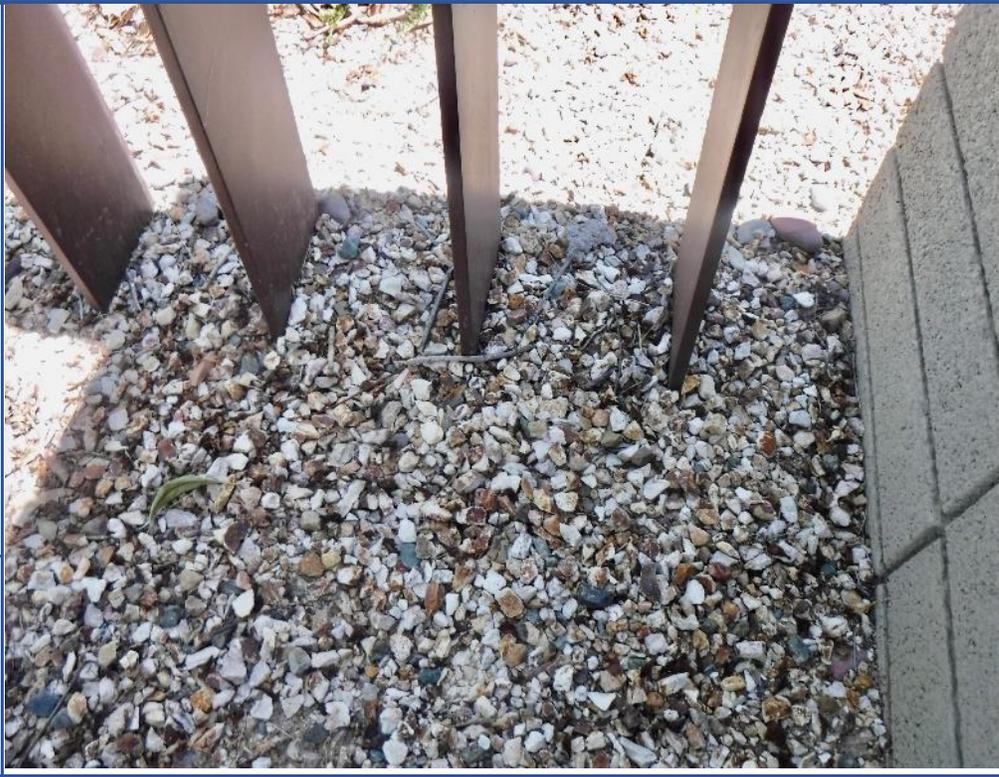
<p>Description:</p> <p>Issue - bottom of iron fencing partially under granite</p>
<p>93</p>
