PROPERTY: SOUTHERN ENCLAVE HOMEOWNERS ASSOCIATION
PHOENIX, ARIZONA

SERVICE: FULL RESERVE FUND ANALYSIS

ATTACHMENT: 22-0081 – FINAL REPORT

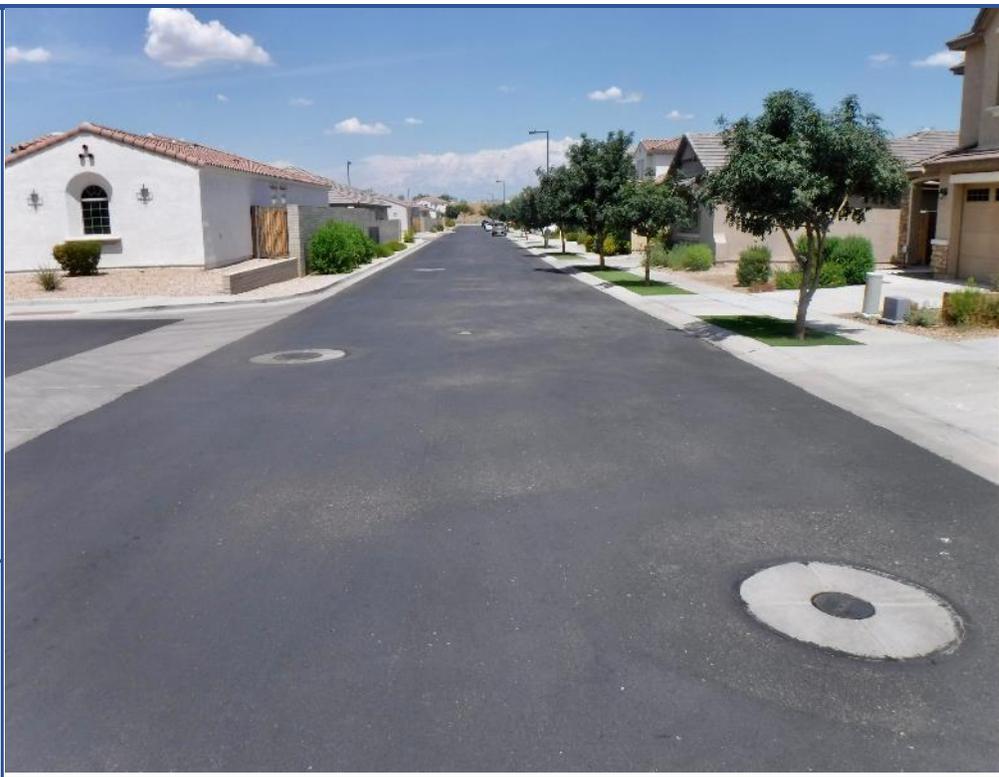
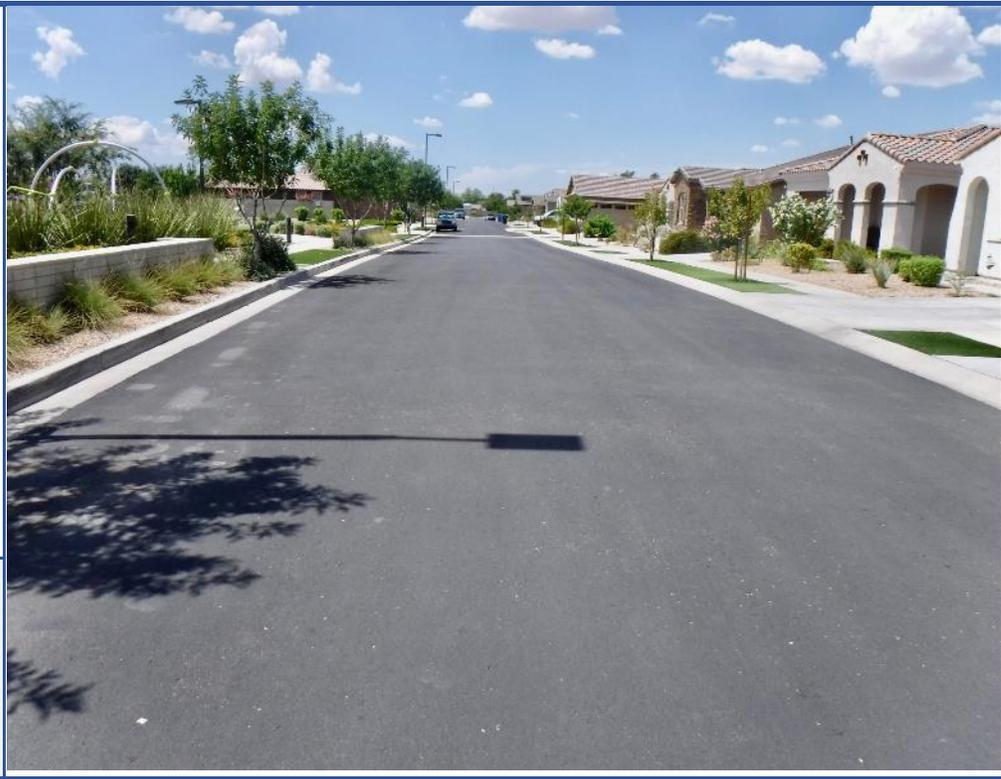
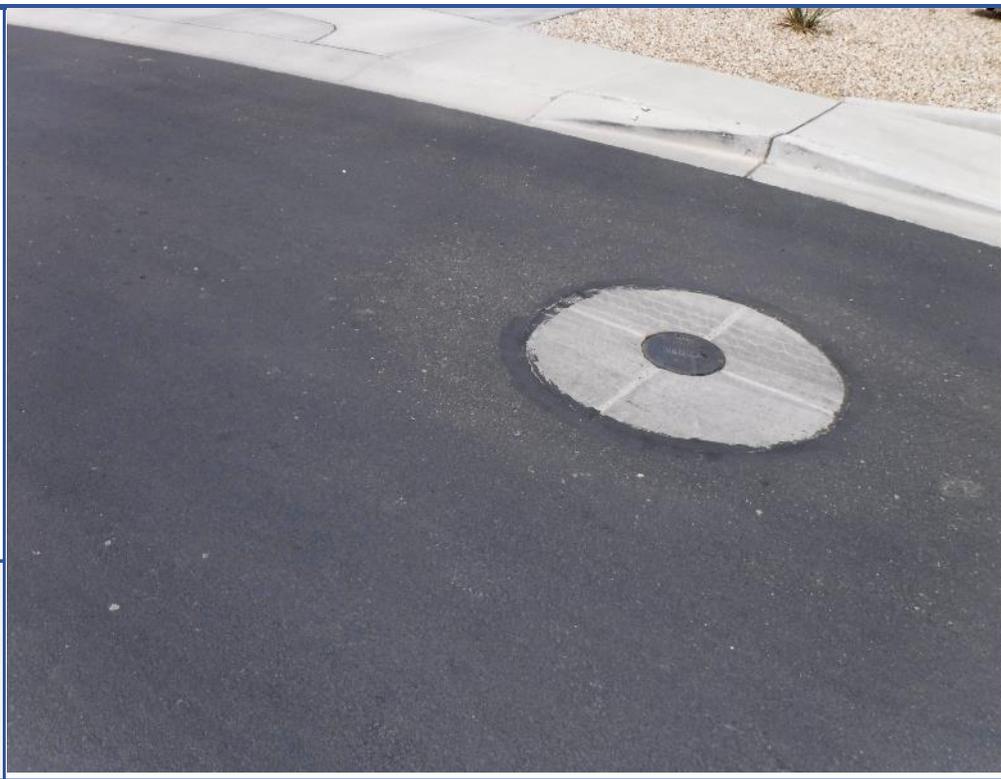
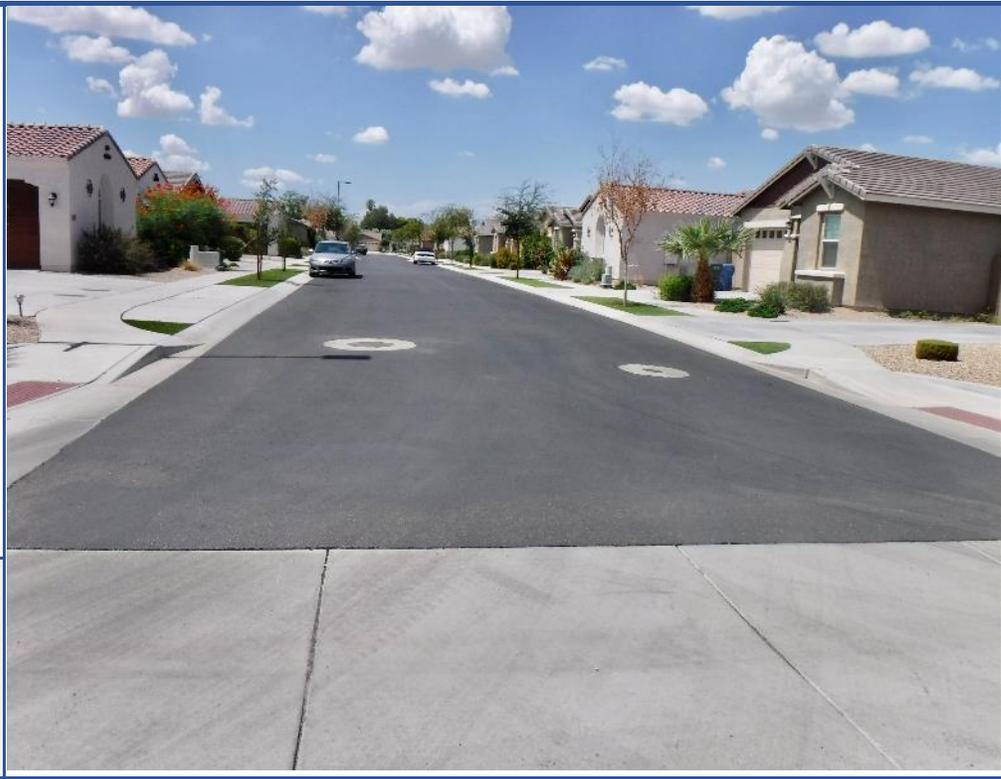
The network of interior roads providing access to the units are in good general condition, this includes asphalt-paved roads and stamped asphalt-paved entrance.

<p>Description:</p> <p>Sample - asphalt streets</p>
<p>94</p>

- ✓ Private Asphalt Streets – Seal coating, crack sealing, and repairs in Years 6, 10, 14, 18, 24, and 27
 - Year 22 is skipped due to remove and replace in Year 23 and then the cycle begins again in Year 24

- ✓ Private Asphalt Streets – Remove and Replace in Year 23
 - The remaining useful life may be extended through consistent maintenance as noted in the previous bullets; although asphalt street may look good, the seal coating should not be skipped

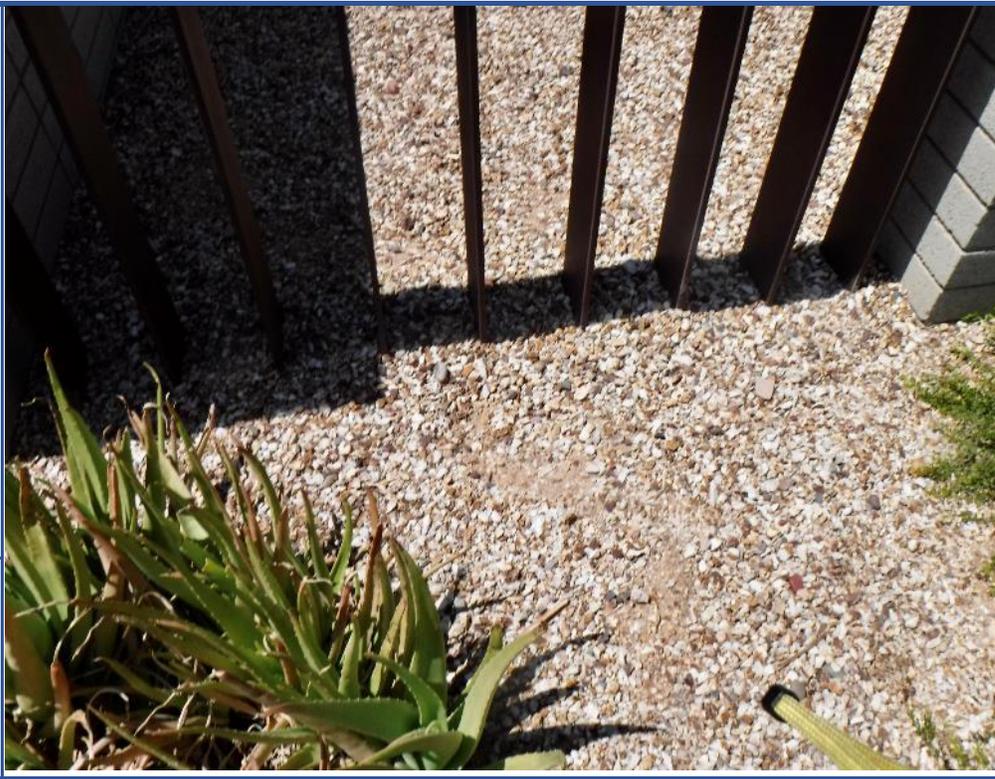
99

Issue - bottom of iron fencing partially under granite

- ✓ Steel fence, heavy gate is planned for replacement in Year 28
 - This is a patina finish and does not require painting
 - There were sections of this fence that were buried by the gravel – this should be pulled back so that the fencing components do not deteriorate prematurely
