**RESERVE STUDY UPDATE  
FOR  
CIRCLE G RANCHES 4 HOMEOWNERS  
ASSOCIATION**

January 12, 2026

## EXECUTIVE SUMMARY

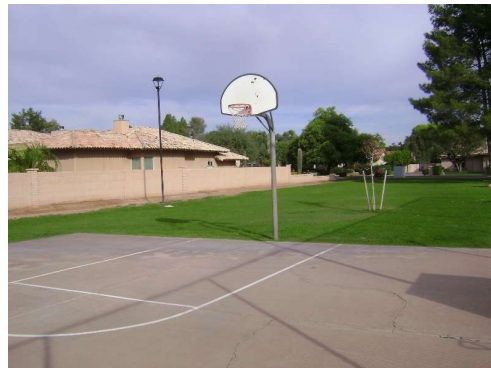
### Pole Lights (Recreation) - Paint

Poor condition. Budget to paint recreation area pole lights.

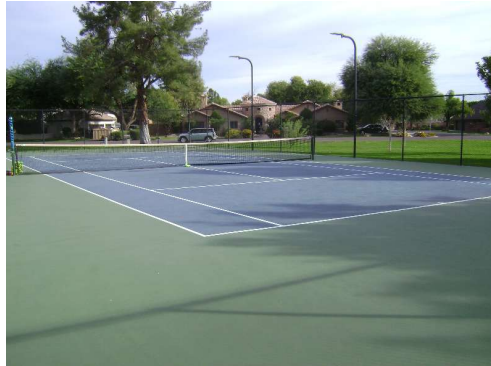
Fair to poor condition. Budget to paint (9) poles.

2018 - Painted total \$1,900.

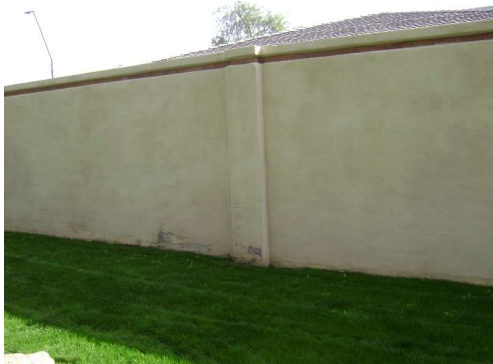
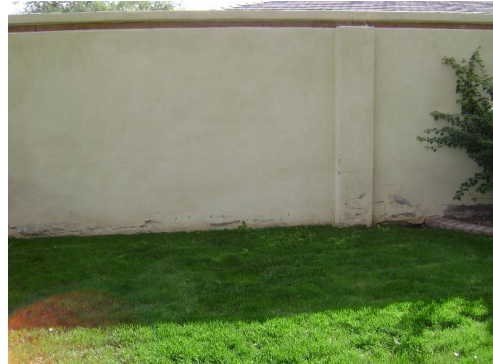
Poor condition. Budget to paint masonry block stucco walls. Locations include entrance,

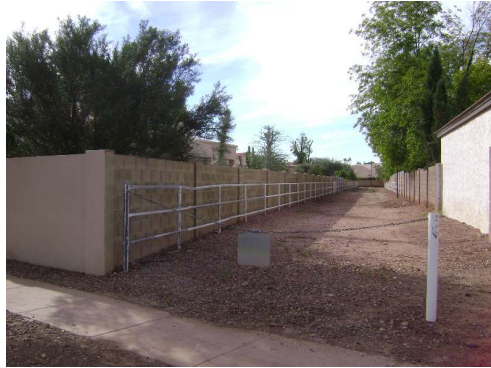
**Bridle Path Chains & Posts (A) - Replace**

Fair condition. Budget to replace bridle path chains and posts. Low priority - life adjustment.

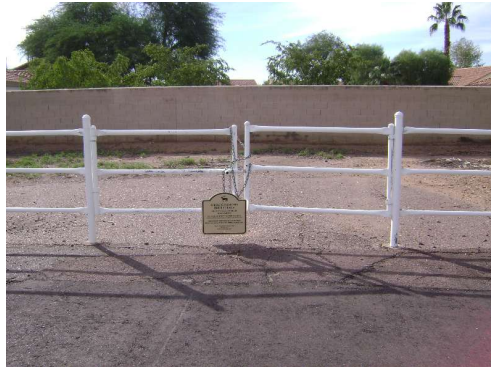
### *Bridle Path Fencing & Gate (B) - Replace continued...*

Fair condition. Budget to replace approximately 40 LF of split rail fencing/gates. Location South end of Fairfield Dr. Low priority - life adjustment.

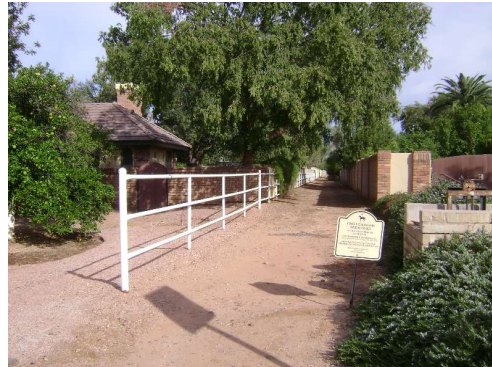
*Bridle Path Rails - Replace/Paint continued...*

Unfunded. Prior report stated owner's responsibility. Various conditions. All need paint.

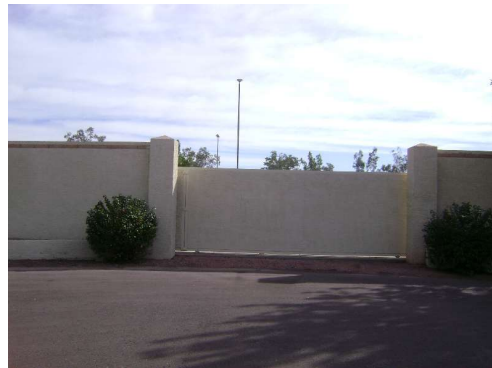
### Emergency Gate - Replace

Good condition. Budget to replace emergency fire gate with block wall. Approximately 25 LF.

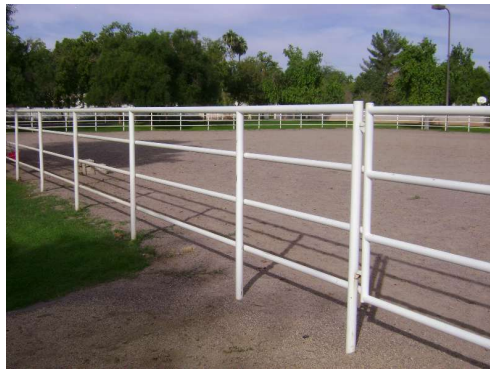
**Horse Arena Split Rail Fence - Repair/Replace Footings**

Poor condition. Budget to repair and/or replace footings where needed. Reportedly footings are failing. Approximately 670 LF of split rail fencing.

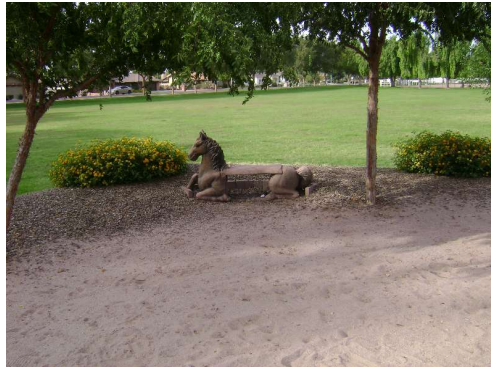
*Horse Benches - Replace continued...*

Unfunded. No anticipation to replace.

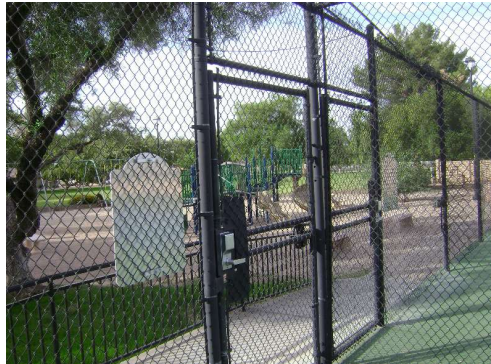
Fair condition. Budget to paint chain link tennis fencing. Approximately 600 SF. Life adjustment due to condition.

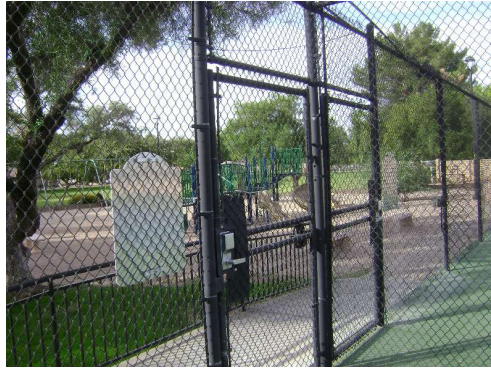
### Tennis Fence - Replace

Good condition. Budget to replace chain link tennis fencing. Approximately 540 LF.  
2018 - Replaced fence total \$10,800.

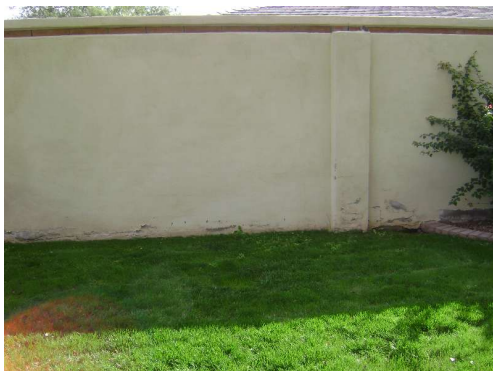
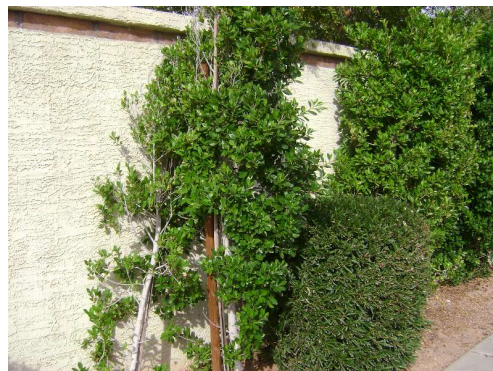
### Walls (Stucco) A - Repair

Various conditions. Budget to repair painted stucco walls. Location entrance Warner Rd &

Fairfield Dr. and North of lots 157 & 158 along Warner Rd. Recommend paint with minor stucco repair soon to preserve and aesthetics. In conjunction with wall paint, see asset ID 1008. Approximately 7,800 SF of wall.

2018 - Repaired.

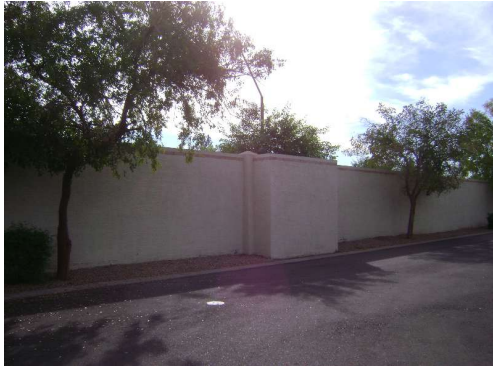
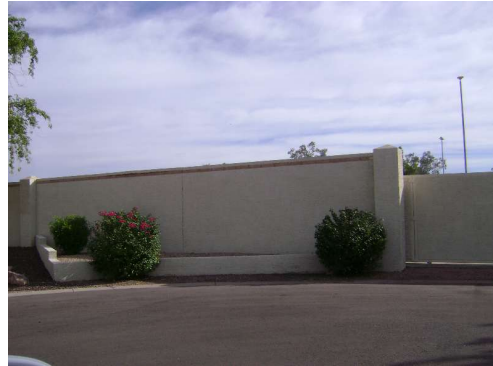
**Walls (Stucco) B - Repair**

Various conditions. Budget to repair painted stucco walls. Location along Price Rd. Recommend paint with minor stucco repair soon to preserve and aesthetics. In conjunction with wall paint, see asset ID 1008. Approximately 17,000 SF of wall.

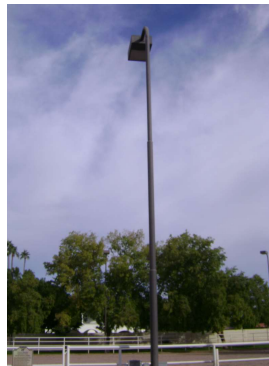
**Horse Arena Lights - Replace**

Assume working condition. Budget to replace horse arena lights including heads and poles.

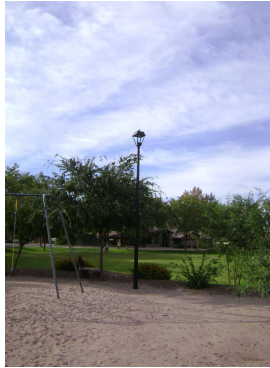
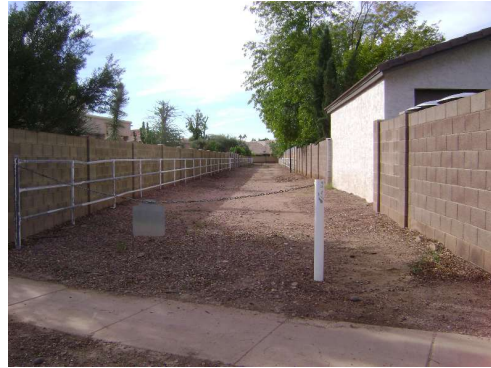
**Pole Lights (Community) - Replace**

Unfunded. Leased from APS. Unknown (working) condition.

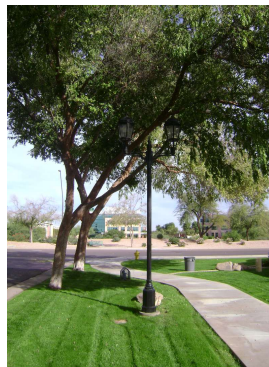
**Pole Lights (Entrance) - Replace**

Condition (working) unknown. Budget to replace (5) entrance pole lights. Location on Fairfield Dr.

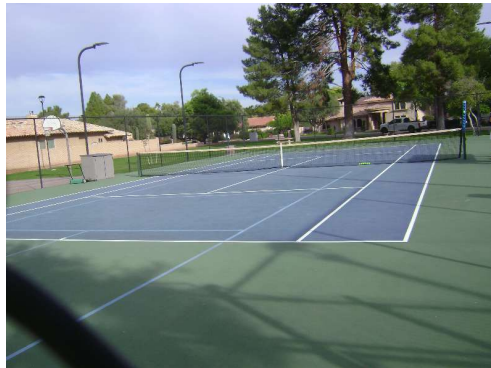
**Tennis Lights - Replace Heads**

Working condition. Budget to replace (12) LED heads. Does not include pole replacement.  
2024 - Convert to LED heads total \$4,930.

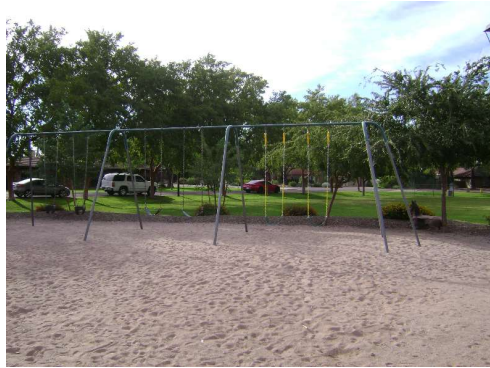
**Swing Set Poles - Replace**

Old but sturdy condition. Budget to replace swing set poles. Operating budget for swing hardware and seats replacement.

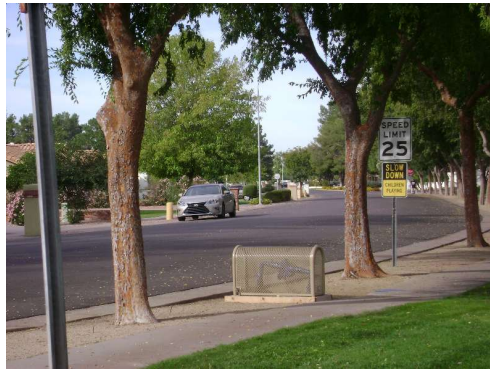
**Backflow Valves - Replace - Phase1**

Working condition. Budget to replace (2) 3" backflow valves. Placed in service date based on community age.

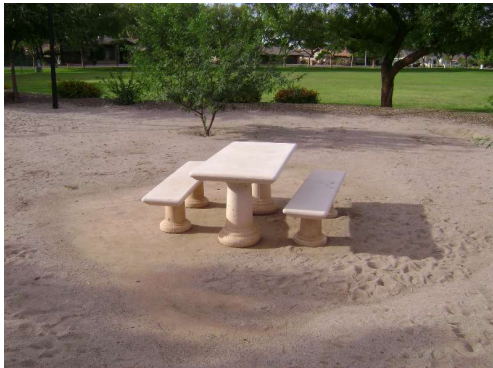
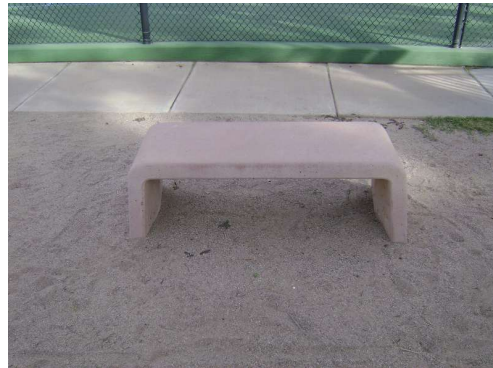
### Park Furnishings - Replace

Fair condition. Budget to replace park furnishings including rectangle concrete tables, benches and trash cans.

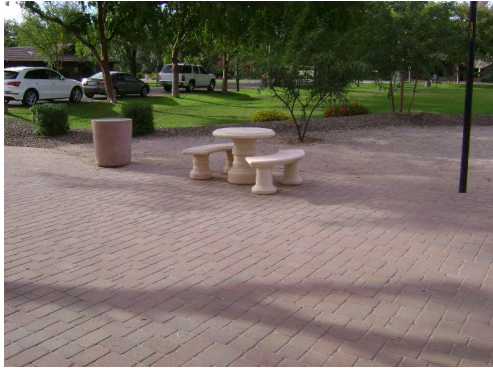
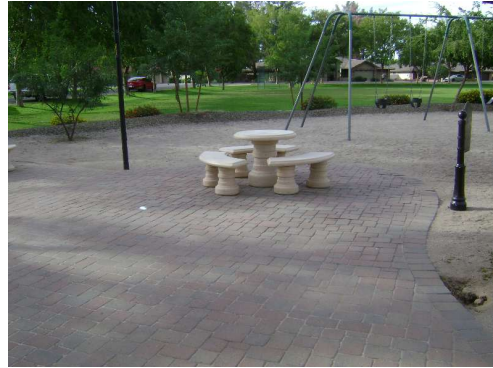
### Playground Furnishings - Replace

Fair condition. Budget to replace park furnishings including round concrete tables with benches.

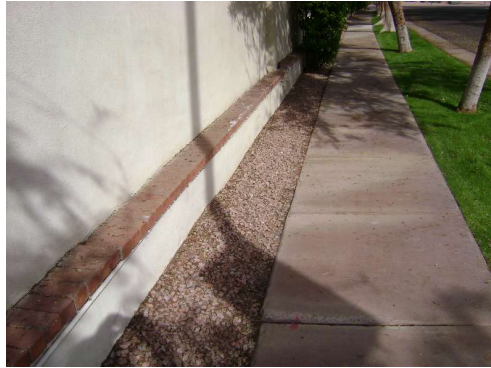
Good condition. Budget to replenish granite located on Warner Rd. & Fairfield Dr. and along Price interior areas where needed. Approximately 40,000 SF.
