**RESERVE STUDY UPDATE  
FOR  
CIRCLE G RANCHES 4 HOMEOWNERS  
ASSOCIATION**

June 5, 2026

## EXECUTIVE SUMMARY

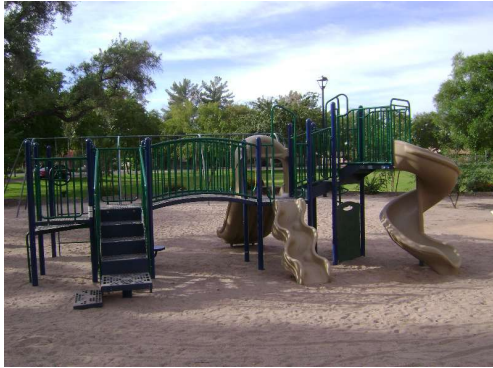
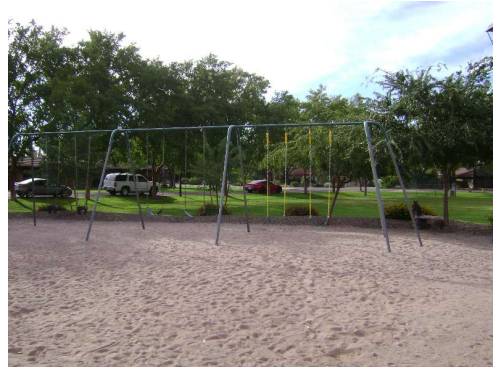
Good condition. Budget to paint play structure and swing set.

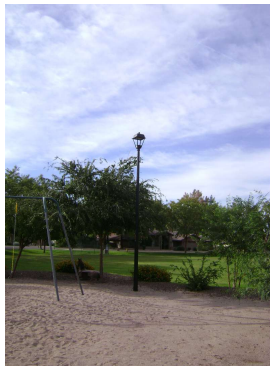
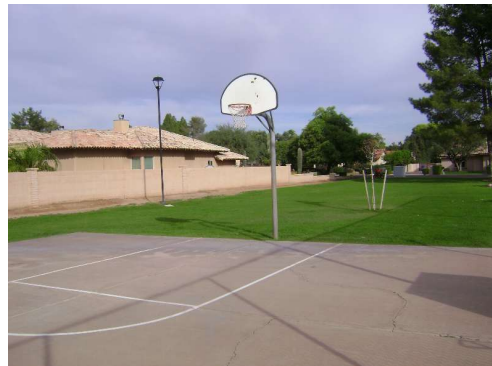
### Pole Lights (Recreation) - Paint

Poor condition. Budget to paint recreation area pole lights.

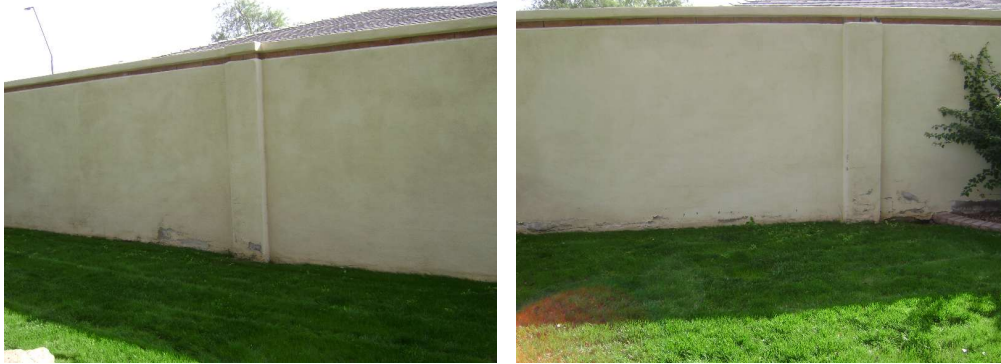
*Walls (Stucco) - Paint continued...*

Poor condition. Budget to paint masonry block stucco walls. Locations include entrance, Warner Rd., Price Rd., South of community along bridle path, and interior walls.

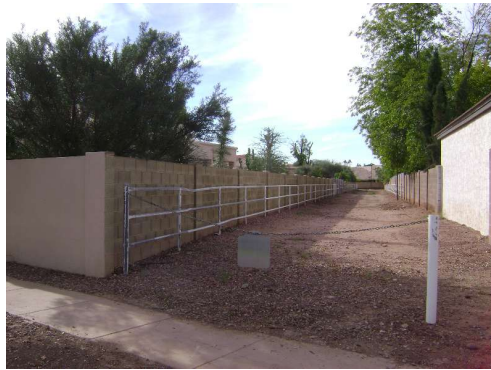
**Bridle Path Chains & Posts (A) - Replace**

Fair condition. Budget to replace bridle path chains and posts. Low priority - life adjustment.

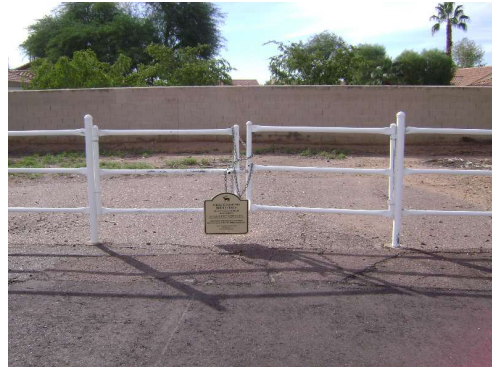
*Bridle Path Fencing & Gate (B) - Replace continued...*

Fair condition. Budget to replace approximately 40 LF of split rail fencing/gates. Location South end of Fairfield Dr. Low priority - life adjustment.

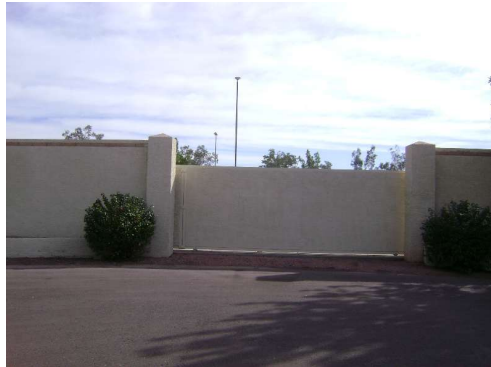
*Emergency Gate - Replace continued...*

Good condition. Budget to replace emergency fire gate with block wall. Approximately 25 LF.

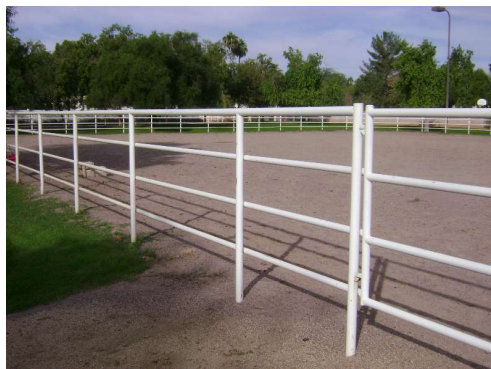
**Horse Arena Split Rail Fence - Repair/Replace Footings**

Poor condition. Budget to repair and/or replace footings where needed. Reportedly footings are failing. Approximately 670 LF of split rail fencing. Association requests to defer indefinitely.

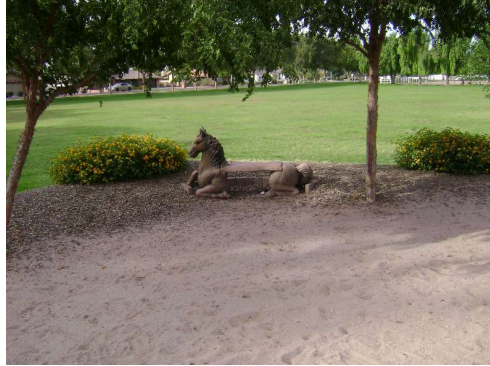
### Horse Benches - Replace

Unfunded. No anticipation to replace.

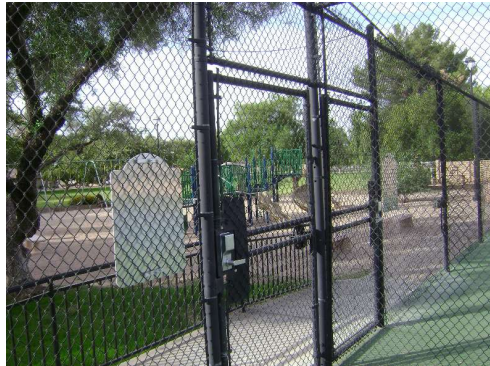
### Tennis Fence - Paint

Fair condition. Budget to paint chain link tennis fencing. Approximately 600 SF. Life

adjustment due to condition.

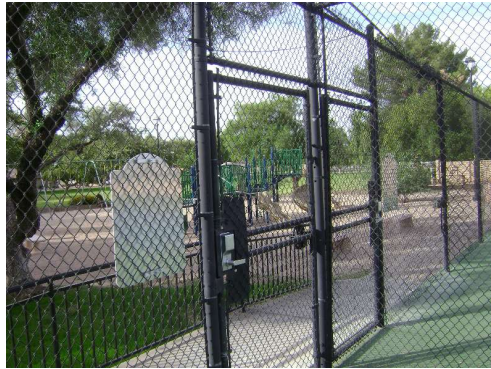
### Tennis Fence - Replace

Good condition. Budget to replace chain link tennis fencing. Approximately 540 LF.

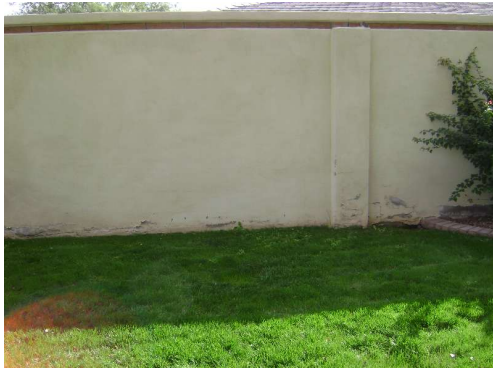
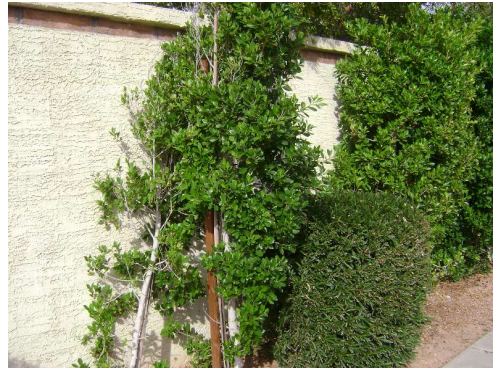
### *Walls (Stucco) A - Repair continued...*

Various conditions. Budget to repair painted stucco walls. Location entrance Warner Rd & Fairfield Dr. and North of lots 157 & 158 along Warner Rd. Recommend paint with minor stucco repair soon to preserve and aesthetics. In conjunction with wall paint, see asset ID 1008. Approximately 7,800 SF of wall.

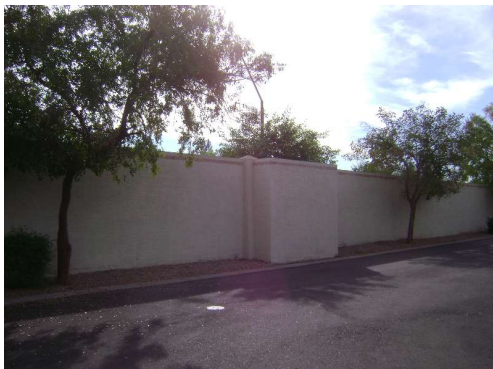
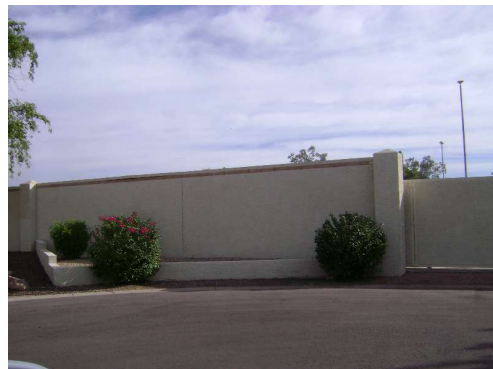
### Walls (Stucco) B - Repair

Various conditions. Budget to repair painted stucco walls. Location along Price Rd. Recommend paint with minor stucco repair soon to preserve and aesthetics. In conjunction with

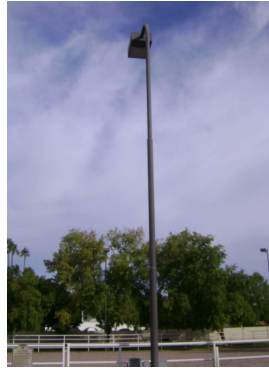
Poor condition. Budget to paint horse arena light poles.

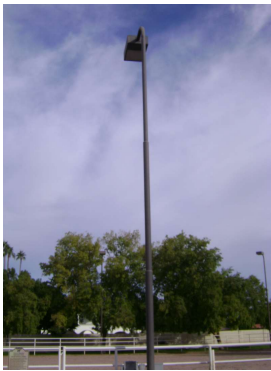
Horse Arena Lights - Replace continued...

Assume working condition. Budget to replace horse arena lights including heads and poles.  
Association requested this be deferred indefinitely.

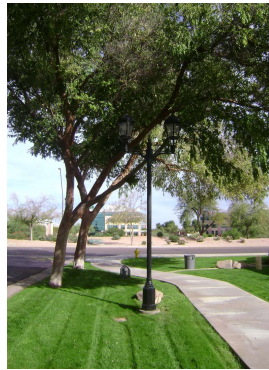
**Pole Lights (Entrance) - Replace**

Condition (working) unknown. Budget to replace (5) entrance pole lights. Location on Fairfield Dr.

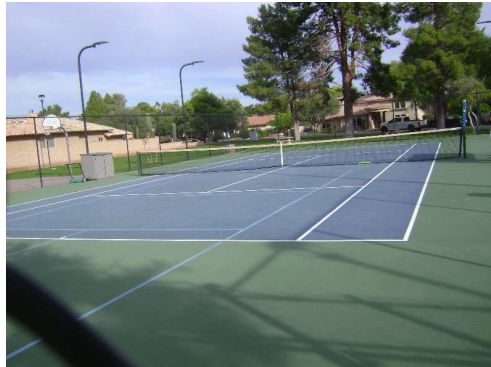
*Tennis Lights - Replace Heads continued...*

Working condition. Budget to replace (12) LED heads. Does not include pole replacement.  
2024 - Convert to LED heads total \$4,930.

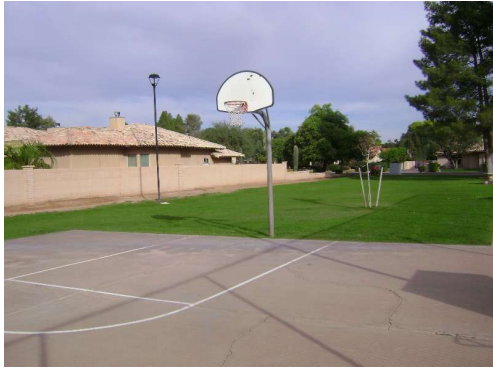
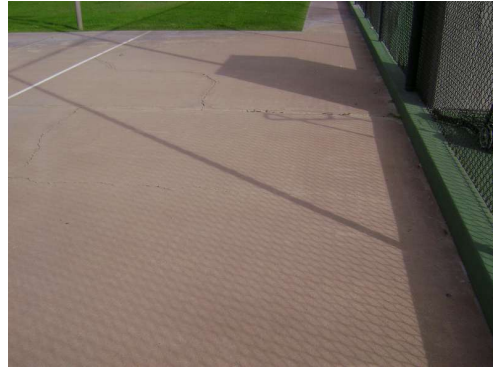
**Basketball Court Concrete - Replace**

Poor condition. Budget to replace the 1/2 court basketball with full court basketball in conjunction of removing the racquetball structure.

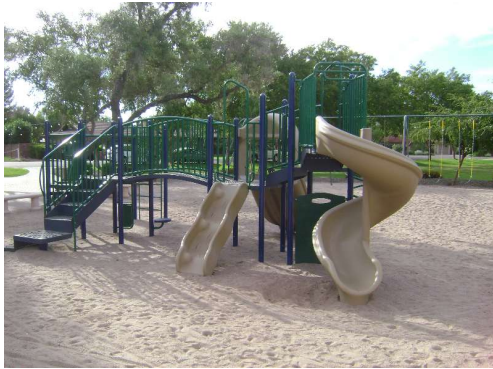
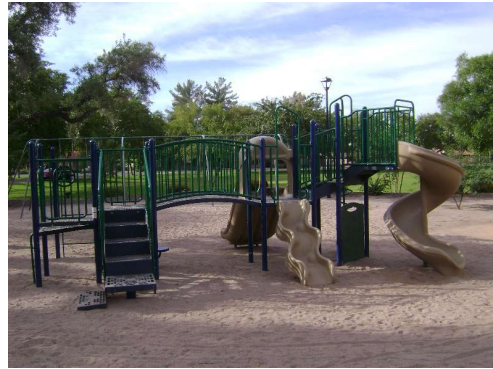
*Play Structure - Replace continued...*

Good condition. Budget to replace large play structure.

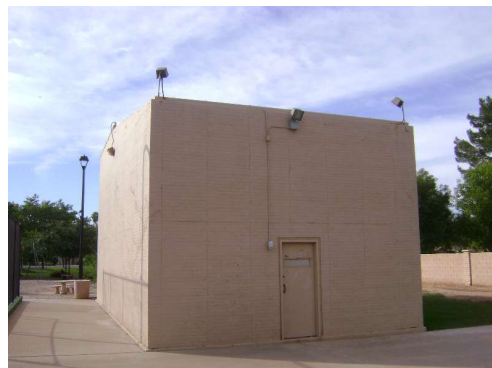
Non use. Budget for one time demo of racquetball structure.

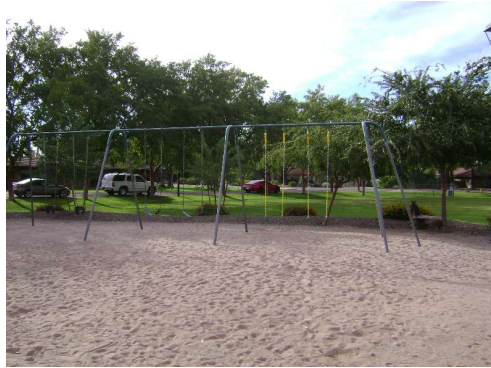
**Swing Set Poles - Replace**

Old but sturdy condition. Budget to replace swing set poles. Operating budget for swing hardware and seats replacement.

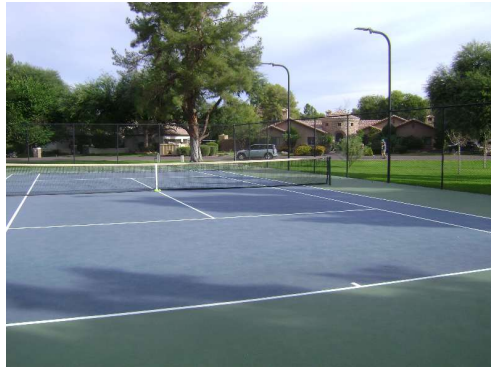
*Tennis Courts - Resurface continued...*

Good condition. Budget to resurface two tennis courts. No anticipation to replace courts. Replaced in 2018 with post tension concrete total \$86,000. Noted no cracking. Resurfaced approximately 2-3 years ago.

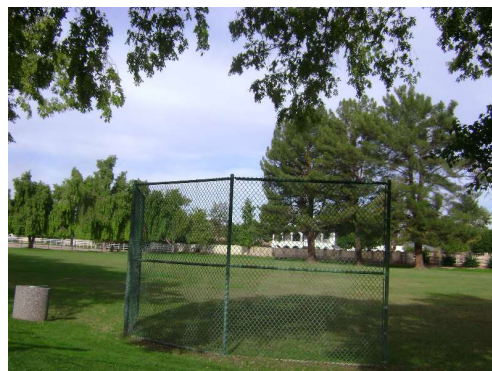
#### Baseball Backstop - Replace

Fair condition. Budget to replace chain baseball backstop. Noted bent out of shape but sturdy.

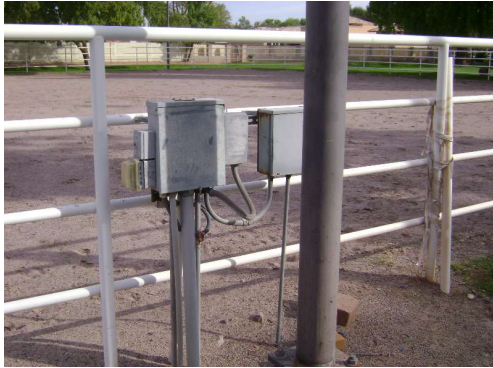
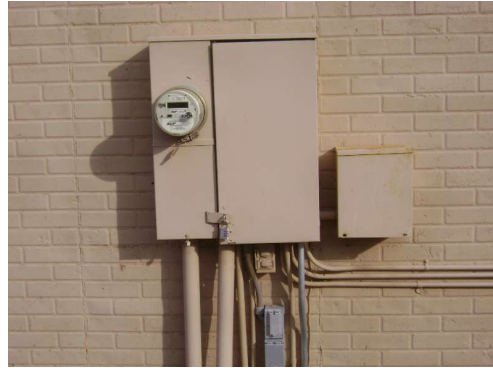
### Electric Panel - Replace

Budget to replace electric panels assume 100 amp panels. Located on raquetball and horse arenas. One will be replaced when building is torn down and replaced with full basketball court.

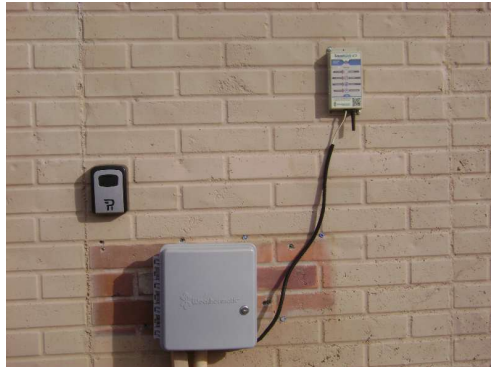
### *Irrigation Controllers - Replace continued...*

Unfunded, under threshold. Budget to replace Weathermatic w/smart link irrigation controllers. Approximately, \$350 each.

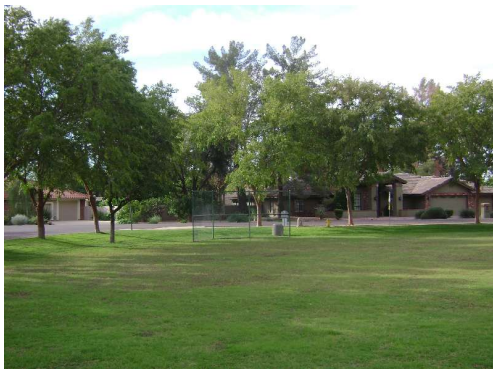
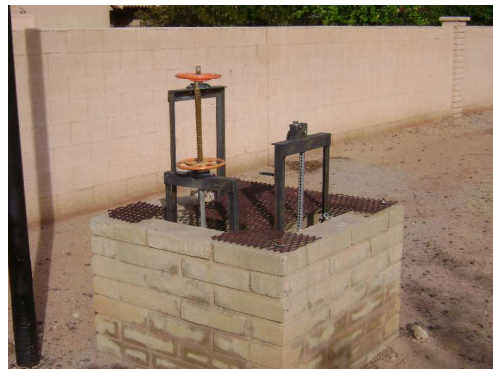
#### Irrigation System (Flood) - Refurbish

Budget to refurbish flood irrigation system. Location near baseball and basketball areas. Noted (2) irrigation lift stations these are unfunded and have a long life.

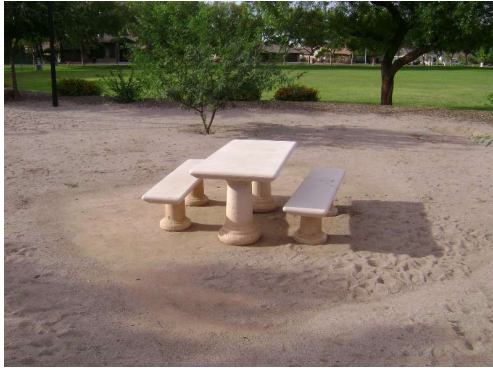
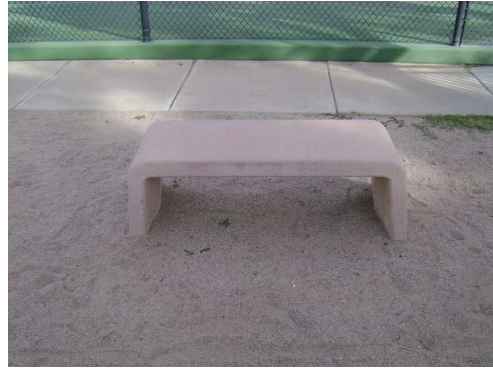
### Park Furnishings - Replace

Fair condition. Budget to replace park furnishings including rectangle concrete tables, benches and trash cans.

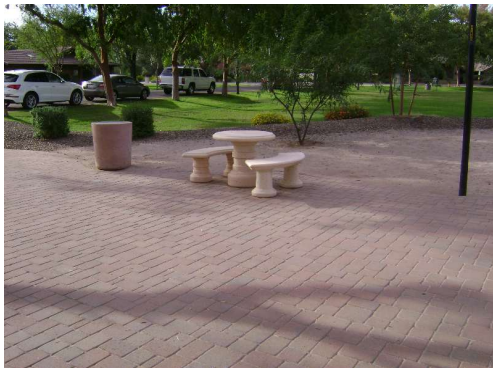
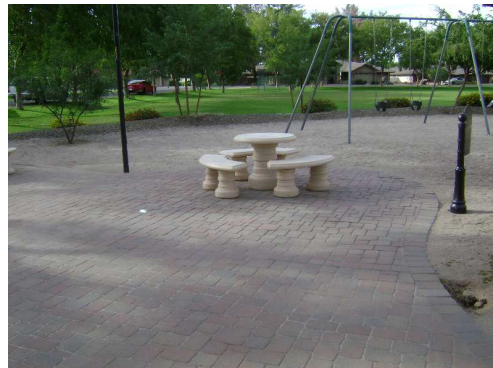
### Playground Furnishings - Replace

Fair condition. Budget to replace park furnishings including round concrete tables with

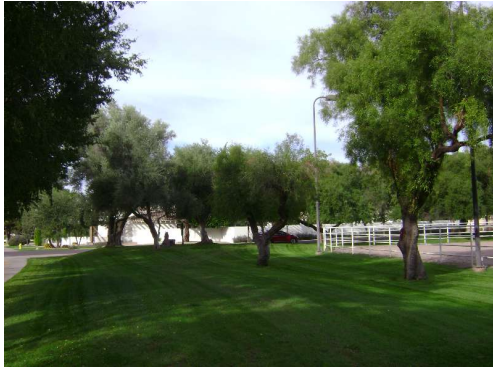
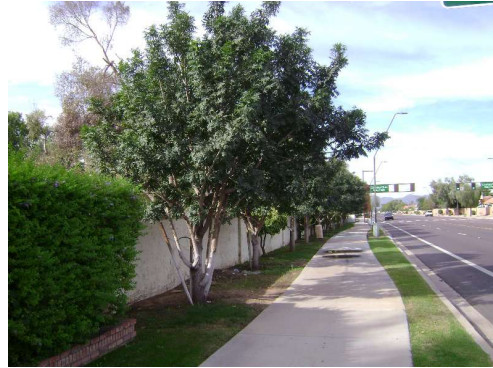
Budget to remove and/or replace trees and plantings throughout the community.

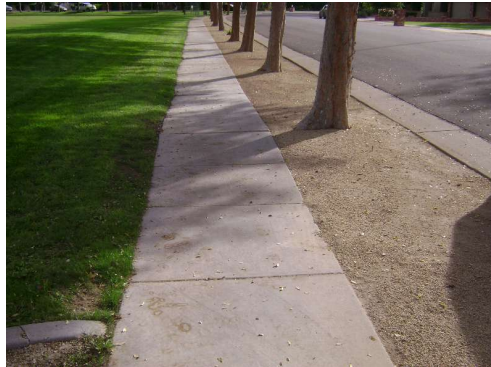
### Concrete Components - Repair/Replace Sections continued...

Fair condition. Budget to repair and/or replace sections of concrete walkways or landscape curbing when needed. Noted lifting of sidewalk due to tree roots.

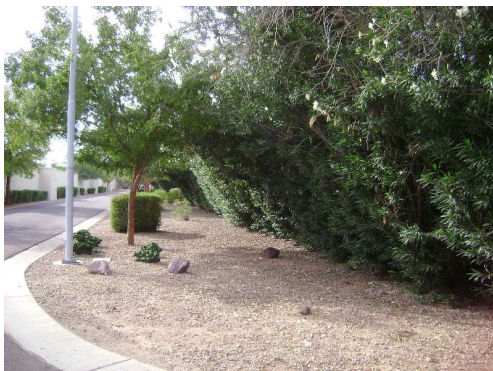
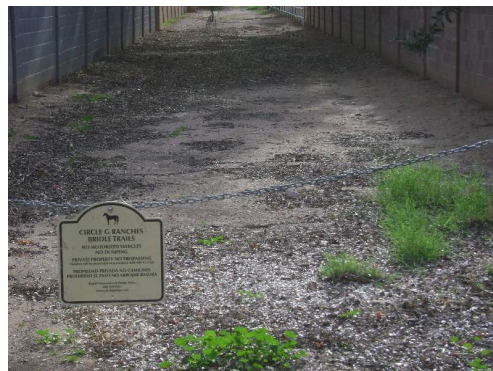
Good condition overall. Budget to replenish granite located on Price Rd. & Caroline Ln., along recreation area sidewalk, bridal path entrances and horse arena walkway where needed. Approximately 2,200 SF.

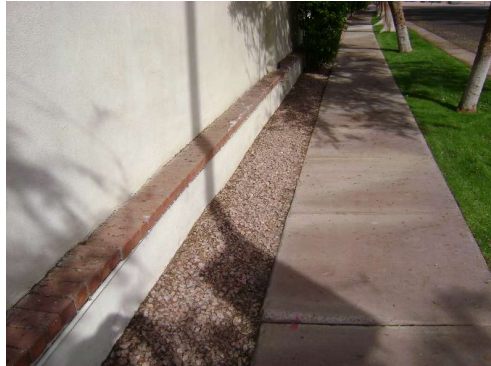
Good condition. Budget to replenish granite located on Warner Rd. & Fairfield Dr. and along Price interior areas where needed. Approximately 40,000 SF.

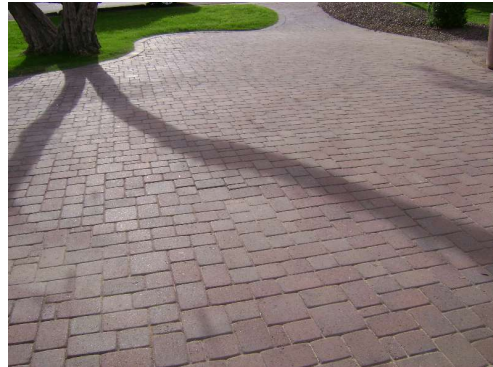
*Pavers (Concrete) - Repair/Replace Pieces continued...*

Good condition. Budget to repair and/or replace sections of concrete pavers. Located near tennis and play structure.

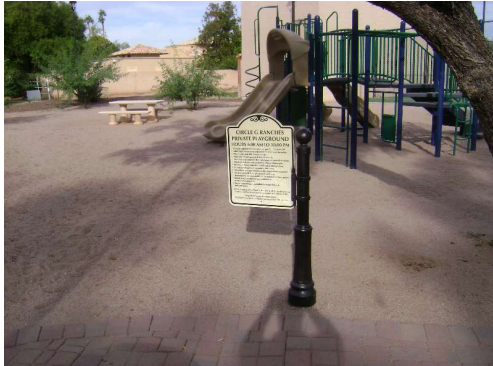
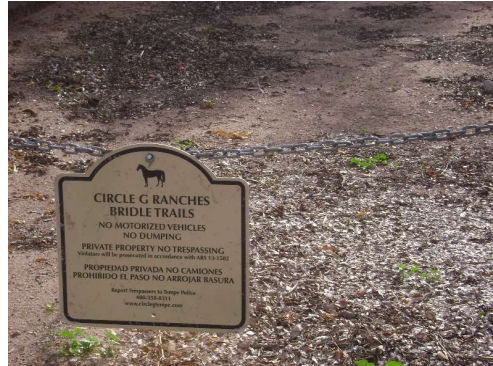
### Directional Signs - Refurbish/replace

Good condition. Budget to refurbish and/or replace signs as needed. Located at the recreation area and grounds. Placed in service date unknown, based on condition.

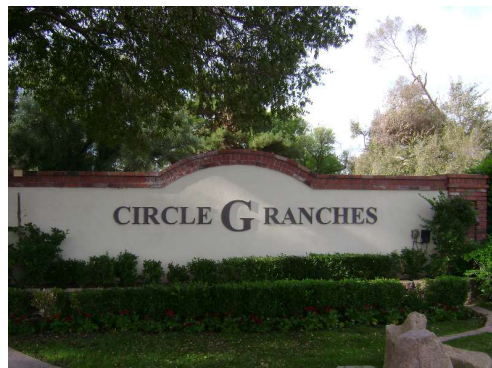
### Monuments - Refurbish

Fair condition. Budget to repair stucco cracks, paint stucco, and paint metal lettering and horse

busts. No anticipation to remove & replace. Location entrance off Warner Rd. In conjunction with wall repairs, see asset ID 1006.
