"Full" Reserve Study

Circle G Ranches 4 Tempe, AZ

Report #: 34770-0
For Period Beginning: January 1, 2019
Expires: December 31, 2019

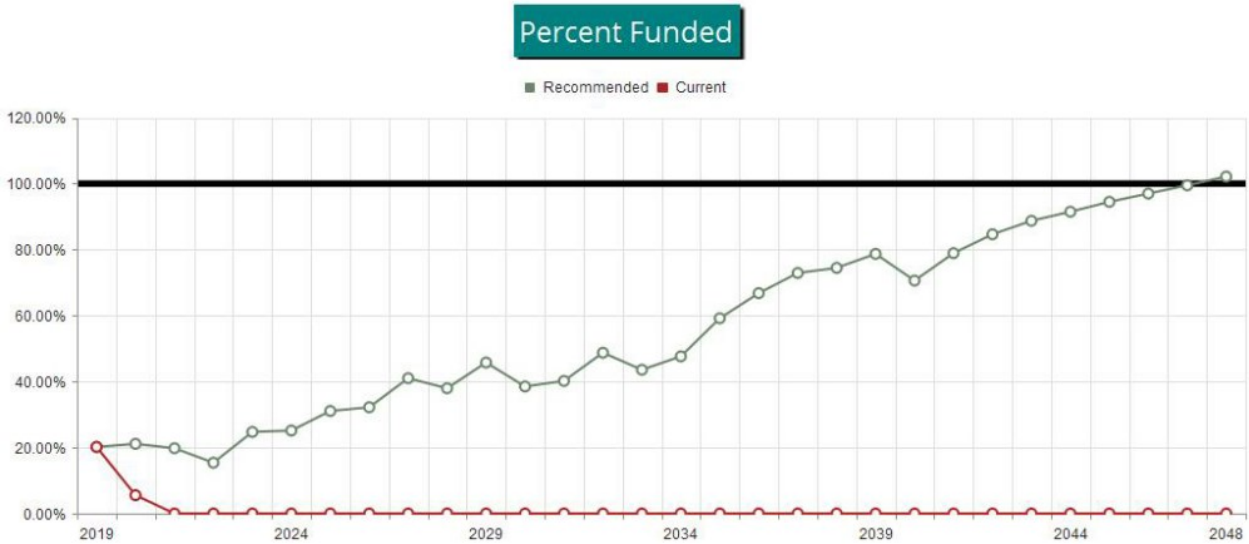
Figure 4

This chart shows the same information plotted on a Percent Funded scale. It is clear here to see how your Reserve Fund strength approaches the 100% Funded level under our recommended multi-year Funding Plan.

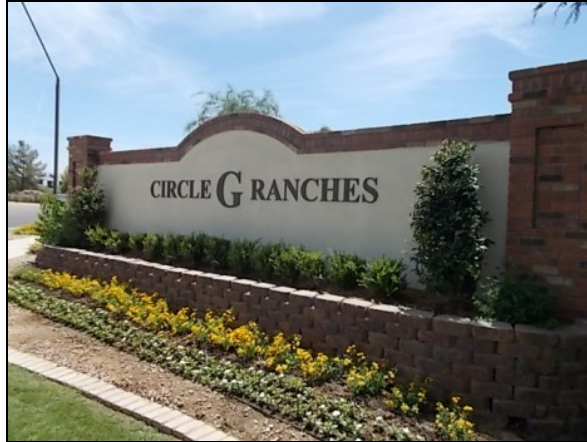
Comments: These monument signs were refurbished by volunteers in the community during 2018. Monuments consist of (28) metal letters.

Useful Life:
20 yearsRemaining Life:
7 years

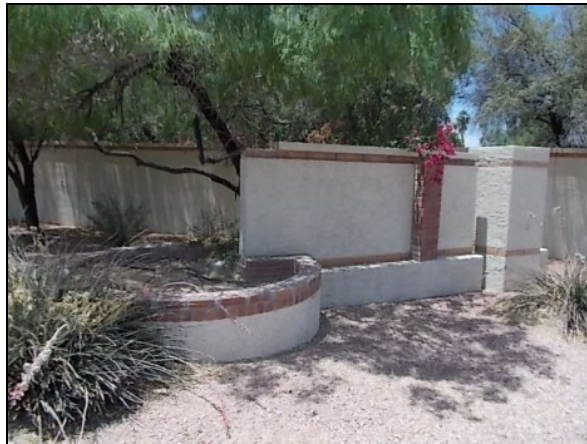
Comments: This monument sign is currently blank. This component funds to refurbish it in the future.

Useful Life:
20 yearsRemaining Life:
2 years

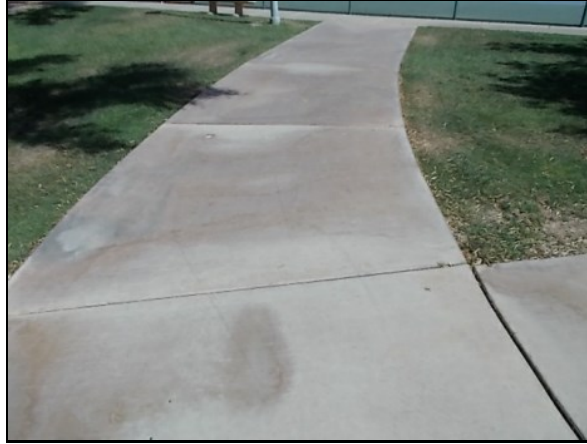
Useful Life:
3 years

Remaining Life:
2 years

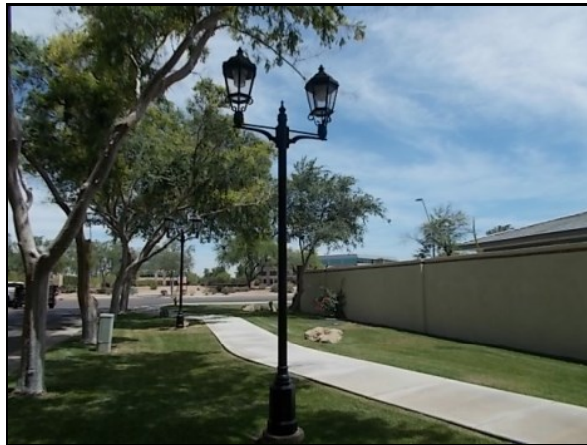
Useful Life:
30 years

Remaining Life:
10 years
