“Full” Reserve Study

48 East HOA Phoenix, Arizona

Report #: 21767-0
For Period Beginning: January 1, 2017
Expires: December 31, 2017
Date Prepared: October 18, 2016

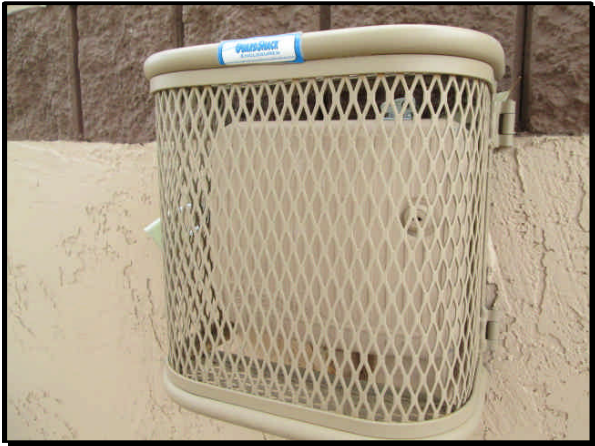
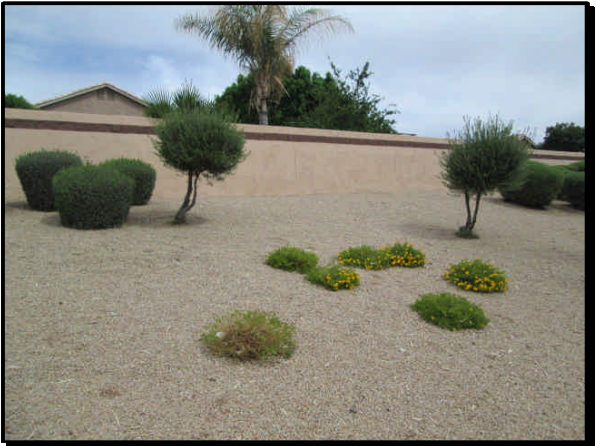
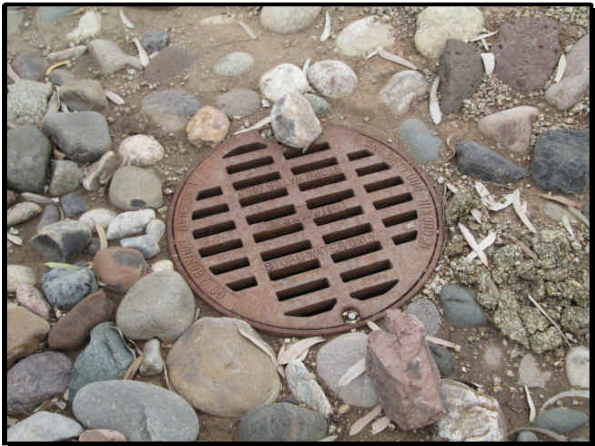
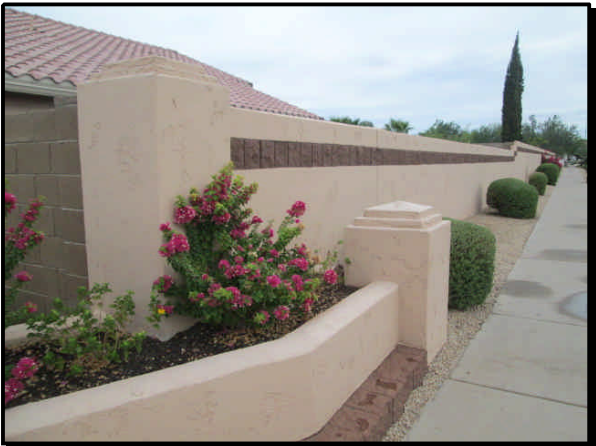
Site Inspection Notes

During our site visit on September 29, 2016, we started by inspecting the landscaping. Next, we inspected the common stucco walls and fence. Finally, we inspected the monument and any remaining common areas.

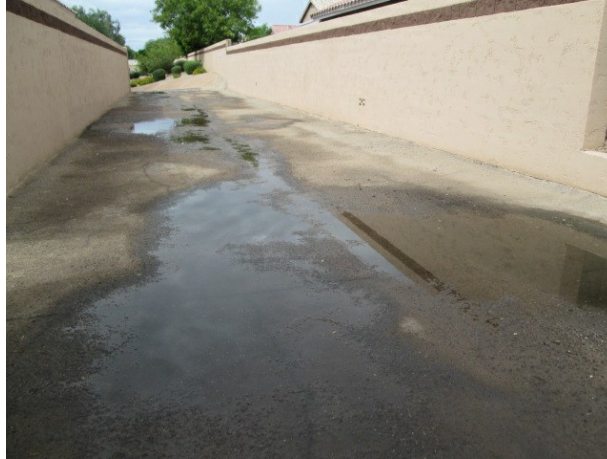
Comp #: 103 Concrete - Repair

Evaluation: There is no expectancy to completely replace the concrete. This component provides an allowance for periodic repairs and/or partial replacements.

Best Case: \$1,700
Allowance for repairs

Worst Case: \$2,300
Higher allowance

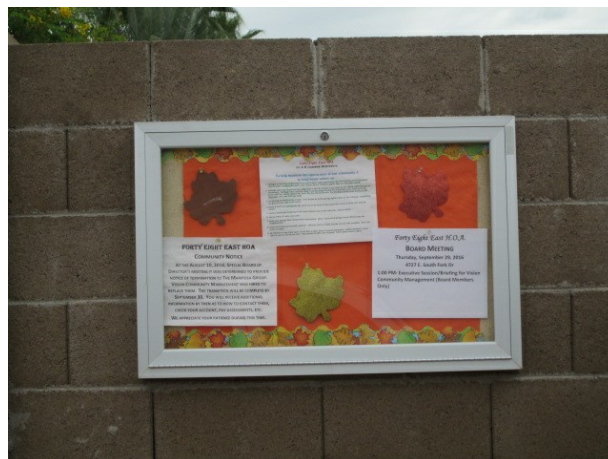
Comp #: 410 Bulletin Boards - Replace

Funded?: No. Replacement cost is expected to be too small for Reserve designation.

Evaluation: Manufactured by United Visual Products. Replace when needed as an Operating expense.

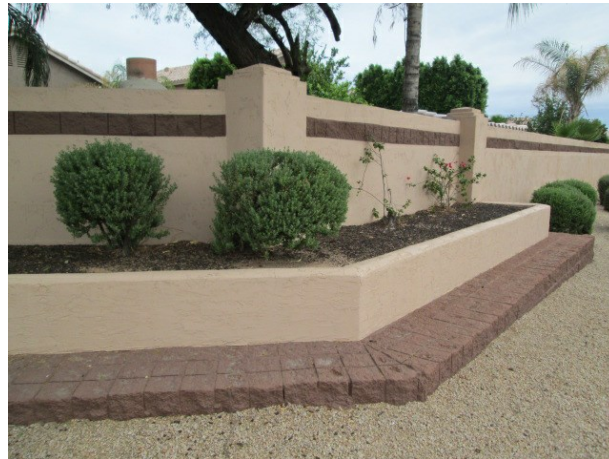
Comp #: 501 Stucco Walls - Repair

History: ~\$17,400 was spent during 2011-2013 for repairs.

Evaluation: Walls are expected to last the life of the community under normal circumstances. This component provides an allowance for repairs and/or partial replacement due to excessive settling or other sources of damage.

Best Case: \$16,000
Allowance for repairs

Worst Case: \$20,000
Higher allowance

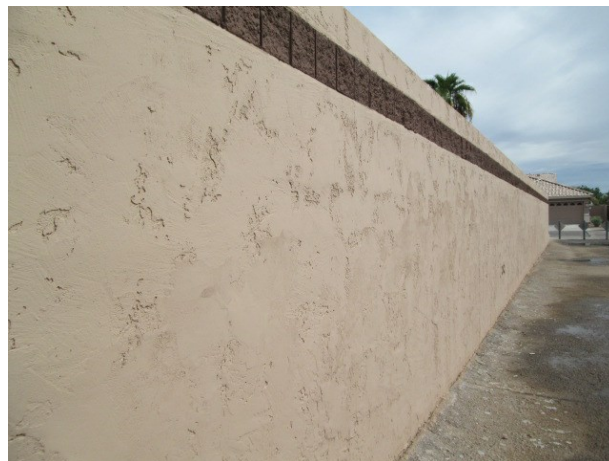
Useful Life:
7 years

Remaining Life:
4 years

Best Case: \$10,000
Estimate to repaint

Worst Case: \$12,000
Higher estimate

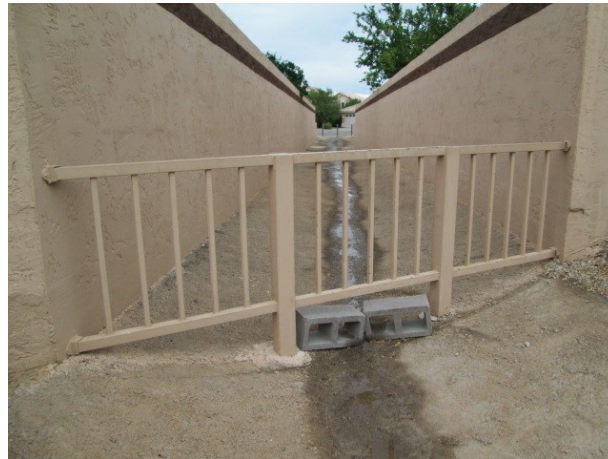
Comp #: 510 Metal Fence - Replace

Evaluation: Some rust issues evident. Future replacement should be anticipated. Periodic repainting every 3-4 years should be completed as an Operating expense to maintain the appearance and to inhibit rust.

Best Case: \$900
Estimate to replace

Worst Case: \$1,100
Higher estimate

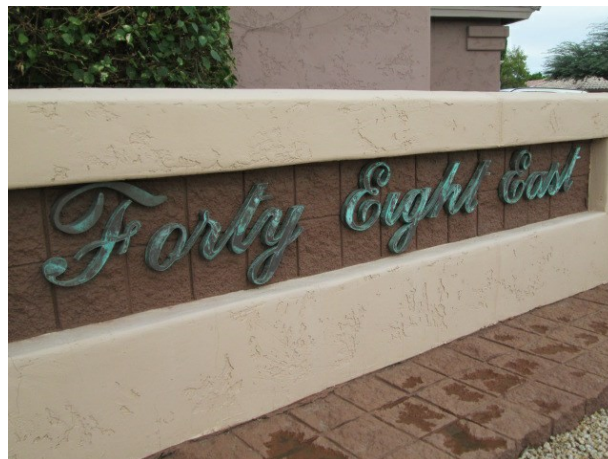
Evaluation: Expect to eventually replace the metal lettering to update and modernize the appearance. No issues observed at this time.

Best Case: \$2,200
Estimate to refurbish

Worst Case: \$2,800
Higher estimate

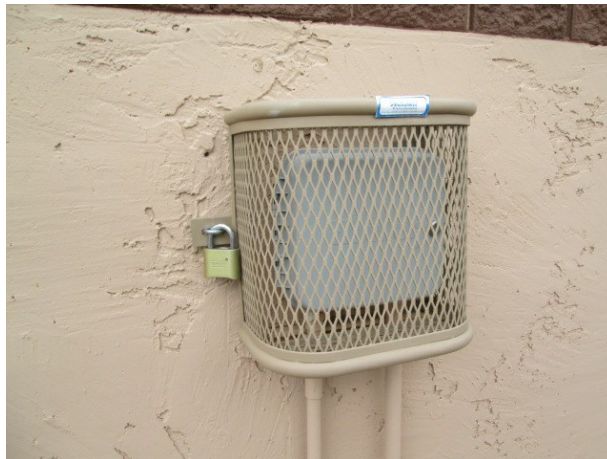
Comp #: 801 Irrigation Controllers - Replace **Quantity:** (2) Controllers

Funded?: No. Individual replacement cost is expected to be too small for Reserve designation.

Evaluation: There is (1) Hardie controller and (1) Hunter controller. Replace as-needed using Operating funds.

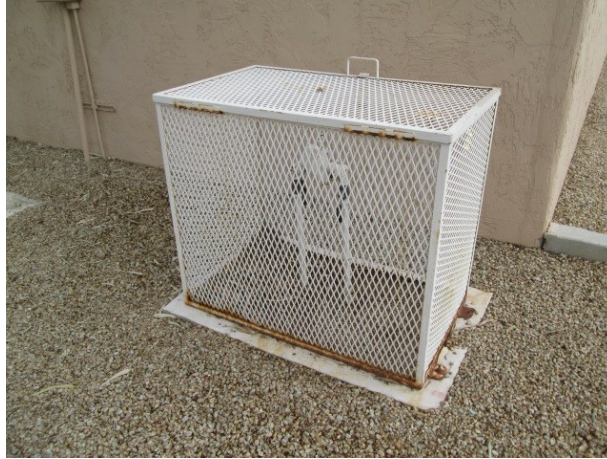
Comp #: 803 Backflow Valves - Replace **Quantity:** (2) Valves
Funded?: No. Replacement cost is too small for Reserve designation.
History: The backflow valve bordering 48th St was replaced during 2016 for ~\$350.
Location: Bordering Chandler Blvd & 48th St
Evaluation: Replace individually as-needed using Operating funds. No Reserve funding required.

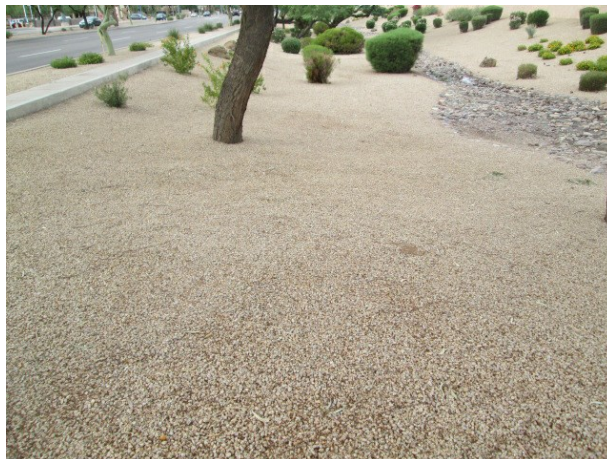
Comp #: 805 Landscape Granite - Replenish **Quantity:** Approx 300 Tons
Funded?: Yes.
History: Replenished during 2014 for ~\$27,300.
Location: Common areas bordering Chandler Blvd & 48th St
Evaluation: There is no expectancy to replace the landscape granite. This component provides funding to periodically top-dress with a new 1" layer. Surfaces appear generally full and in good shape.

Best Case: \$26,000
Estimate to replenish

Worst Case: \$32,000
Higher estimate

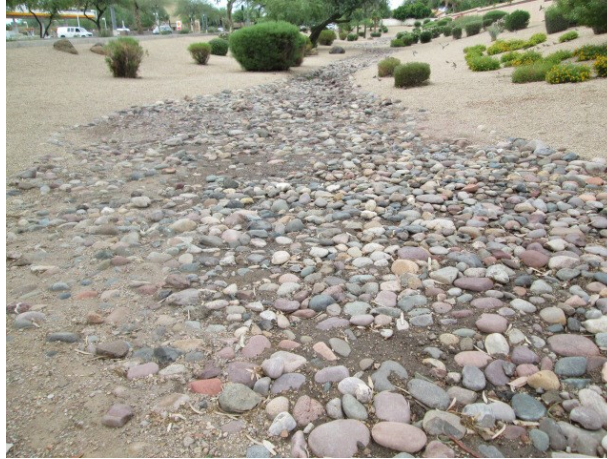
Useful Life:
20 years

Remaining Life:
0 years

Best Case: \$4,000

Worst Case: \$5,000

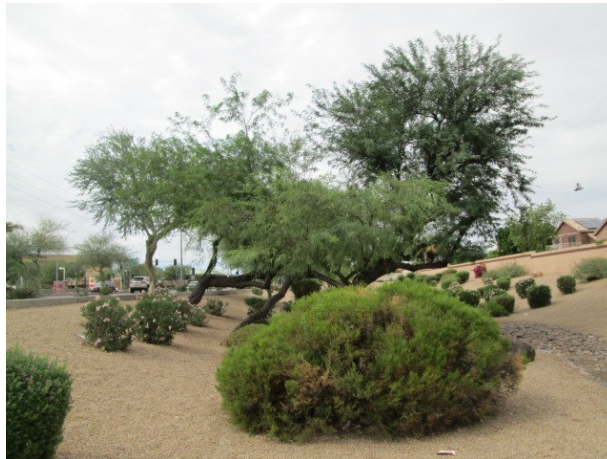
Comp #: 808 Trees + Plants - Trim/Replace

Funded?: No. Recommend maintaining trees and plants annually as an Operating expense.

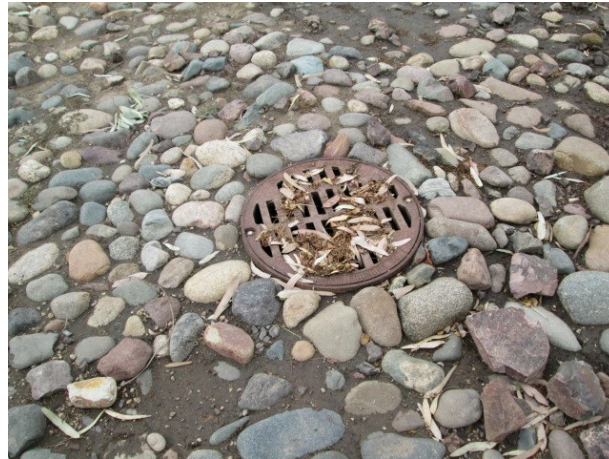
Useful Life:
5 years

Remaining Life:
2 years

Best Case: \$2,000
Estimate to inspect/clean

Worst Case: \$2,300
Higher estimate

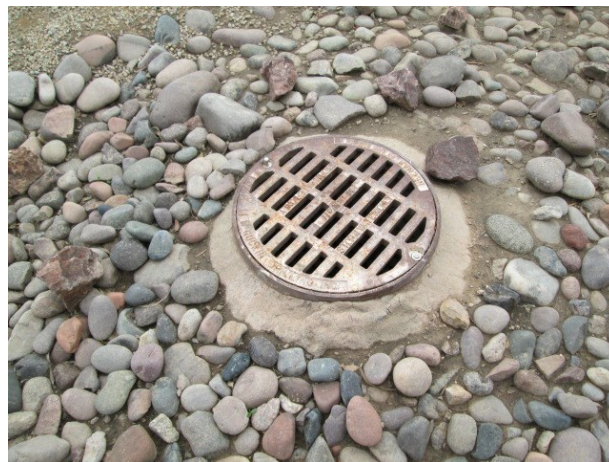
Comp #: 812 Drywells - Partial Replace

Evaluation: Replacement of drywells is typically due to improper installation or neglect. Funding is provided to replace (1) of (4) drywells eventually, in the event failure does occur.

Best Case: \$14,000
Estimate to replace (1) of (4)
drywells

Worst Case: \$18,000
Higher estimate
