Scottsdale Park Villas HOA
Scottsdale, AZ

Report #: 15925-0
Beginning: January 1, 2023
Expires: December 31, 2023

RESERVE STUDY
"Full"

October 12, 2022

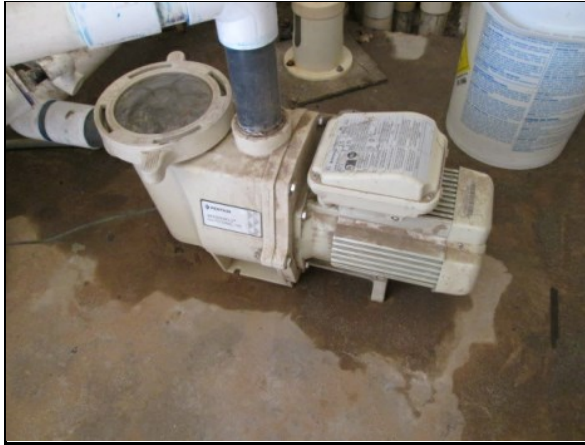
Comp #: 1292 Pool Pump - Replace

History: Replaced around 2020, based on manufacture date.

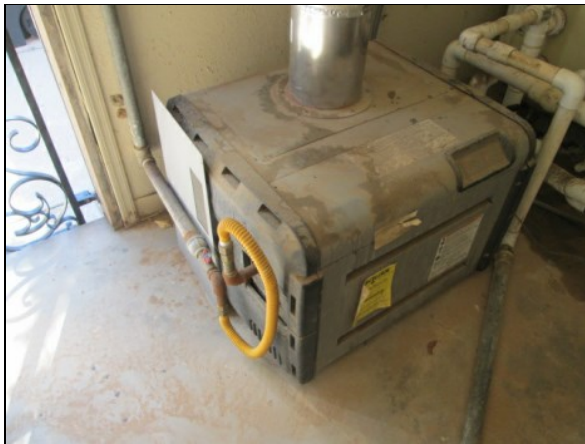
Comp #: 1296 Pool Heater - Replace

History: Replaced around 2008, based on serial number.

Comments: Appears to be older. Based on age, replacement should be expected soon.

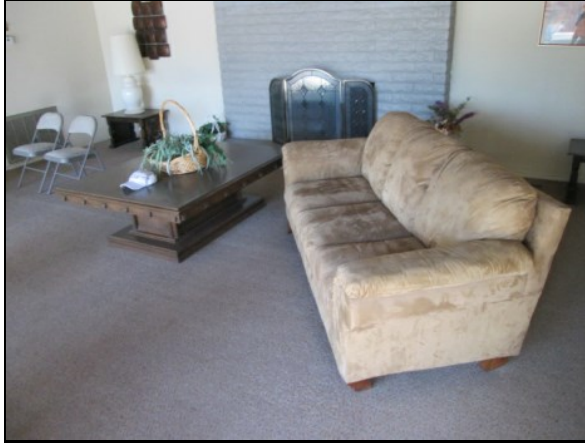
Comments: This component funds a partial remodel for the clubhouse building, which includes replacement of the carpet, furniture, kitchen appliances and paint between complete remodel intervals. Useful life reflects minimal use. Useful life is scheduled to offset complete remodel intervals.

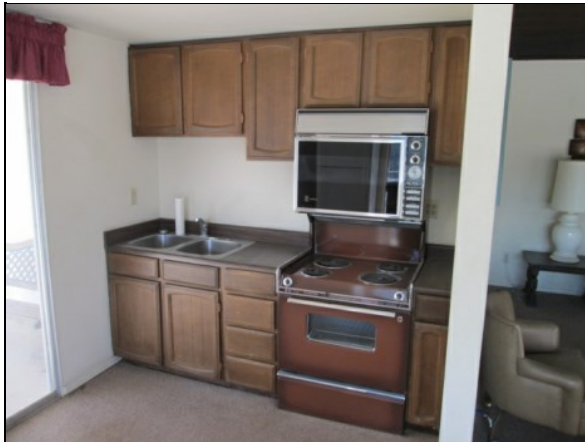
Comments: The clubhouse interiors are mostly original. Overall, the clubhouse appears to receive minimal use. This component funds a complete remodel for the clubhouse building, which includes replacement of the lighting, carpet, furniture, kitchen appliances, kitchen cabinetry, kitchen counters and paint. Useful life reflects minimal use.

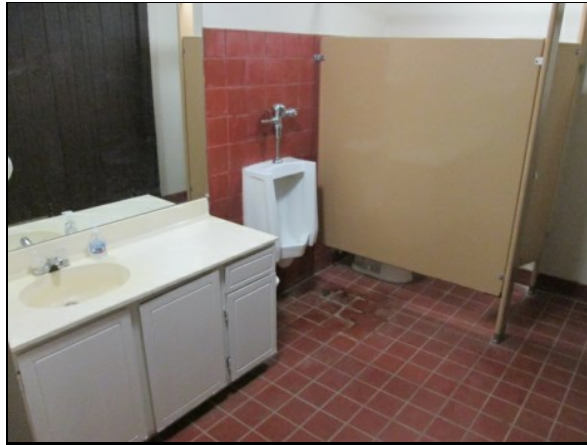
Comments: Appear to be older, dated and worn. This component funds to remodel the pool restrooms, which includes replacement of the lighting, mirrors, sinks, counters, cabinetry, toilets, urinal, stalls, tile surfaces and paint.

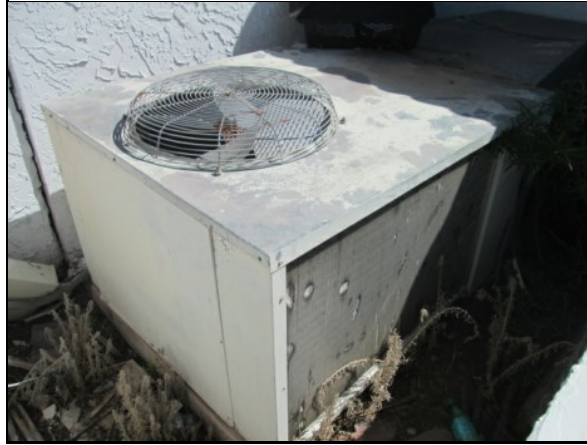
Comp #: 1330 HVAC Unit - Replace (Clubhouse)

Comments: The clubhouse HVAC unit is reportedly not functional at this time and needs to be replaced. There was no visible information tag for this unit.

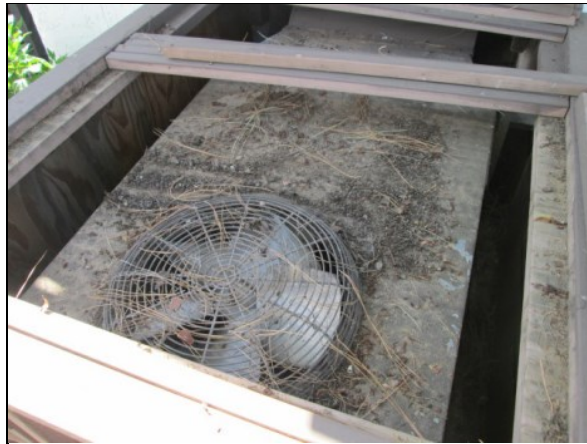
Comp #: 1330 HVAC Unit - Replace (Storage)

Funded?: No. We assume there is no expectancy to replace the storage building HVAC at this time.

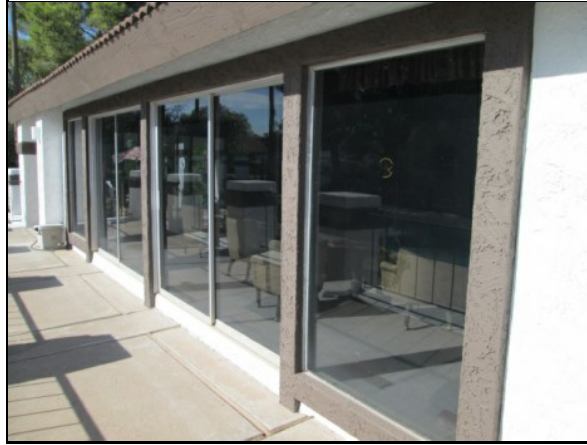
Comp #: 1340 Doors & Windows - Replace

Comments: Quantity includes (2) screen doors, (2) metal doors, (2) wood doors, (5) sliding glass doors and (3) windows totaling approximately 85 Sq Ft. Appear to be older and worn.

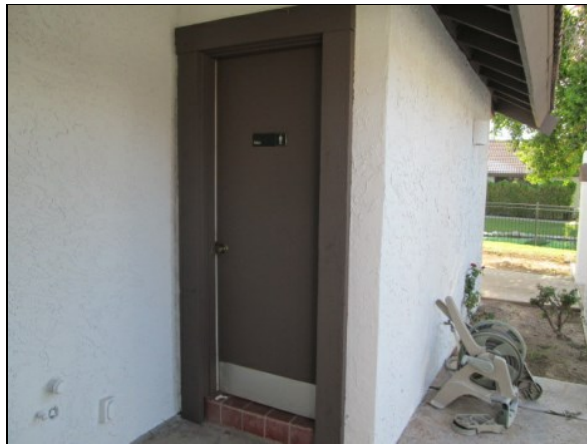
Comp #: 1342 Doors - Replace (Restrooms)

History: Replaced in 2021-2022 for \$1,302.

Funded?: No. Cost is below the Reserve expense threshold. Recommend replacing as needed with Operating funds or include with the clubhouse and storage building door & window replacement projects.

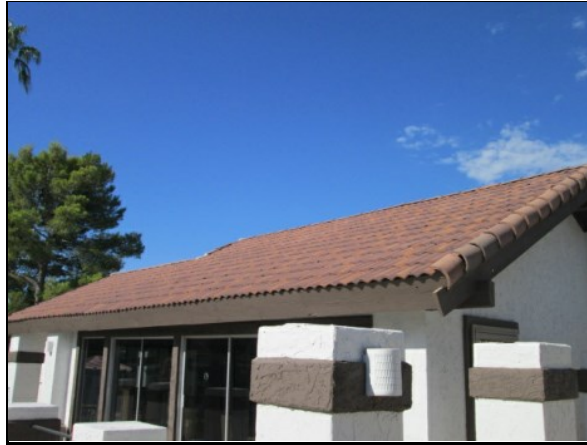
Comments: There is no expectancy to replace all of the tiles under normal circumstances. Replacement of the felt paper underlayment should be anticipated eventually. Life span will vary depending on the quality of underlayment installed. These roofs are reportedly older.

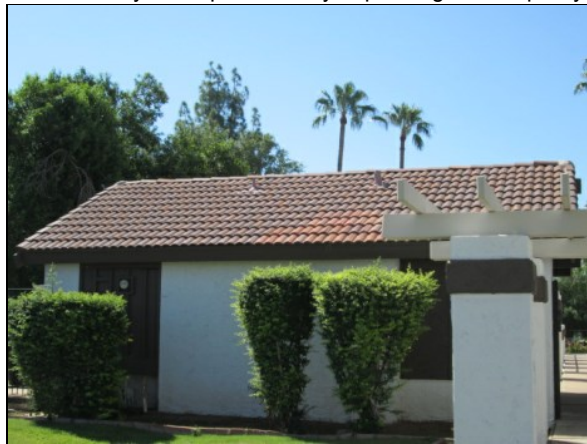
Comments: There is no expectancy to replace all of the tiles under normal circumstances. Replacement of the felt paper underlayment should be anticipated eventually. Life span will vary depending on the quality of underlayment installed.

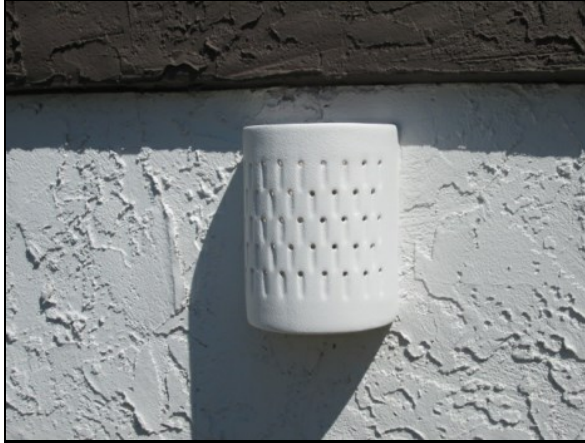
Comp #: 1500 Wall Lights - Replace

Comments: Quantity includes approximately (12) pool area wall lights, (115) unit wall lights and (9) unit drive lights. Some fixtures were observed to be broken. Treat repairs and individual replacements as a maintenance expense. Expect to eventually replace all of the fixtures to update and modernize the lighting while also restoring the appearance.

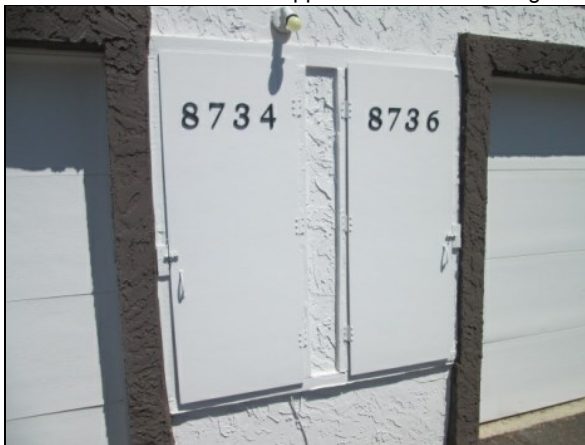
Comp #: 1510 Utility Doors - Replace

History: Replaced (47) doors in 2021-2022 for \$7,036.

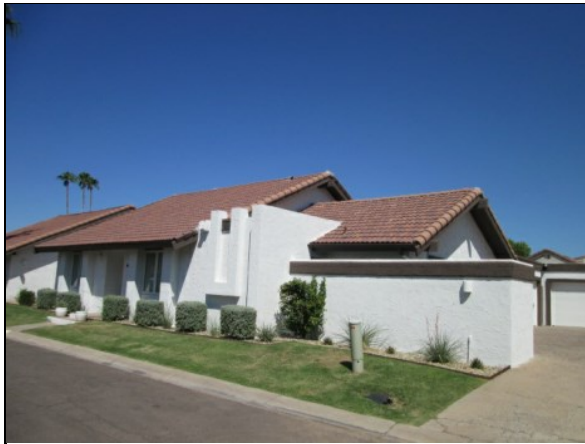
Comp #: 1550 Building Exteriors - Repaint/Repair

Comments: Surfaces appear to be uniform and in good shape. This component funds to periodically repaint and repair the building exteriors. Common area stucco walls and columns are included.
