Update "With-Site-Visit" Reserve Study

Creekwood Ranch HOA Chandler, AZ

Report #: 14356-2
For Period Beginning: January 1, 2018
Expires: December 31, 2018

Date Prepared: June 13, 2018

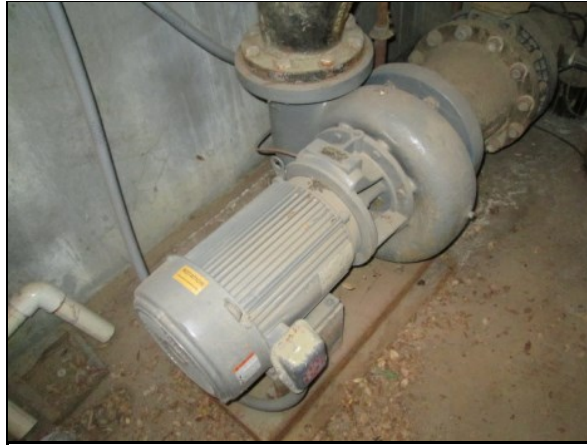
Comp #: 1704 Water Feature Pump - Replace

History: Original pump from 2001 was replaced during 2013 for ~\$6,300.

Estimate to replace, add repair cost for total

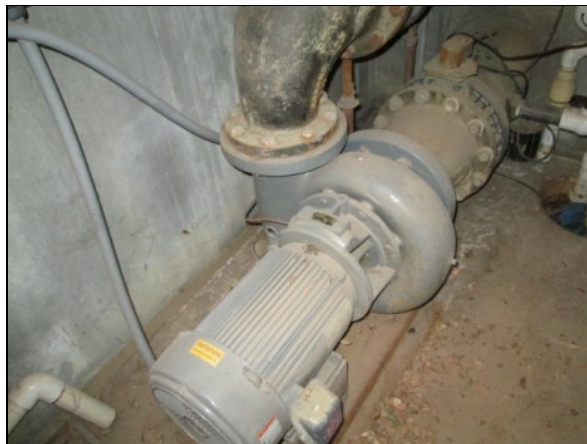
Comp #: 1705 Water Feature Pump - Repair

Evaluation: This component provides funding to periodically repair/refurbish the pump and motor. Motor- Catalog: UJ5S3AP, Model: G42305.

Allowance to repair

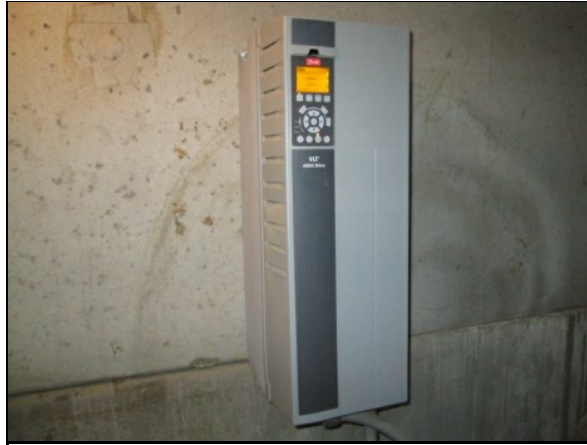
Comp #: 1710 Water Feature Pump VFD - Replace

Evaluation: Appears functional and in good condition. Future replacement should be anticipated.

Estimate to replace

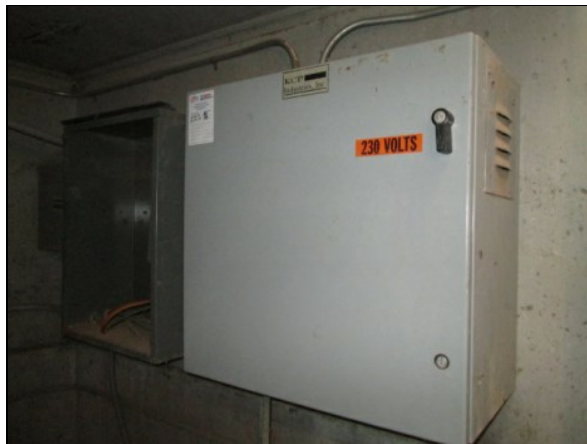
Comp #: 1715 Water Feature Pump Panel - Replace

Funded?: No. There is no expectancy for replacement in the foreseeable future. Repair as-needed using Operating funds.

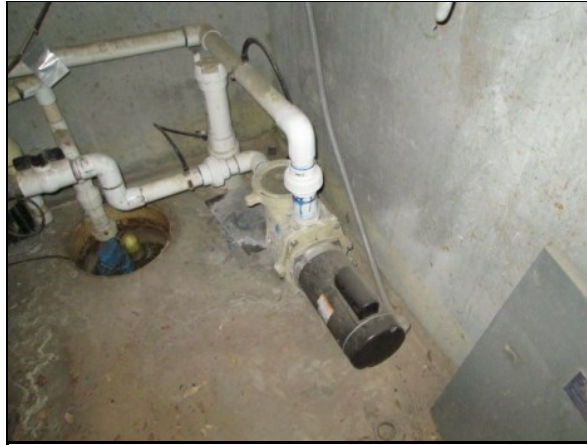
Comp #: 1740 Circulation Pump - Replace

Evaluation: Appears functional with some leaking evident. Future replacement should be anticipated. Mfg. Date: 12/7/2013.

Estimate to replace

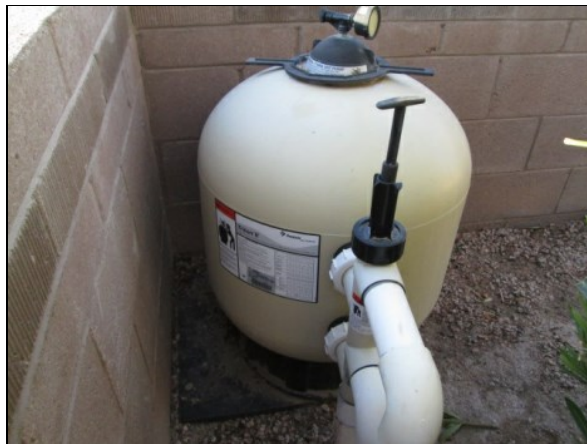
Comp #: 1745 Filter - Replace

Evaluation: Appears clean and functional. Future replacement should be anticipated. Mfg. Date: 09/23/2013.

Estimate to replace

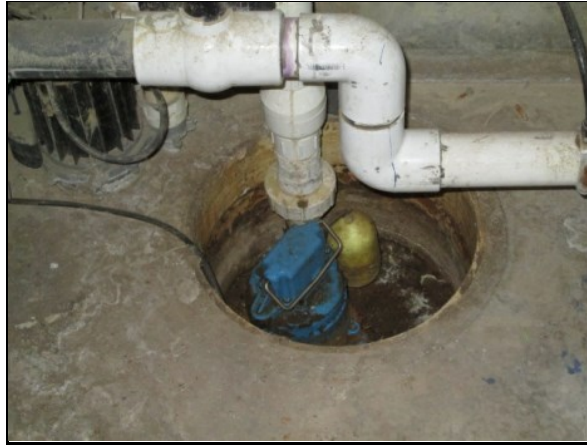
Comp #: 1750 Sump Pump - Replace

Funded?: No. Replacement cost is relatively inexpensive and should be treated as an Operating expense.

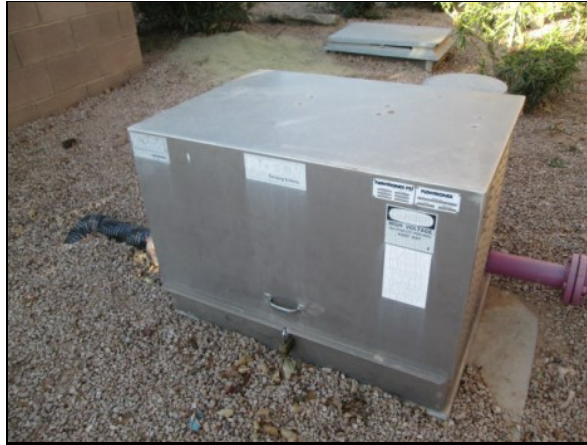
Comp #: 1760 Irrigation Pump System - Replace

Evaluation: This is packaged booster pump system. Complete replacement of the packaged system should be anticipated eventually. Model: FBS-F-35-60-5-3-1-230-PR-B-A, Serial: 10540F.

Estimate to replace, add repair cost for total

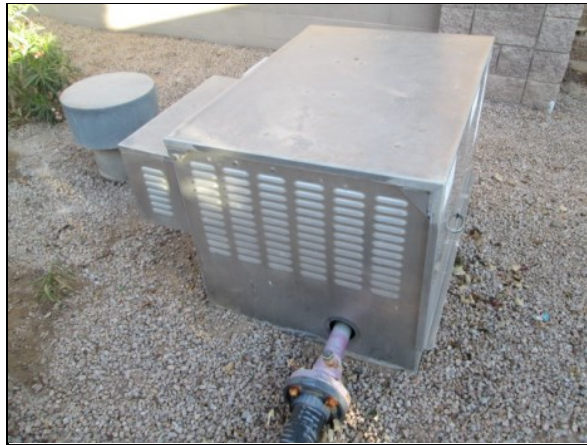
Comp #: 1765 Irrigation Pump System - Repair

Evaluation: The packaged system will reportedly need periodic refurbishing. This may include replacing the pump motor, seals, repairing the fan, and repairing the control panel.

Allowance to repair
