Update "With-Site-Visit" Reserve Study

Veritas at McCormick Ranch Scottsdale, AZ

Report #: 22584-2
For Period Beginning: January 1, 2020
Expires: December 31, 2020

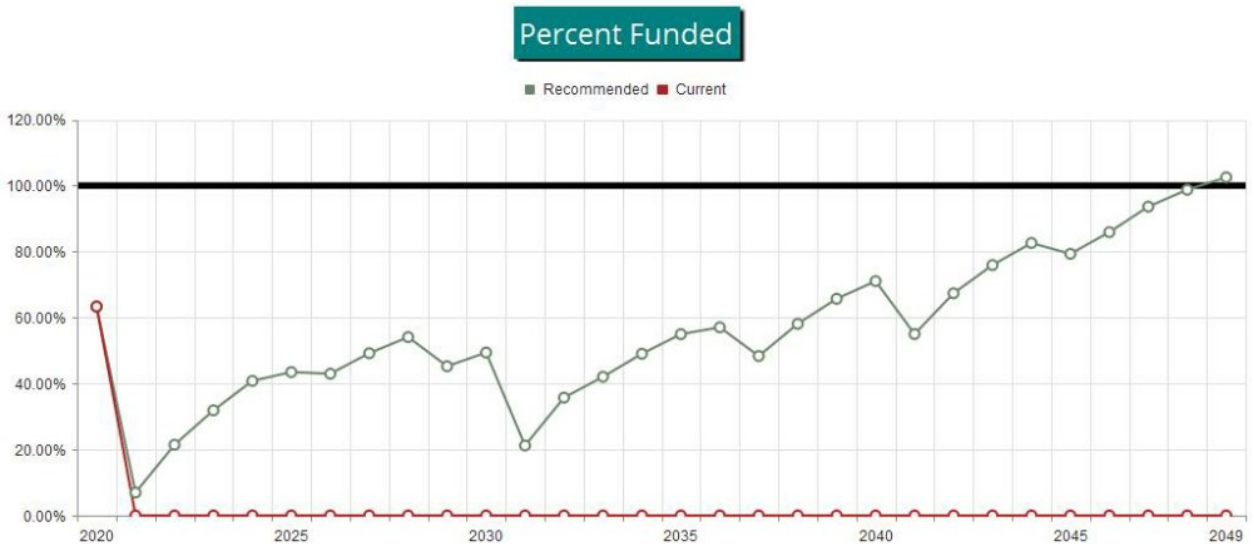
Figure 4

This chart shows the same information plotted on a Percent Funded scale. It is clear here to see how your Reserve Fund strength approaches the 100% Funded level under our recommended multi-year Funding Plan.

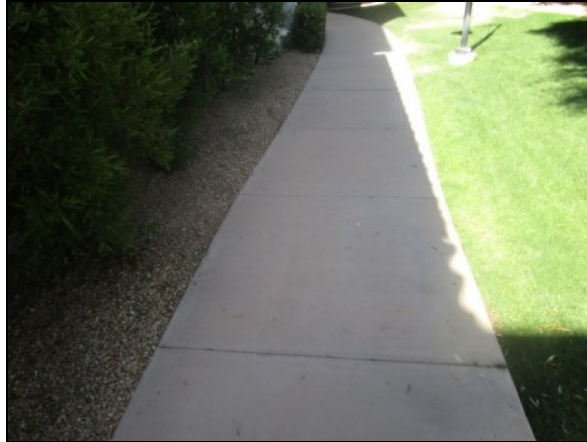
Useful Life:
5 years

Remaining Life:
2 years

Best Case: \$ 2,000

Worst Case: \$ 2,800

| # Component | Quantity | Useful Life | Rem. Useful Life | Current Cost Estimate | | |
|---|---|---|---|---|---|---|
| 103 | Walkways - Repair | Numerous Sq Ft | 5 | 2 | \$2,000 | \$2,800 |

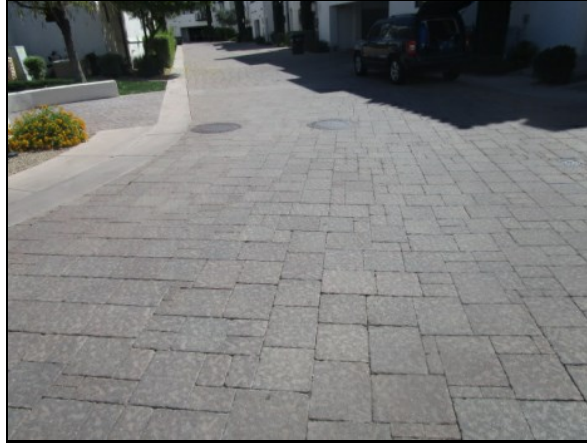
Useful Life:
10 years

Remaining Life:
0 years

Best Case: \$ 14,000

Worst Case: \$ 18,600

| # Component | Quantity | Useful Life | Rem. Useful Life | Current Cost Estimate | | |
|---|---|---|---|---|---|---|
| 205 | Pavers - Sand/Seal/Repair | Approx 31,000 Sq Ft | 10 | 0 | \$14,000 | \$18,600 |

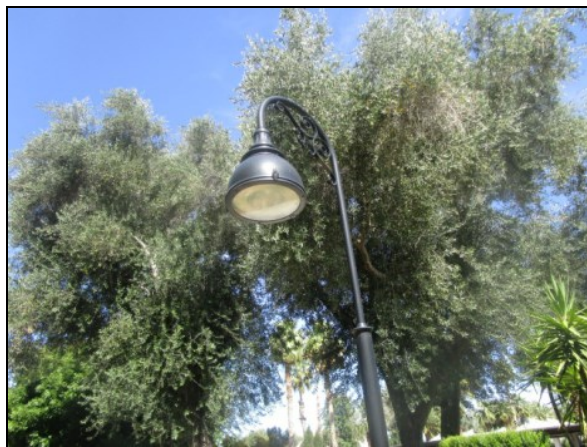
Useful Life:
35 years

Remaining Life:
24 years

Best Case: \$ 92,000

Worst Case: \$ 120,000

| # Component | Quantity | Useful Life | Rem. Useful Life | Current Cost Estimate | | |
|---|---|---|---|---|---|---|
| 320 | Pole Lights - Replace | (40) Pole Lights | 35 | 24 | \$92,000 | \$120,000 |

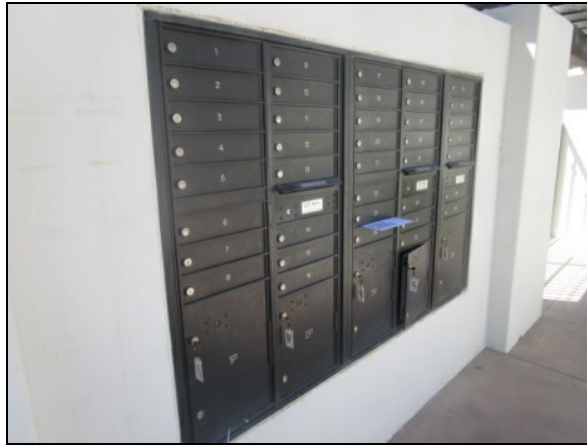
Useful Life:
20 years

Remaining Life:
9 years

Best Case: \$ 3,000

Worst Case: \$ 3,800

| # Component | Quantity | Useful Life | Rem. Useful Life | Current Cost Estimate | | |
|---|---|---|---|---|---|---|
| 403 | Mailboxes - Replace | ~40 Boxes mounted on Wall | 20 | 9 | \$3,000 | \$3,800 |

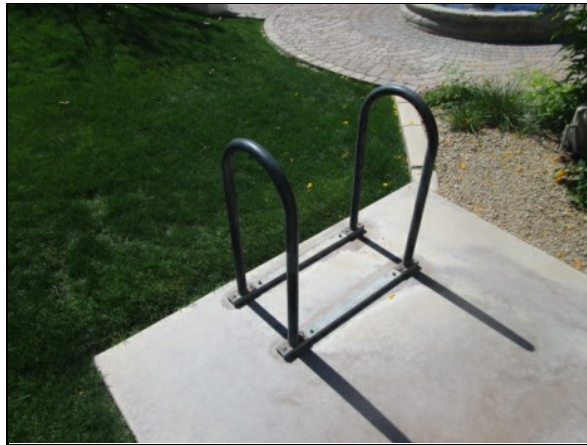
Useful Life:
20 years

Remaining Life:
9 years

Best Case: \$ 900

Worst Case: \$ 1,300

| # Component | Quantity | Useful Life | Rem. Useful Life | Current Cost Estimate | | |
|---|---|---|---|---|---|---|
| 405 | Bike Racks - Replace | (2) Racks | 20 | 9 | \$900 | \$1,300 |

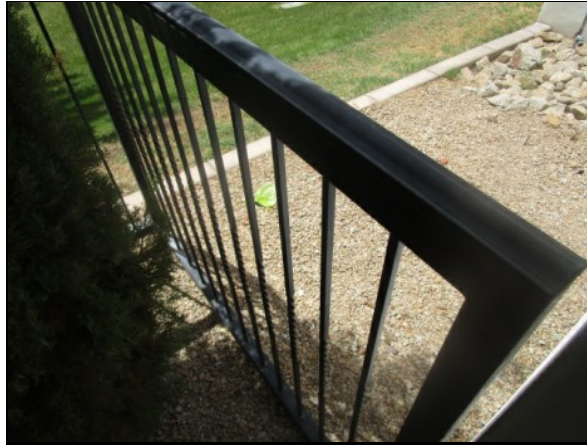
Useful Life:
24 years

Remaining Life:
13 years

Best Case: \$ 3,080

Worst Case: \$ 3,960

| # Component | Quantity | Useful Life | Rem. Useful Life | Current Cost Estimate | | |
|---|---|---|---|---|---|---|
| 503 | Metal Fence - Replace | Approx 88 LF | 24 | 13 | \$3,080 | \$3,960 |

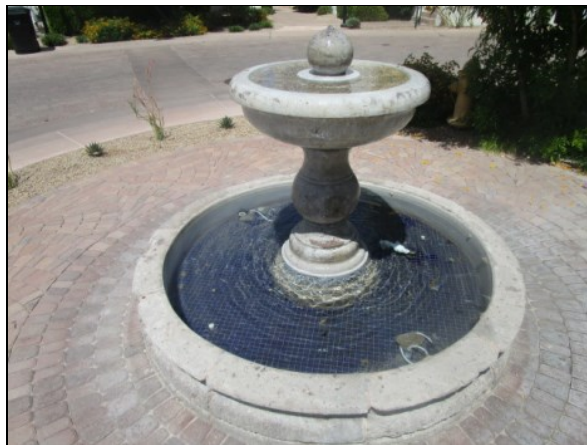
Useful Life:
20 years

Remaining Life:
13 years

Best Case: \$ 1,000

Worst Case: \$ 1,500

| # Component | Quantity | Useful Life | Rem. Useful Life | Current Cost Estimate | | |
|---|---|---|---|---|---|---|
| 650 | Fountain - Replace | (1) Fountain | 20 | 13 | \$1,000 | \$1,500 |

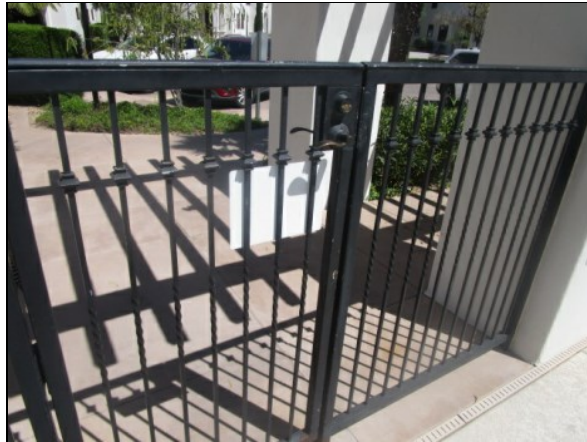
Useful Life:
24 years

Remaining Life:
13 years

Best Case: \$ 5,770

Worst Case: \$ 7,430

| # Component | Quantity | Useful Life | Rem. Useful Life | Current Cost Estimate | | |
|---|---|---|---|---|---|---|
| 503 | Metal Fence - Replace | Approx 165 LF | 24 | 13 | \$5,770 | \$7,430 |

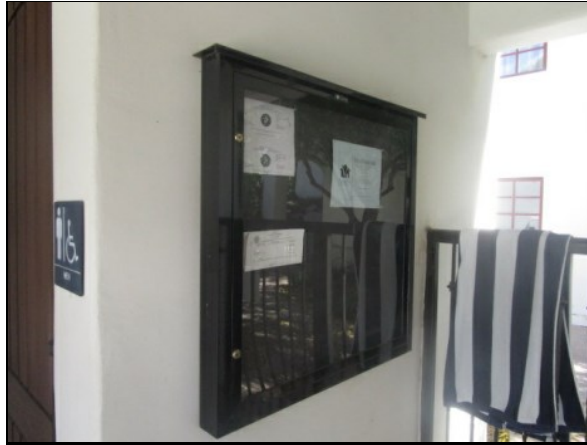
Useful Life:
15 years

Remaining Life:
7 years

Best Case: \$ 700

Worst Case: \$ 1,000

| # Component | Quantity | Useful Life | Rem. Useful Life | Current Cost Estimate | | |
|---|---|---|---|---|---|---|
| 640 | Bulletin Board - Replace | (1) Claridge Board | 15 | 7 | \$700 | \$1,000 |

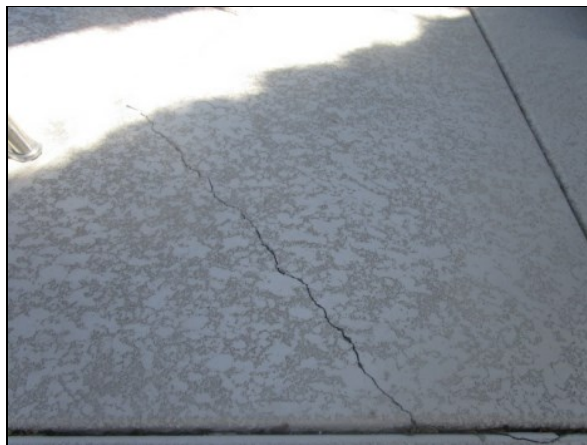
Useful Life:
4 years

Remaining Life:
0 years

Best Case: \$ 3,520

Worst Case: \$ 4,700

| # Component | Quantity | Useful Life | Rem. Useful Life | Current Cost Estimate | | |
|---|---|---|---|---|---|---|
| 1201 | Pool Deck - Seal/Repair | Approx 2,350 Sq Ft | 4 | 0 | \$3,520 | \$4,700 |

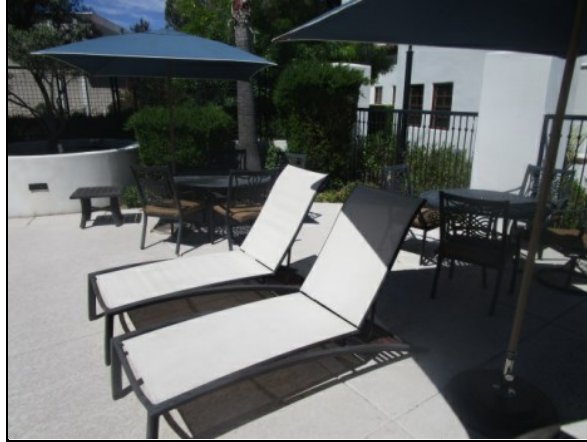
Useful Life:
10 years

Remaining Life:
2 years

Best Case: \$ 4,800

Worst Case: \$ 6,800

| # Component | Quantity | Useful Life | Rem. Useful Life | Current Cost Estimate | | |
|---|---|---|---|---|---|---|
| 1204 | Pool Furniture - Replace | (23) Assorted Pieces | 10 | 2 | \$4,800 | \$6,800 |

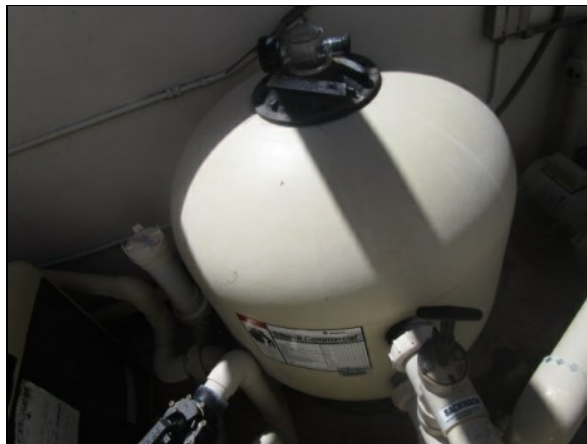
Useful Life:
15 years

Remaining Life:
4 years

Best Case: \$ 1,100

Worst Case: \$ 1,600

| # Component | Quantity | Useful Life | Rem. Useful Life | Current Cost Estimate | | |
|---|---|---|---|---|---|---|
| 1220 | Pool Filter - Replace | (1) Triton II, TR-100 | 15 | 4 | \$1,100 | \$1,600 |

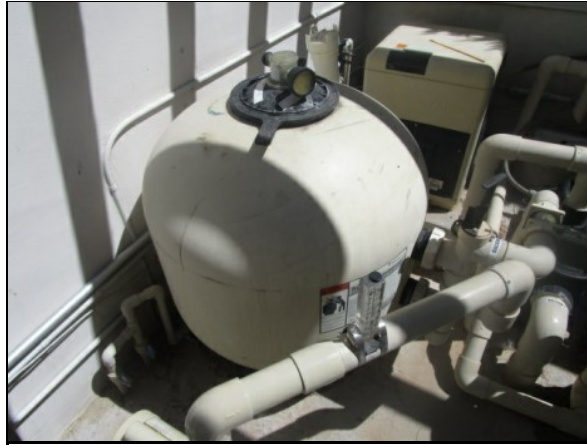
Useful Life:
15 years

Remaining Life:
4 years

Best Case: \$ 1,100

Worst Case: \$ 1,600

| # Component | Quantity | Useful Life | Rem. Useful Life | Current Cost Estimate | | |
|---|---|---|---|---|---|---|
| 1221 | Spa Filter - Replace | (1) Triton II, TR-100 | 15 | 4 | \$1,100 | \$1,600 |

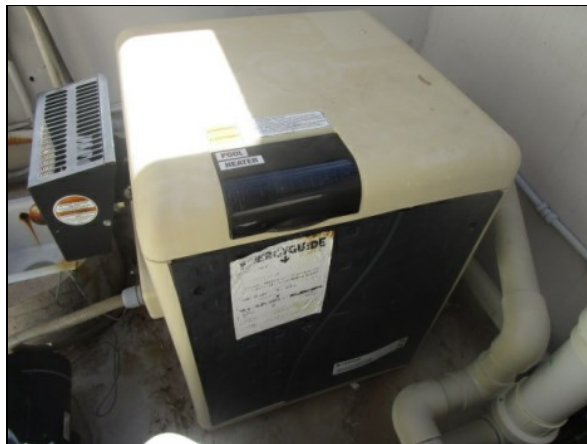
Useful Life:
8 years

Remaining Life:
6 years

Best Case: \$ 2,500

Worst Case: \$ 3,000

| # Component | Quantity | Useful Life | Rem. Useful Life | Current Cost Estimate | | |
|---|---|---|---|---|---|---|
| 1222 | Pool Heater - Replace | (1) MasterTemp 400 | 8 | 6 | \$2,500 | \$3,000 |

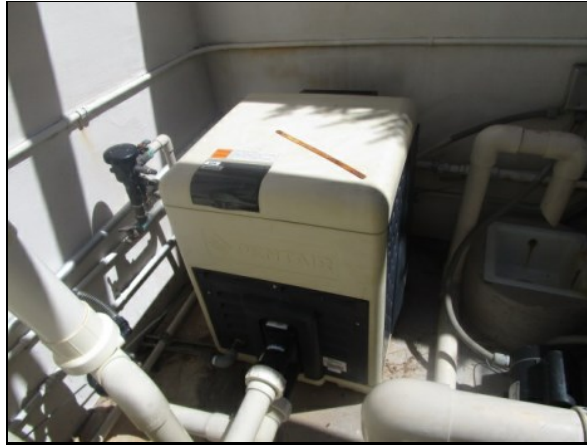
Useful Life:
8 years

Remaining Life:
5 years

Best Case: \$ 2,200

Worst Case: \$ 2,250

| # Component | Quantity | Useful Life | Rem. Useful Life | Current Cost Estimate | | |
|---|---|---|---|---|---|---|
| 1223 | Spa Heater - Replace | (1) MasterTemp 250 | 8 | 5 | \$2,200 | \$2,250 |

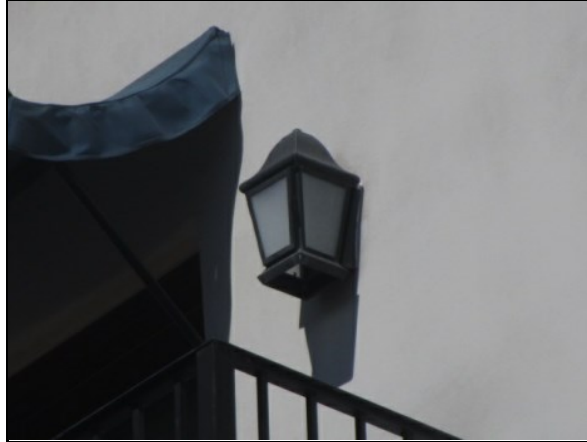
Comp #: 324 Wall Lights - Replace

Comments: Still attractive and assumed to be functional. Future replacement should be anticipated to update and modernize the appearance.

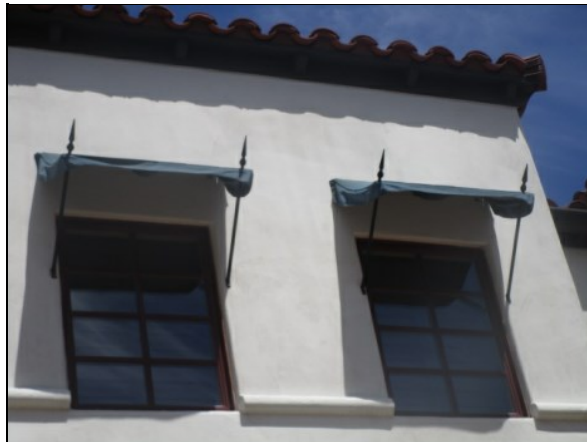
Comp #: 401 Awnings - Replace

Funded?: No. The association is responsible to maintain the awning support components, but not the fabric. There is no expectancy to replace the support components.

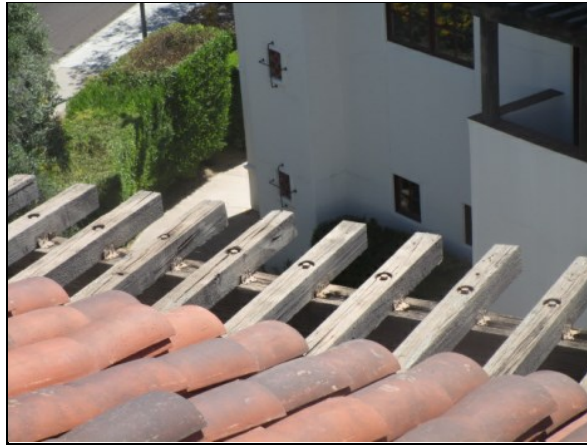
Comp #: 510 Wood Pergolas - Replace

Comments: The association is responsible for maintenance, repairs, and future replacement of the wood pergolas. Appear structurally stable and secure. Useful life assumes pergolas will be repainted/restained periodically to protect and preserve the wood. Combined cost with the repair component accounts for the total estimated replacement budget.

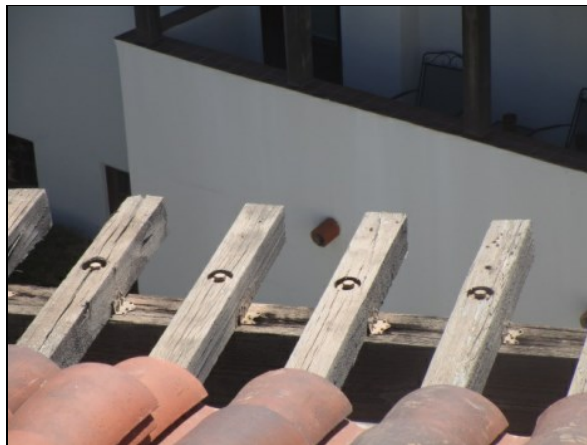
Comp #: 511 Wood Pergolas - Repair

Comments: This project consists of framing, re-flashing, and miscellaneous repairs. Continue to monitor and adjust as needed in future Reserve Study updates.

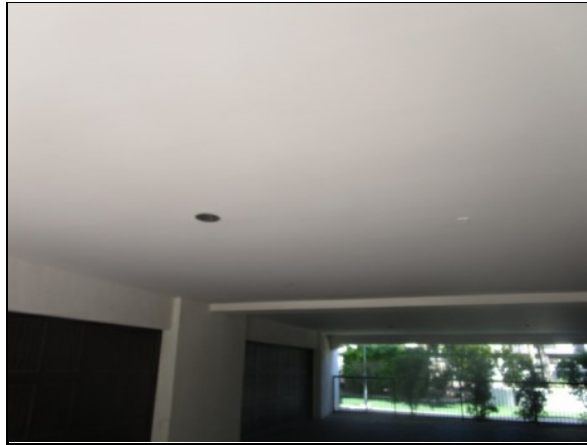
Comp #: 580 Ceilings - Repair

Comments: The ceiling areas adjacent to the garages are composed of drywall, not stucco. Repairs and issues have been reported in the past. This component provides an allowance for periodic repairs to the drywall ceilings. No problems observed or reported while on-site in 2019. The remaining useful life has been extended.

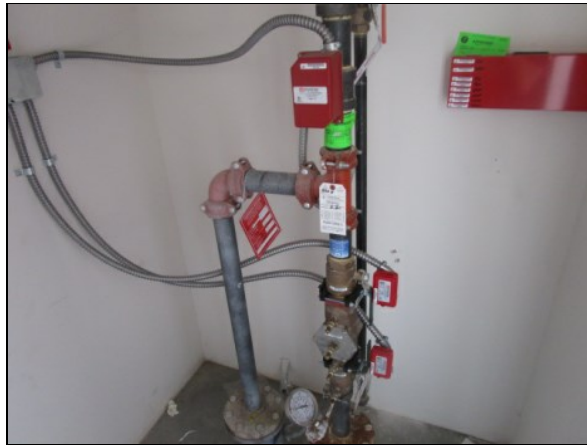
Comp #: 810 Fire Risers - Replace

Funded?: No. Typically, fire risers are repaired on an as-needed basis with no foreseeable need for replacement. No Reserve funding required.

Comments: Risers appeared to be in good physical condition. No reported problems.

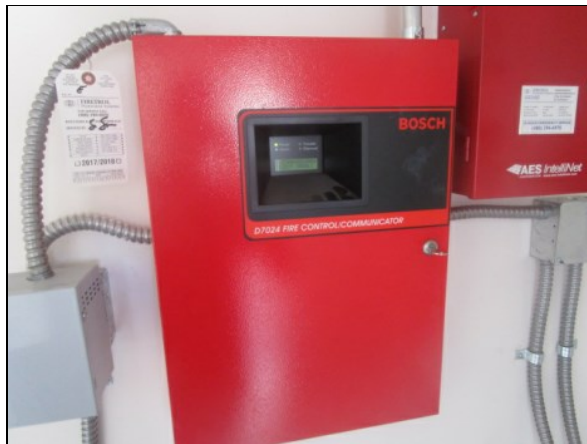
Comp #: 815 Fire Alarm Panels - Replace

Comments: We are not authorized to test or inspect these units. Professionally service and inspect as required. Future replacement should be anticipated. Model: D7024.

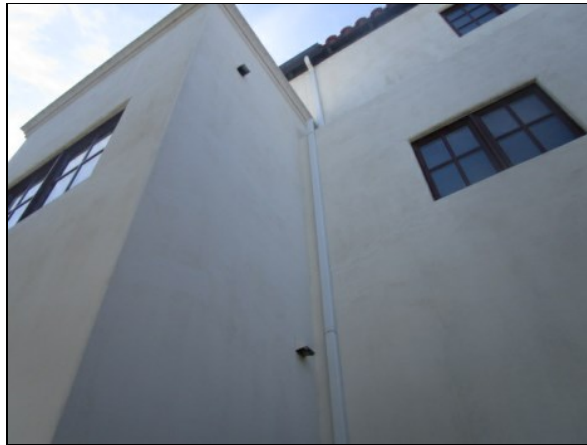
Comp #: 1114 Stucco Surfaces - Repair

Comments: We are planning for a moderate amount of repairs to be done in addition to painting roughly every other painting cycle. Continue to monitor and adjust as needed in future Reserve Study updates.

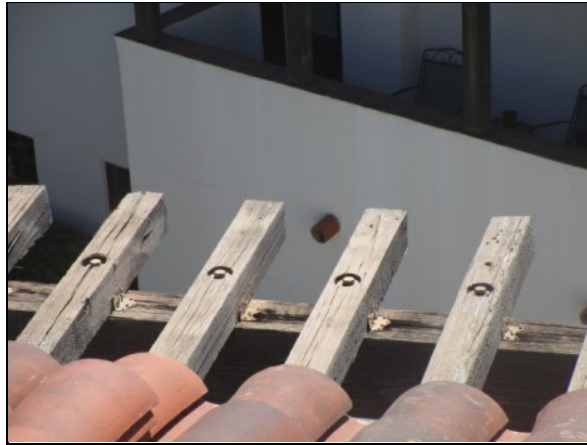
Comments: Surfaces are dry/cracking and need to be painted at this time. The association plan to paint as soon as the construction defect case is completed. Repaint periodically to maintain the appearance and to protect the wood. Treat periodic touch-ups as an Operating expense.

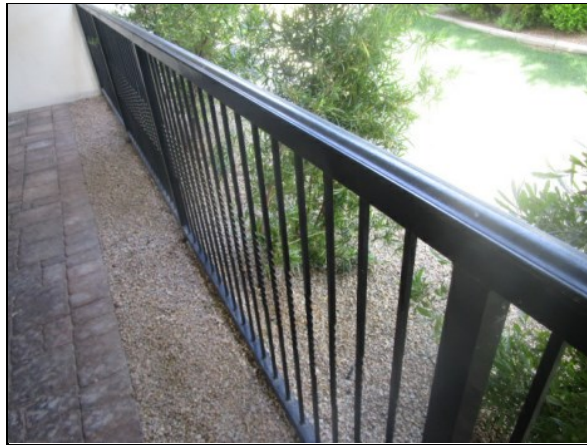
Comments: Fair conditions were noted. The association plans to paint as soon as the construction defect case is completed. Repaint periodically to maintain the appearance and to inhibit rust. Treat periodic touch-ups as an Operating expense.

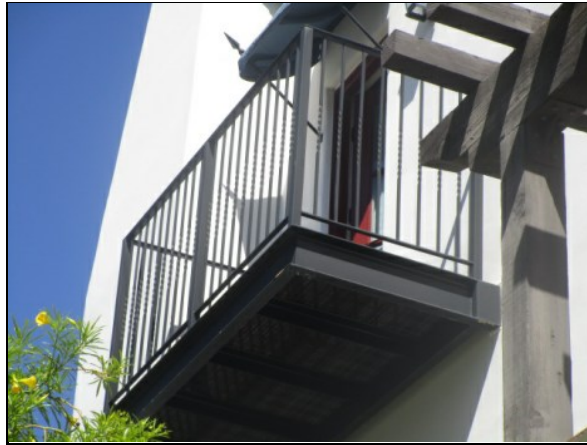
Comp #: 1150 Balconies - Replace (Metal)

Funded?: No. The association is responsible for maintenance and repairs of the balconies. There is no expectancy for replacement of the metal balconies. Total square feet of the metal balconies is approximately 1,020. Repainting is included with the metal surfaces under component #1117.

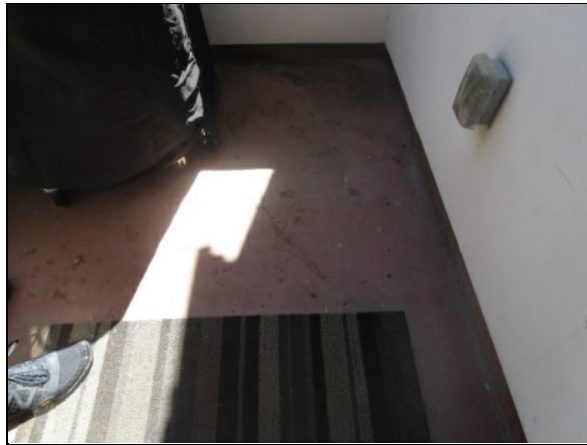
Comp #: 1151 Balcony Decks - Seal/Repair

Comments: The association is responsible for maintenance and repairs of the balcony deck structures. Each owner is responsible for the tile surfaces. This component provides funding to seal and waterproof the decks. The vendor recommends this project is completed every 5-6 years.
